March 7, 2019

SITE VISIT REPORT (SVR)

Salinas El Gabilan Library

1400 Main Street
Salinas, California

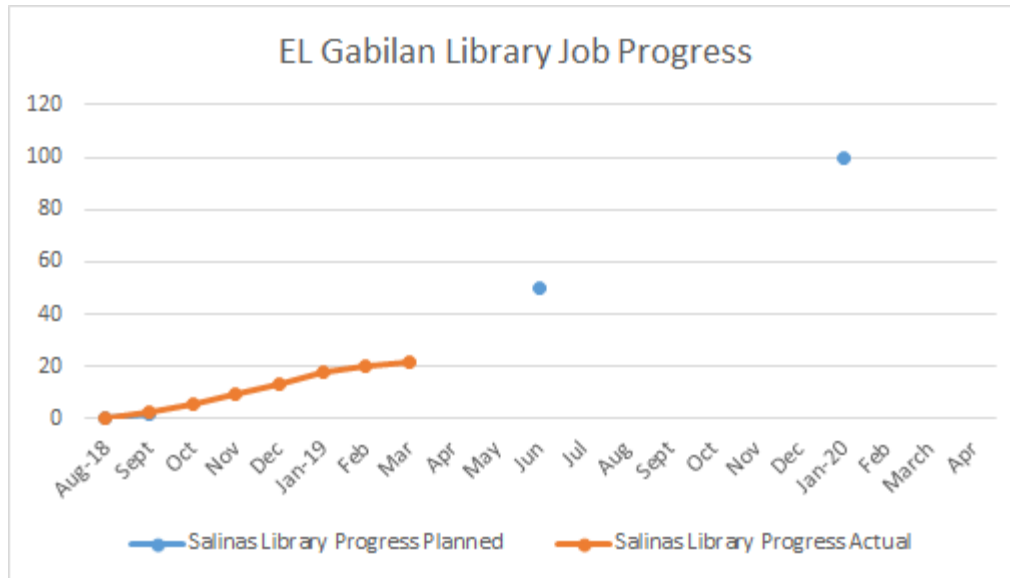
As indicated by the slope of the following graph, the work pace is slower than expected and must increase in the next several months to achieve completion on time.

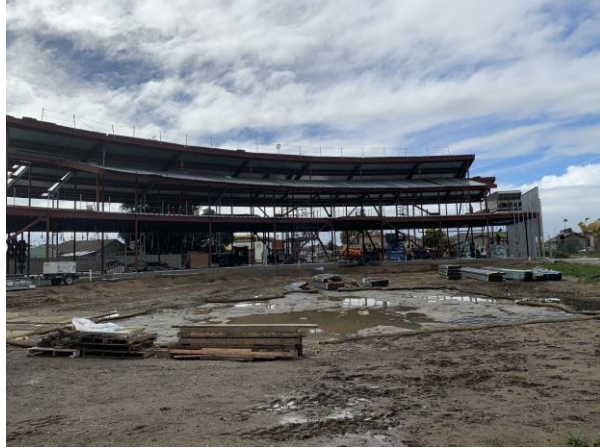
Steel decking spread over 98% of roof framing

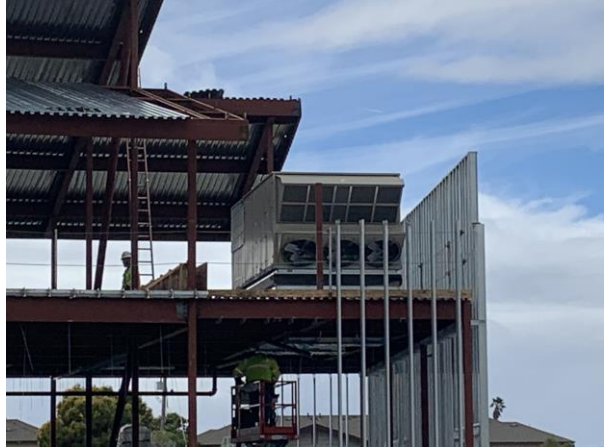
Framing exterior wall north end of east wall

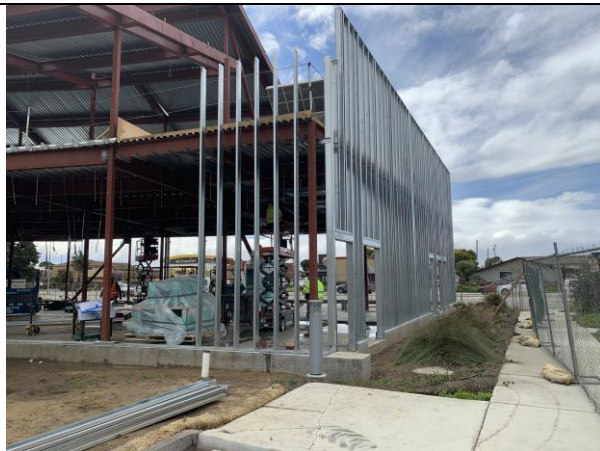
North wall framing in place

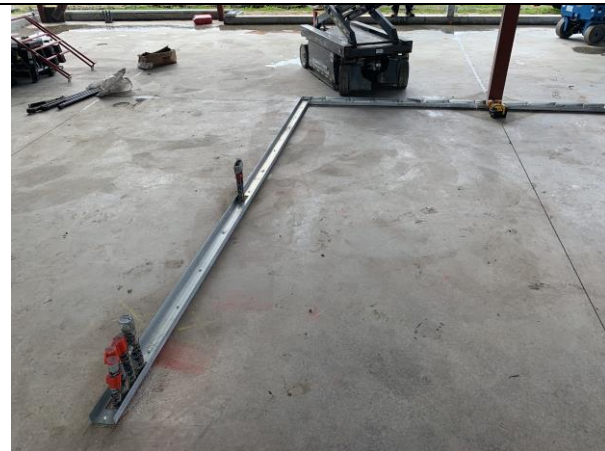
First floor wall framing lower track

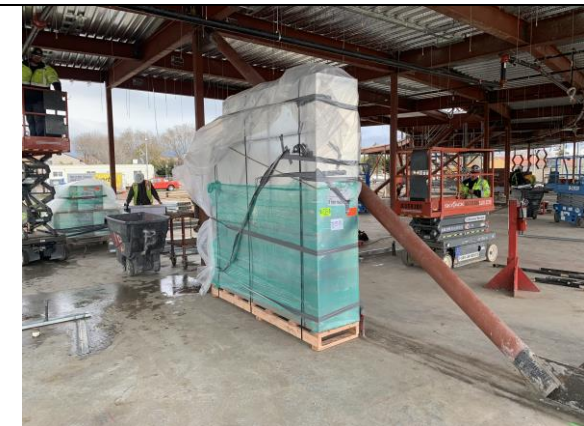
HVAC duct materials on site floor 1

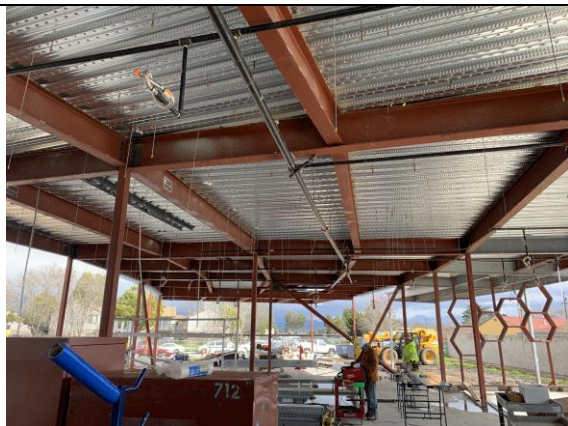
Completed fire sprinklers level 1

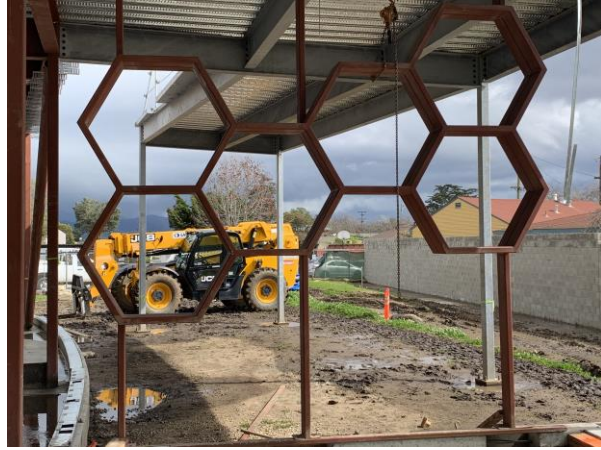
Art wall support installed

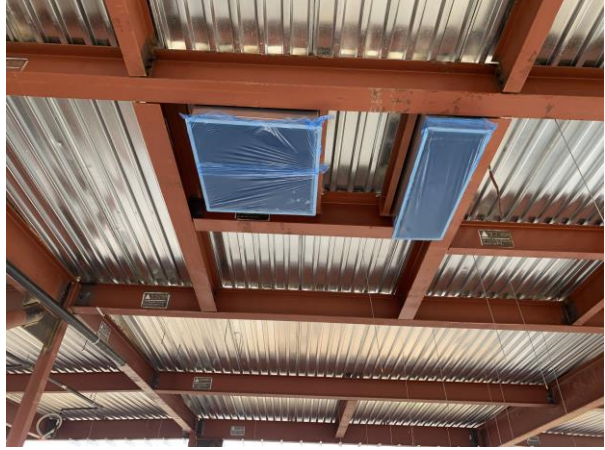
Duct drops through roof deck from rooftop A/C units

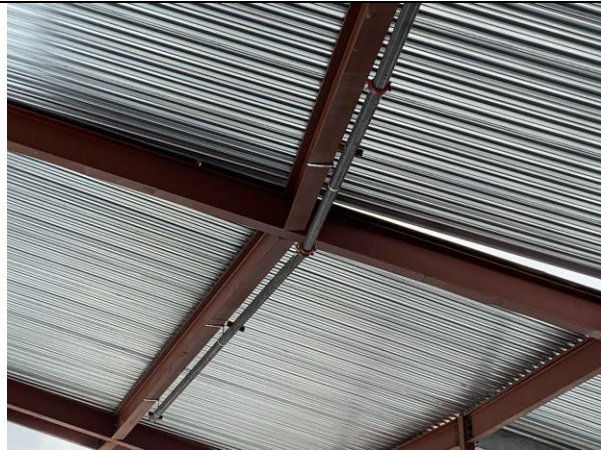
Floor 2 sprinkler main started

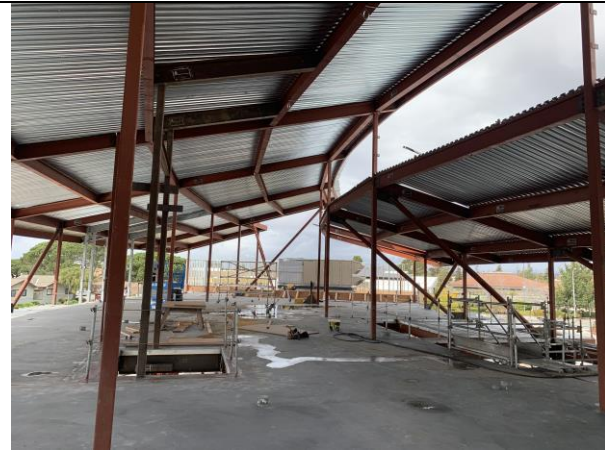
Second floor concrete deck completed

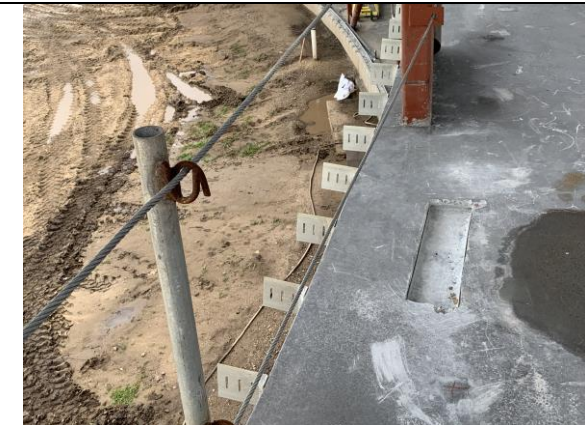
Metal clips for attachment of wall framing

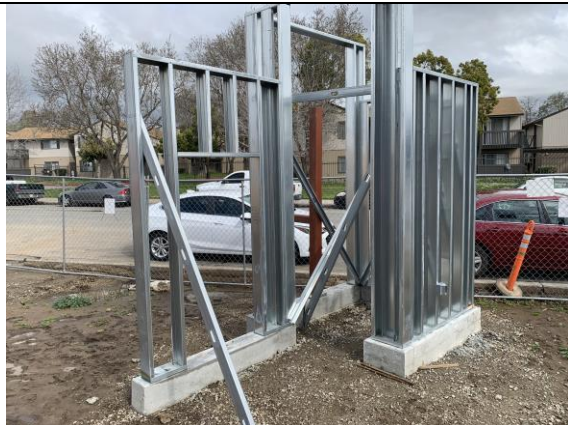
Exterior wall mock up framed
