Historic Structures Report

37-39 Soledad Street

City of Salinas, California | February 2026

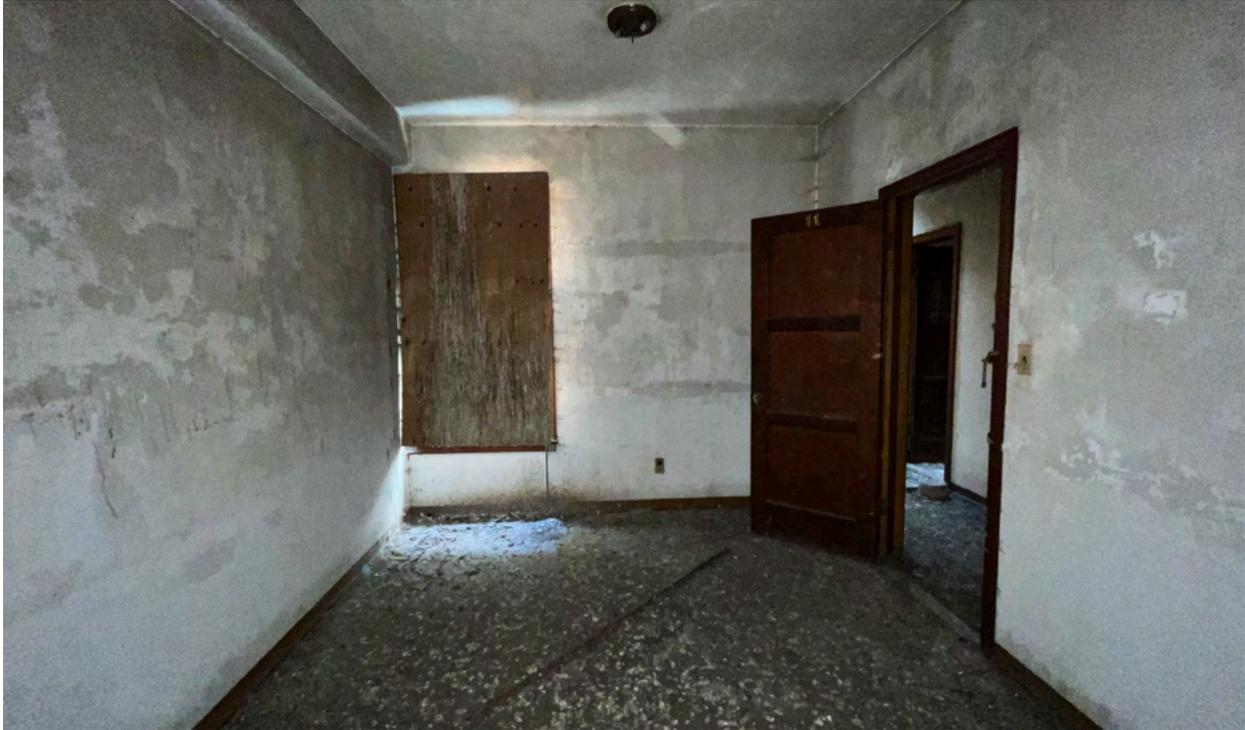
Figure 2.51 (Top) Second floor boarding room with damaged roof, looking west, Groundwork Preservation LLC, 2025.

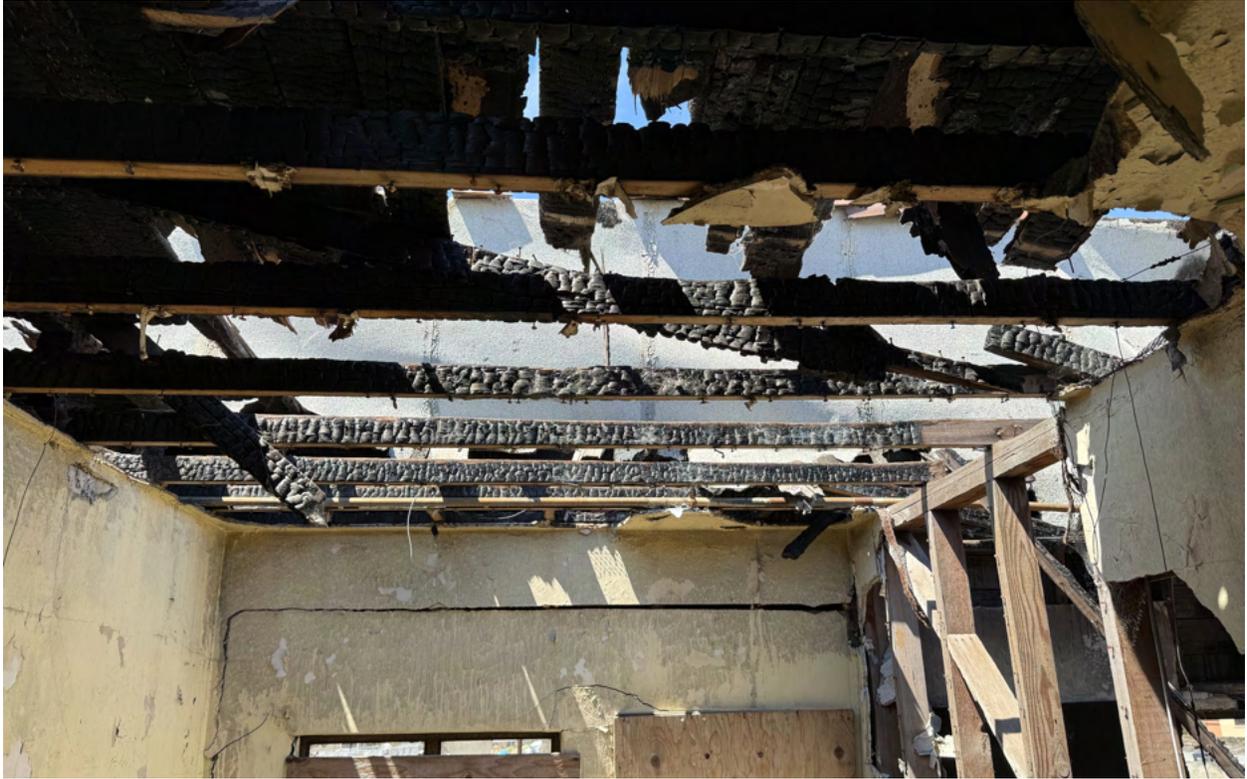
Similarly, leaks from domestic water service (presumed to have occurred over the lifetime of the building) have caused localized decay of framing around bathrooms and kitchens within the space. Removal and replacement of decayed framing will be required during future phases of the site redevelopment.

Figure 4.7 (Top) Fire damage at roof and ceiling framing at 39 Soledad Street, Tipping, 2025.

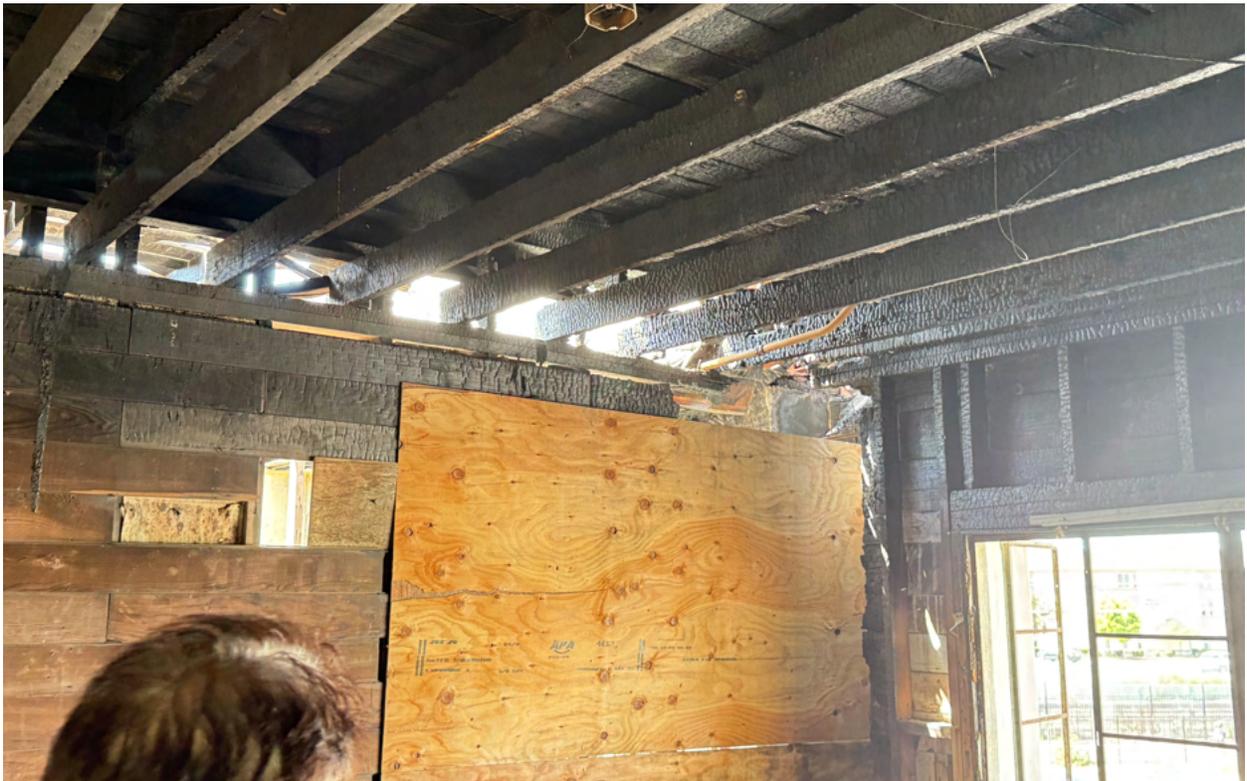
Figure 4.8 (Bottom) Fire damage at central demising wall within 37 Soledad, Tipping, 2025.

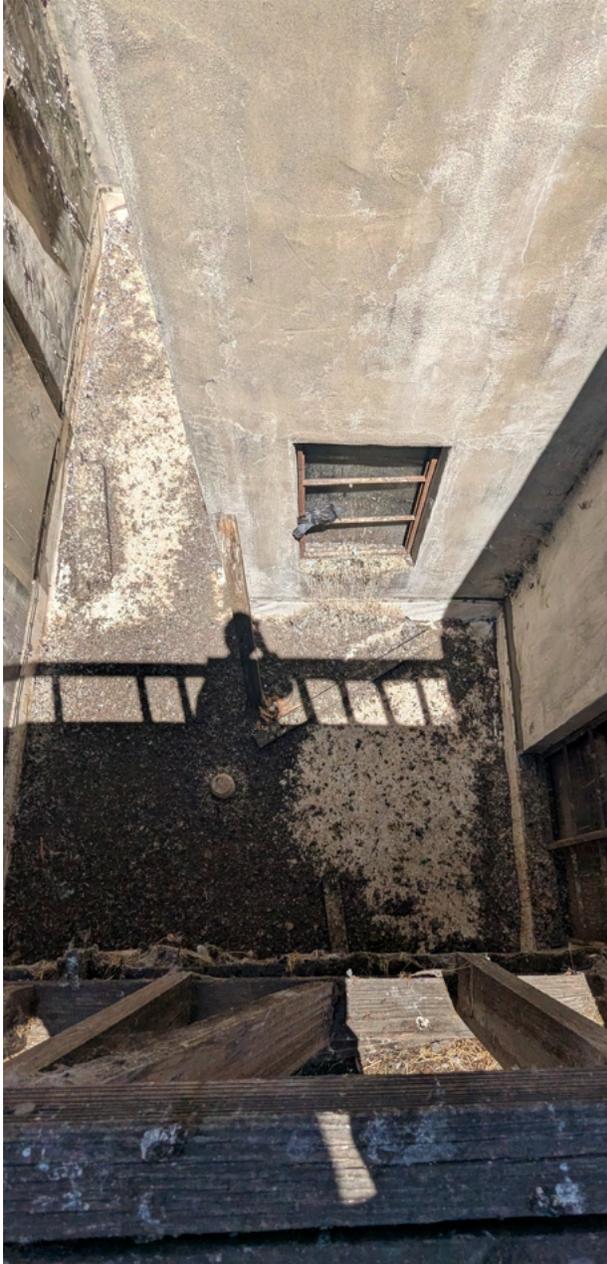
- Lightwell 1 at the building rear has been inhabited by pigeons and has been heavily impacted by bird guano and nesting (Figures 5.3 and 5.4). It is difficult to tell the condition of the TPO roofing but is likely in fair condition. While a roof drain and overflow drain are visible, they likely do not drain. The through wall vents and windows at this opening are all in very poor condition. At the south and west walls, portions of the exterior cement plaster is missing with plywood covering or exposed wood framing. The conditions of these wall areas are extremely poor (Figure 5.5).

Figure 5.3 (Left) The lightwell at the rear of the building houses nesting pigeons, TEF, 2025.

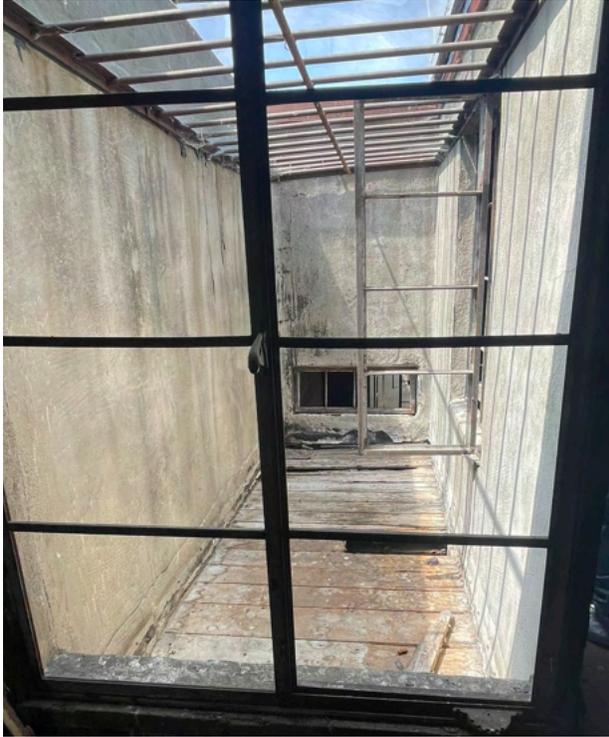
Figure 5.14 (Top Left) Lightwell 2 is in poor condition, Groundwork Preservation, LLC, 2025.

- Lightwell 2, the floor of which is visible from the third floor, has no roofing and no visible means of drainage. The 1x4 wood sheathing is weathered and damaged and the flashing at perimeter is inadequate and poorly executed (Figures 5.14 and 5.16). It is in poor condition. Although a floor/roof drain is not readily evident, a through-wall scupper with conductor head and downspout is evident at Lightwell 6, directly adjacent to Lightwell 2 in Building 39 (Figure 5.15) and may have originally served this lightwell (Additional investigation is recommended). The extant windows and through wall vents are in poor condition and areas of exposed wall are significantly degraded.

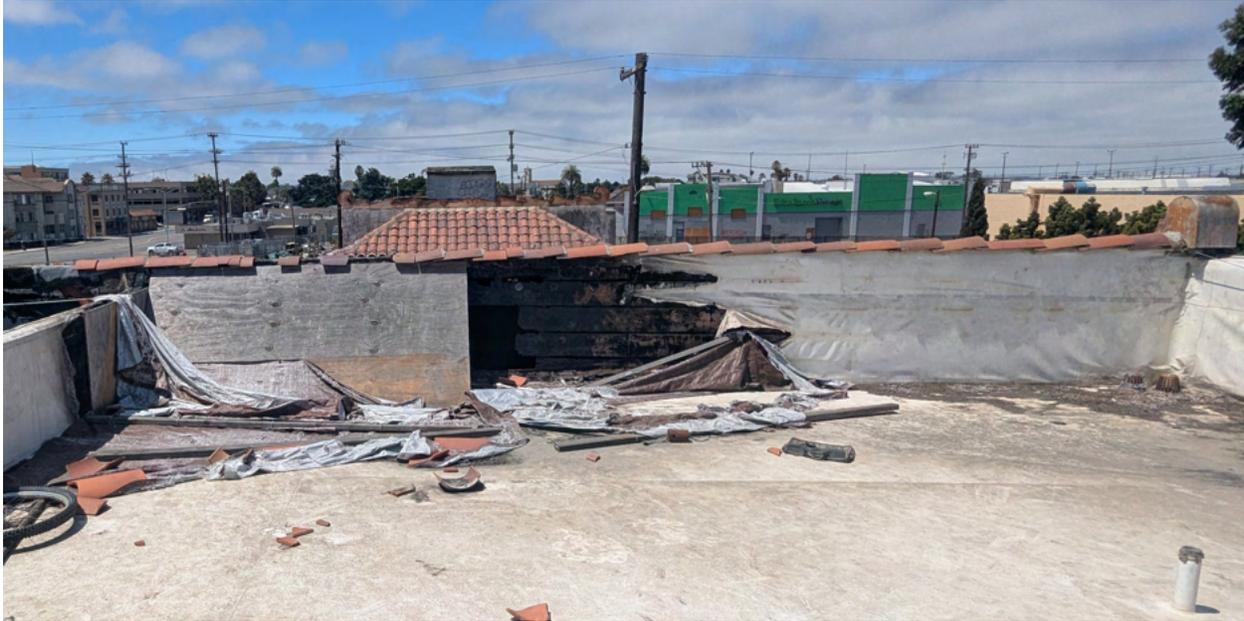
- The barrel clay tiles installed across the front parapet wall are in poor condition. Many are broken, loose, or have fallen off the wall. They present a fall hazard (Figure 5.22).

Figure 5.22
(Top) The burned portion of roof and parapet wall at the west end of the building, TEF, 2025.

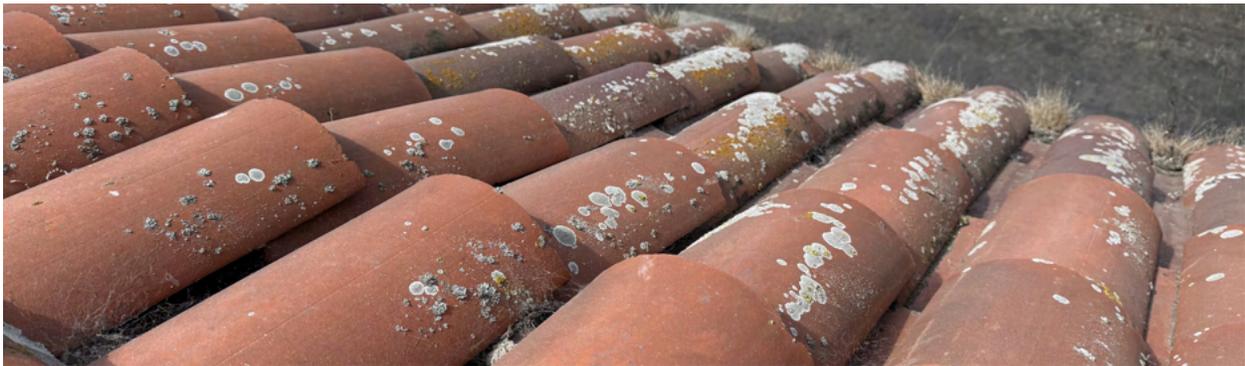
Figure 5.25

- A lack of maintenance has led to a buildup of debris between the tiles. There is evidence of bio growth on and between the tiles, some tiles appear loose and/ or broken (Figure 5.25).
- The 1x wood board soffit has peeling paint and may be water damaged. A small area is missing at the fire-damaged area (Figure 5.26).
- The painted metal ogee gutters at the pent roof eave have rusted through in many locations and have grass growing in them (Figure 5.26). There is no downspout attached to the gutter. Historic photos of the building show a gutter previously existed at the north end of the front façade (see report cover photo).

(Top) Close up view of the barrel clay tiles on the pent roof, Tipping Structural Engineers, 2025.

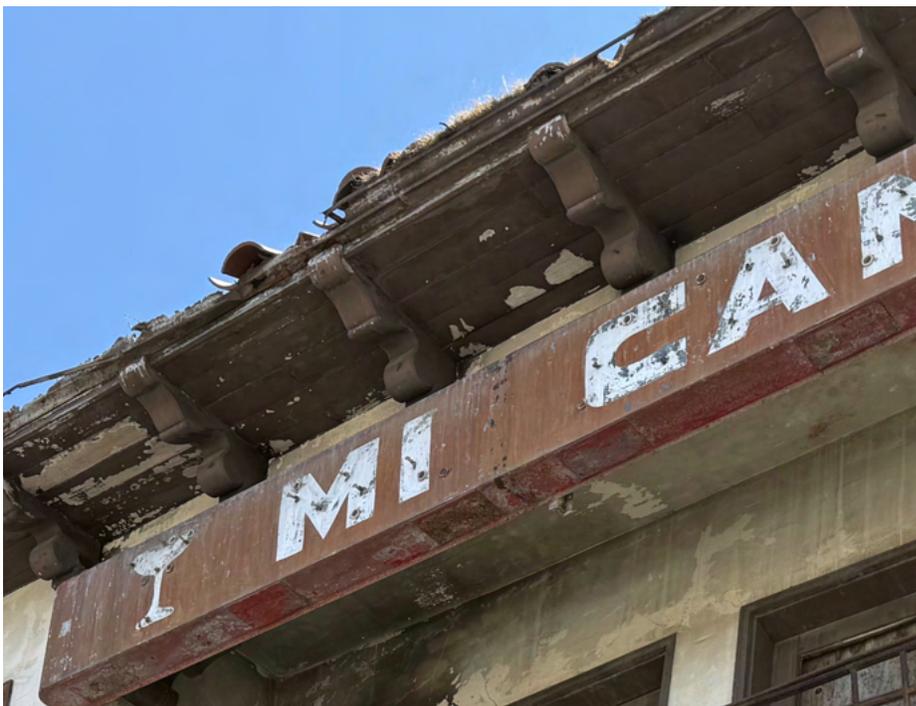
Figure 5.26

(Bottom) View of burned portion of pent roof from below, TEF, 2025.

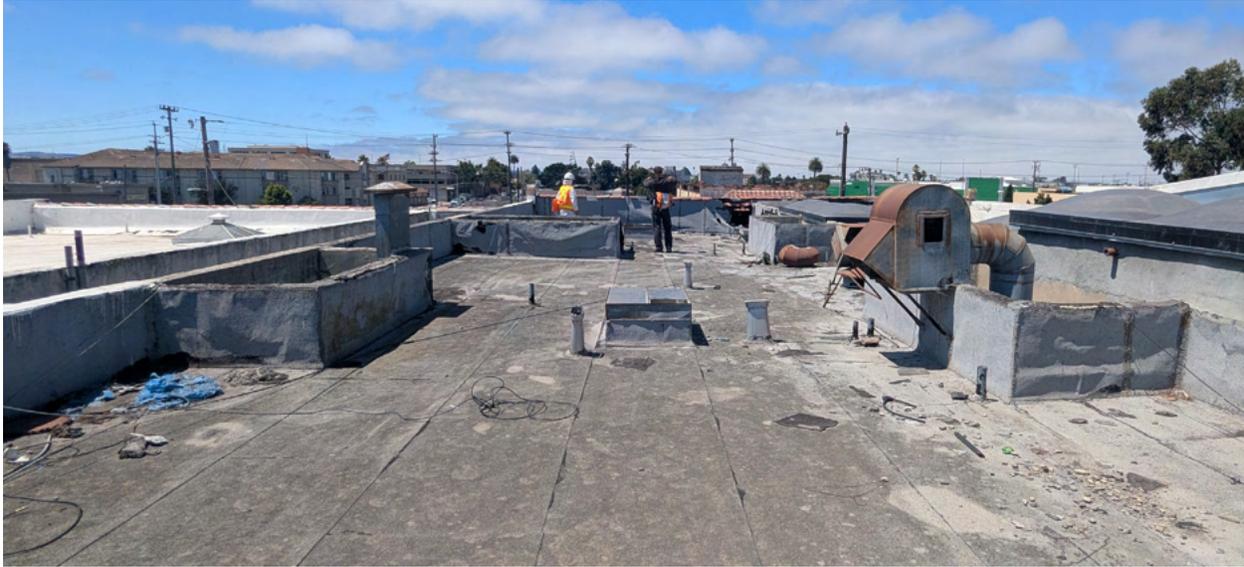
Figure 5.27 (Top) The main roof of 39 is beyond its useful life, TEF, 2025.

Overall, the main roof of 39 Soledad is in extremely poor condition. The existing asphaltic roofing is beyond its useful life and has been patched in many locations (Figure 5.27). The west end of this roof was similarly damaged by fire and has collapsed. Only one roof drain was located for the entirety of this roof within the burned area of roofing – it is not extant. The roof at the rear one-story building similarly is in extremely poor condition. In multiple locations the roof appears to have failed with visible holes through the roof (Figure 5.28). It is a collapse hazard.

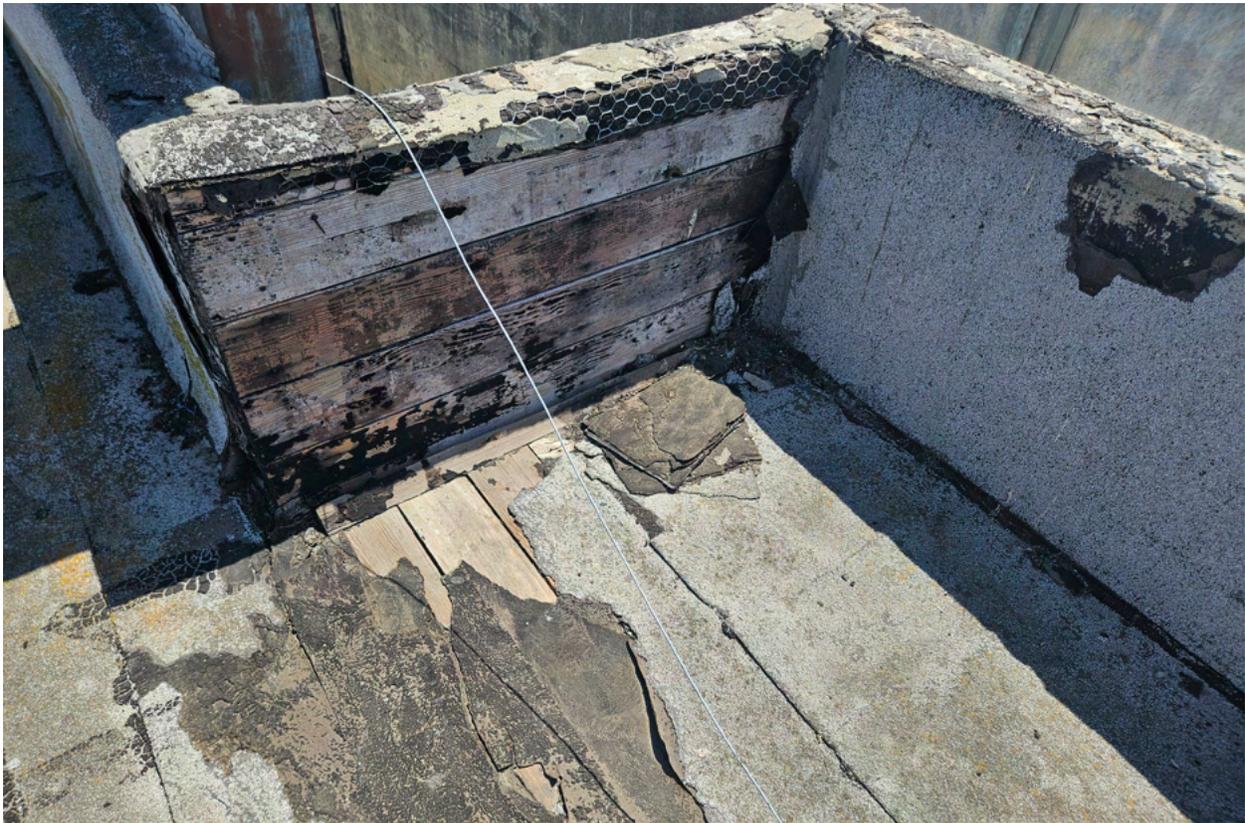
Figure 5.31 (Bottom) Parapet damage at wood-framed wall of Building 39, TEF, 2025.

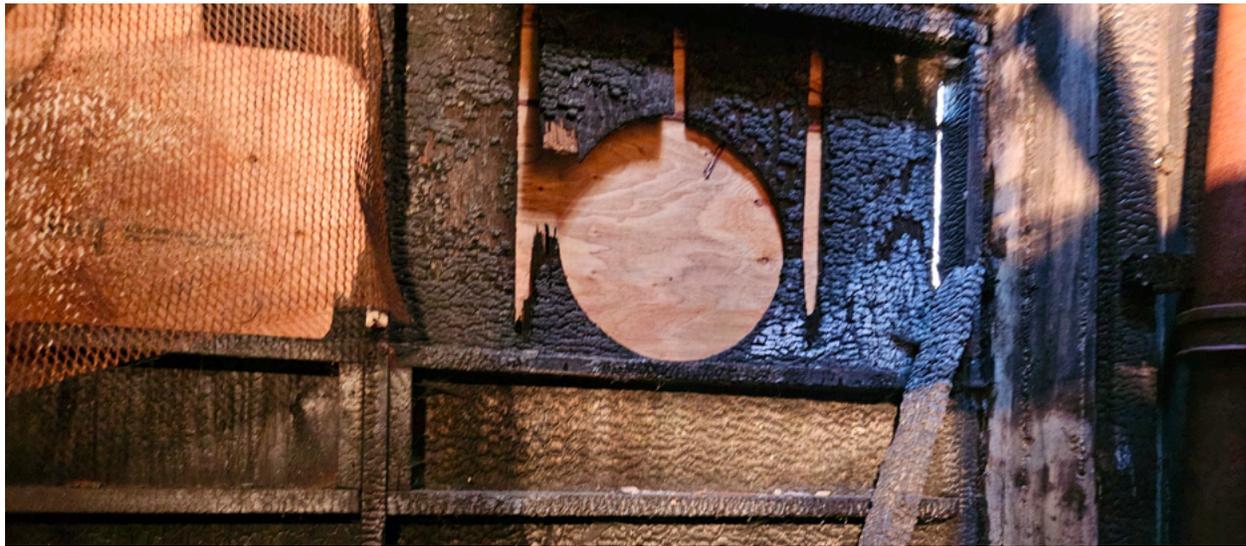
Figure 5.75 (Top) The front storefront and display are fire damaged, TEF, 2026.
