FACILITY CONDITION ASSESSMENT

100 Howard Street
100 Howard Street
Salinas, California 93901

AEI Project No. 448476

City of Salinas
200 Lincoln Avenue
Salinas, California 93901

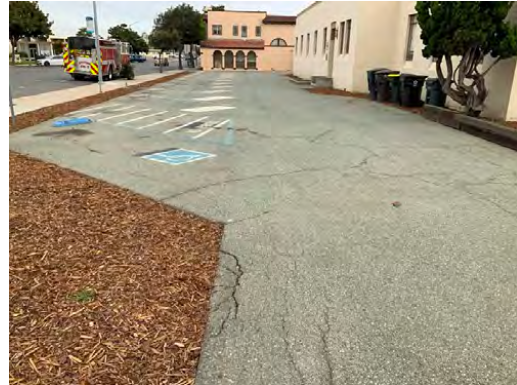
West parking lot cracking

Crack sealing, seal coating, and re-stripping of the asphalt paving are recommended in the short term as well as periodically during the evaluation period. An opinion of cost for this work is included in the Tables.

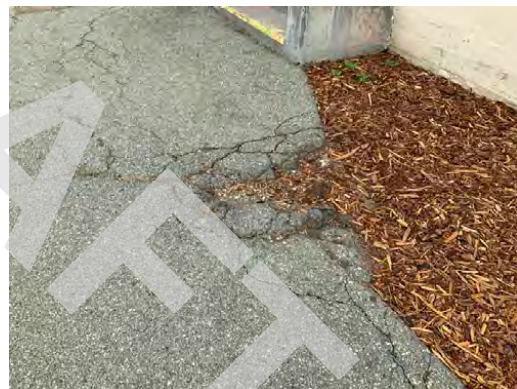
Asphalt damage

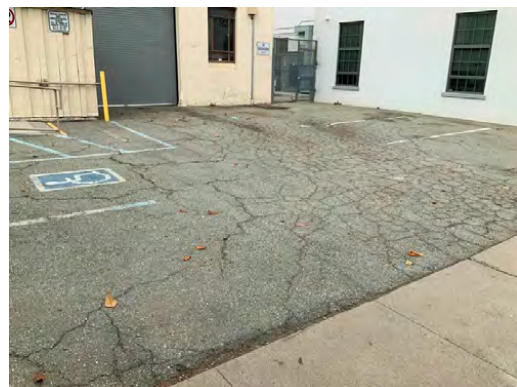
East parking area deteriorated asphalt

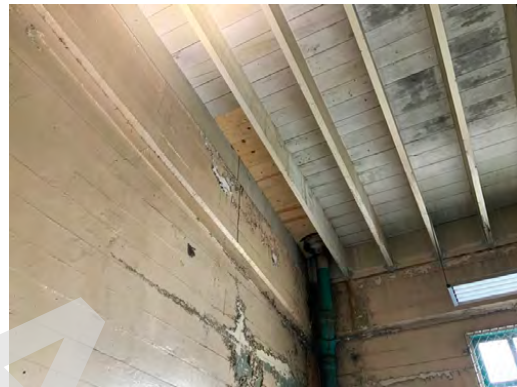
Repaired roof decking

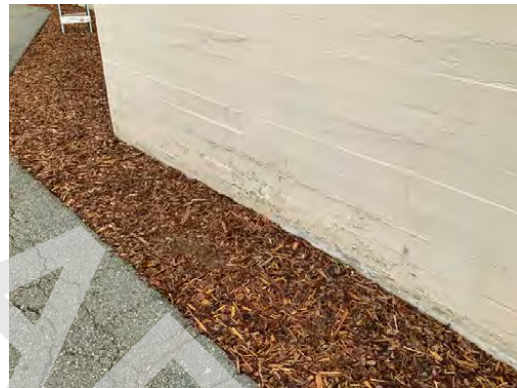
Peeling exterior paint

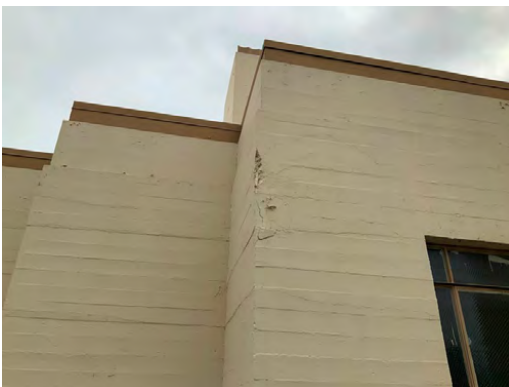
Exterior wall damage

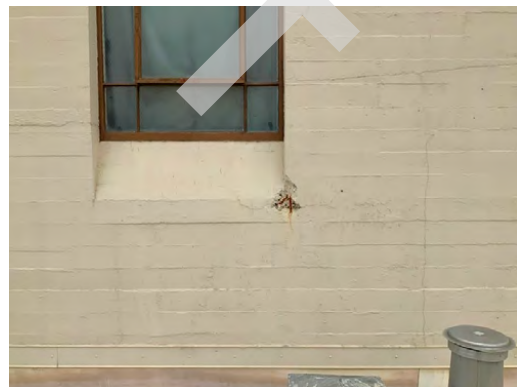
Exterior wall exposed rebar

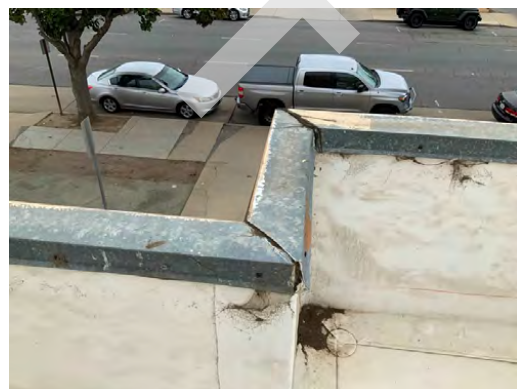
Coping deteriorated sealant

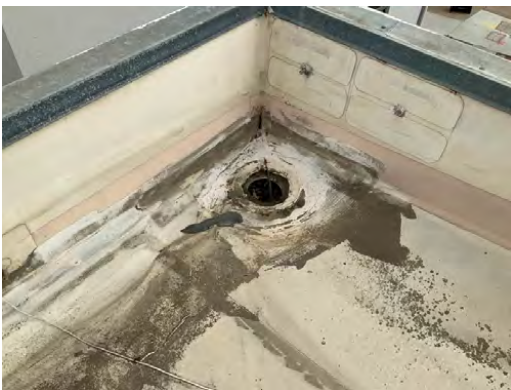
Missing roof drain dome

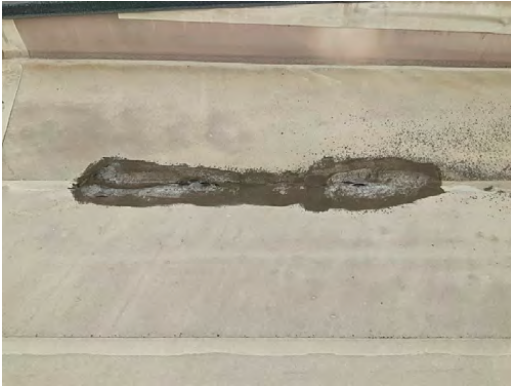
Roof repair damage

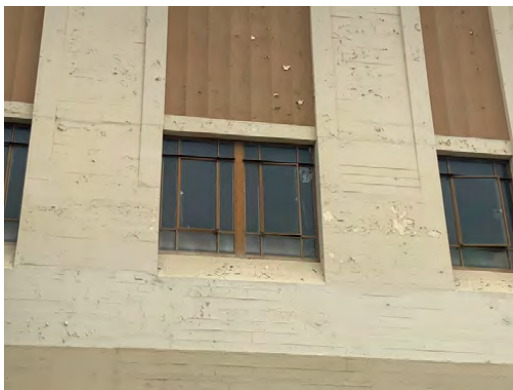
Damaged window on the south elevation

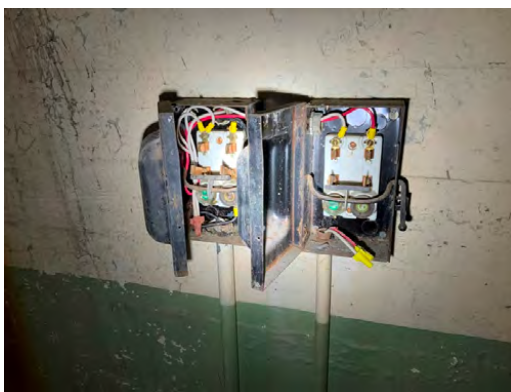
In addition to the screw in fuses, AEI observed knob and tube wiring beneath the stage. Based on the combination of different electrical wiring systems in the building, AEI recommends an electrical upgrade in order to ensure that antiquated systems are removed and replaced. A budgetary allowance for this work is included in the Tables.

Basement screw in fuses

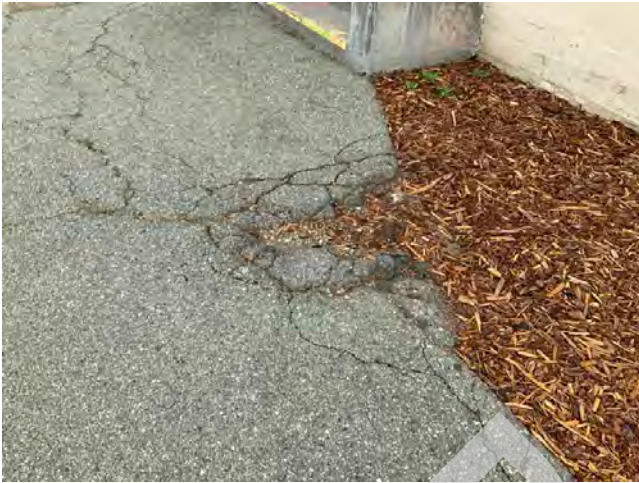
5. Asphalt damage

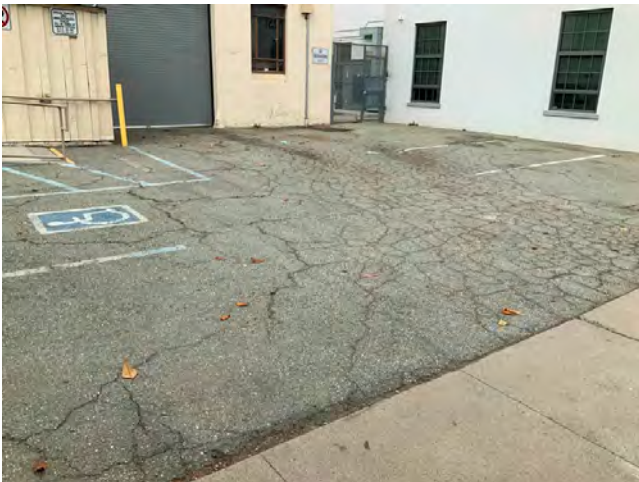
7. Deteriorated asphalt

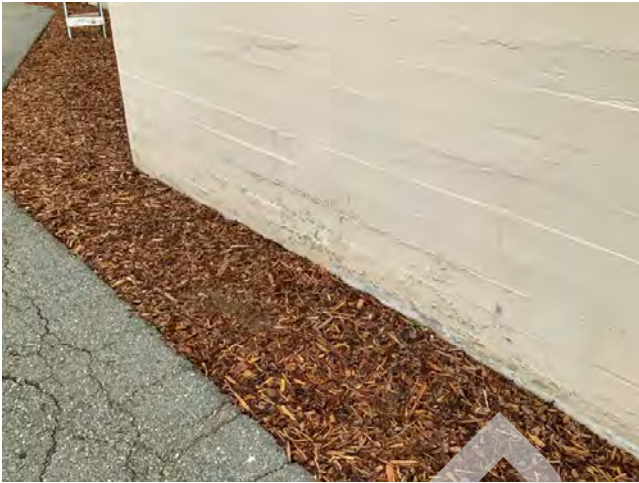
37. Peeling exterior paint

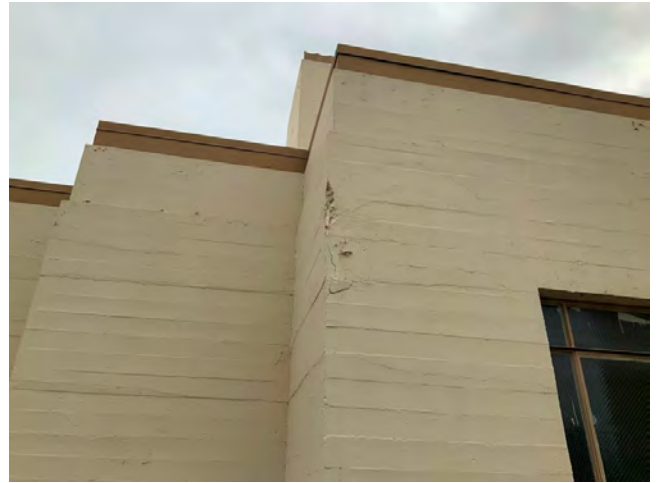
38. Exterior wall damage

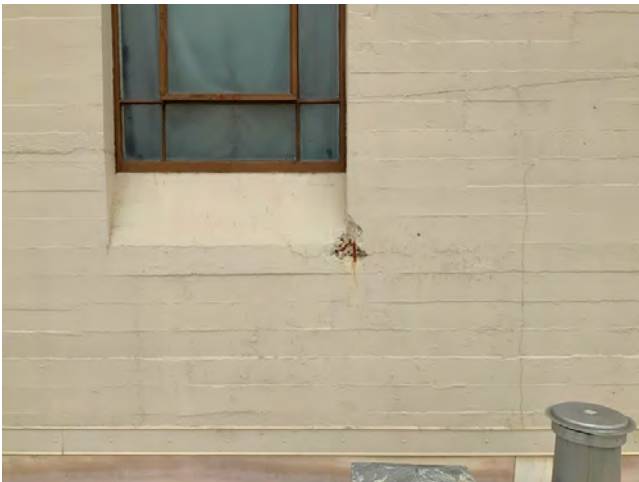
39. Exterior wall exposed rebar

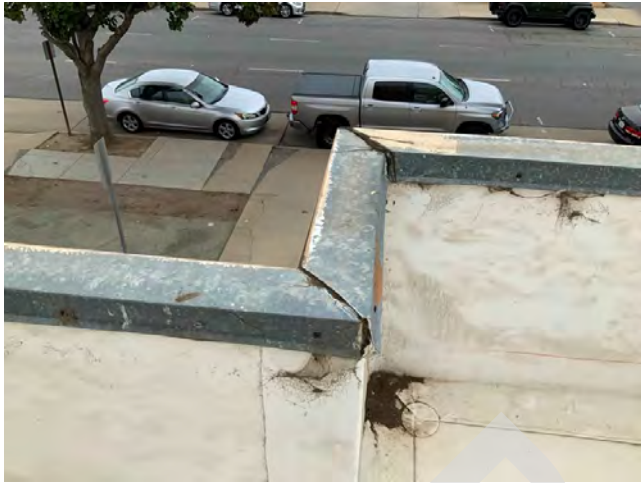
45. Coping missing sealant

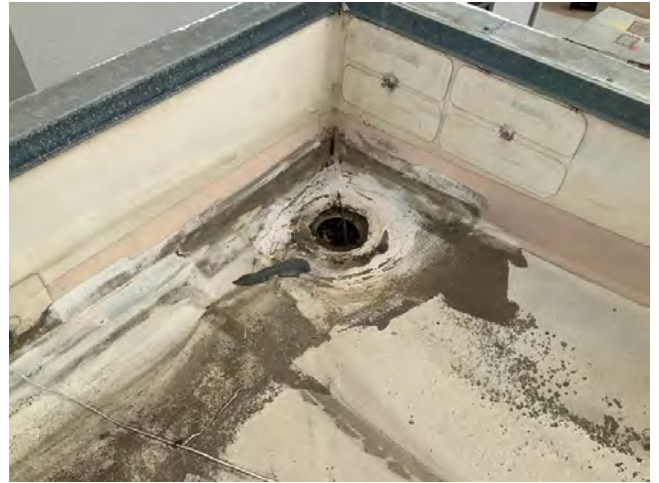
50. Missing roof drain dome

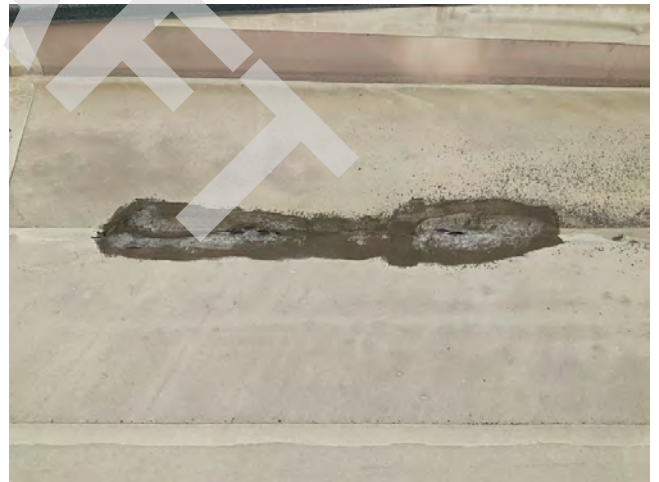
52. Roof repair damage

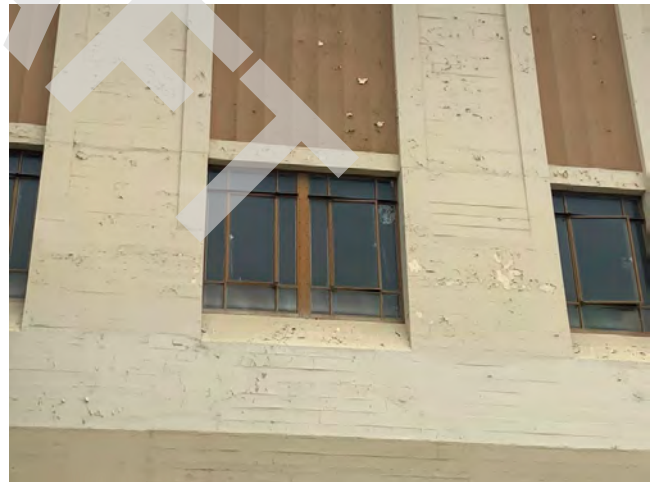
72. Damaged window on the south elevation

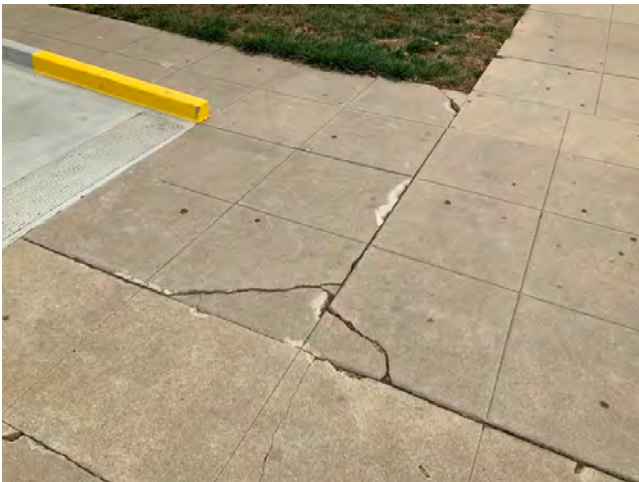
127. South site sidewalk cracking

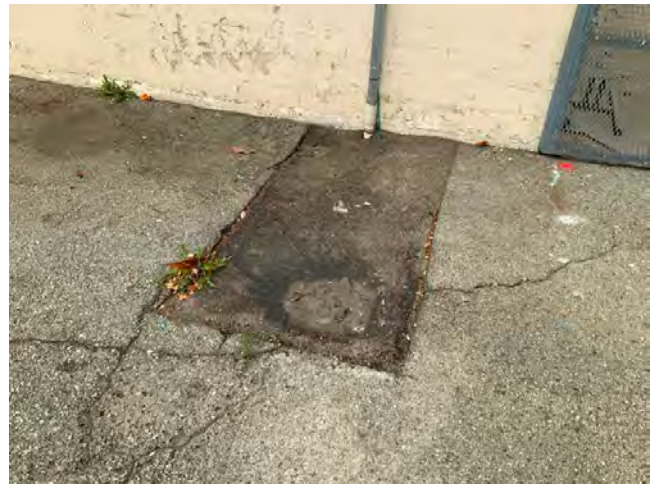
138. Asphalt repair patch

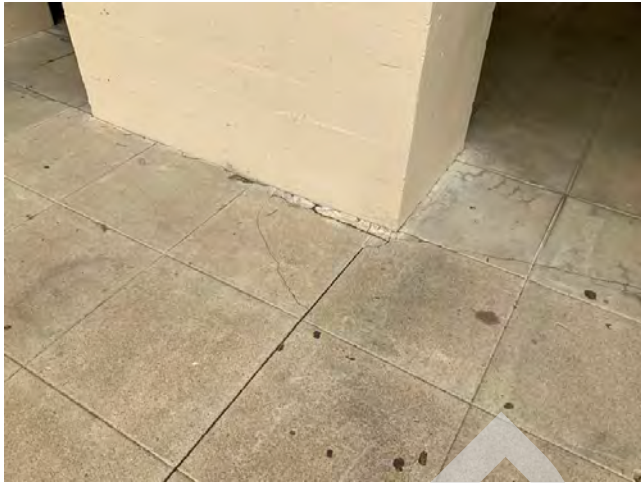
141. Cracking concrete flatwork

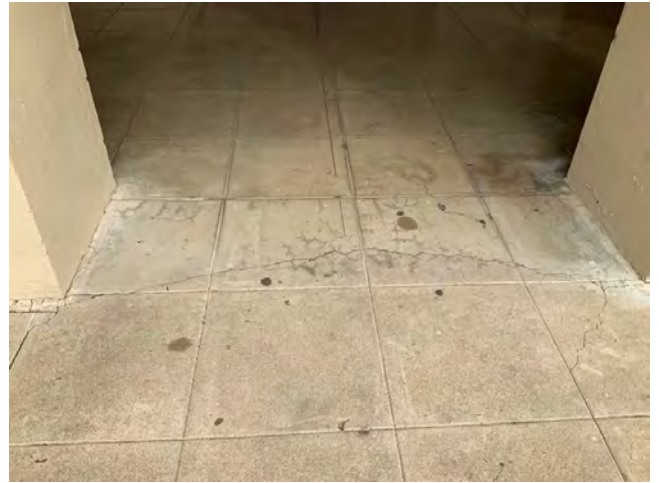
142. Cracking concrete flatwork

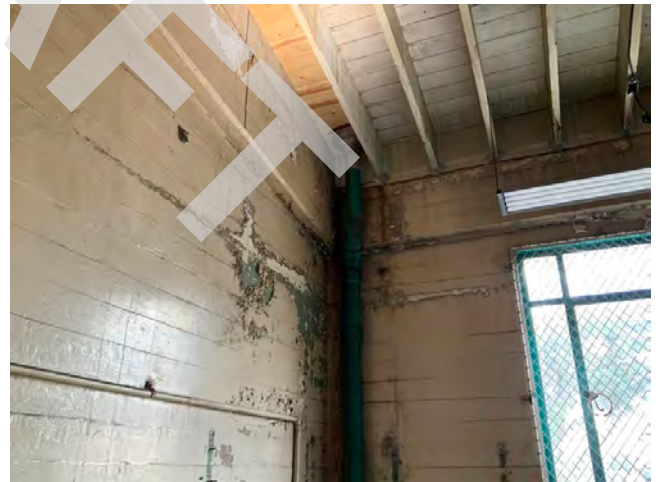
168. East storage room deteriorated paint

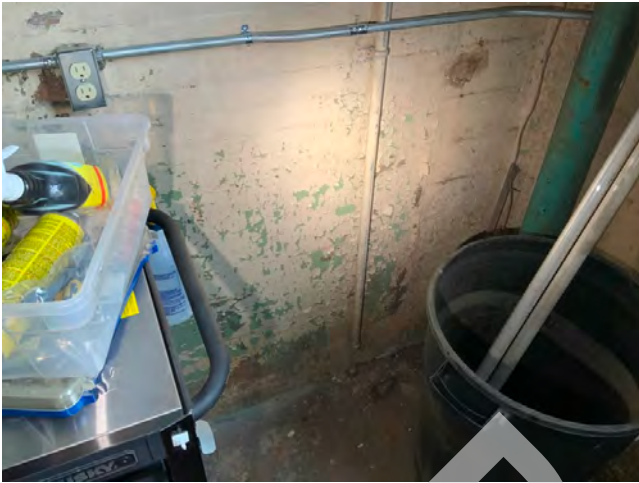
169. Flaking interior paint

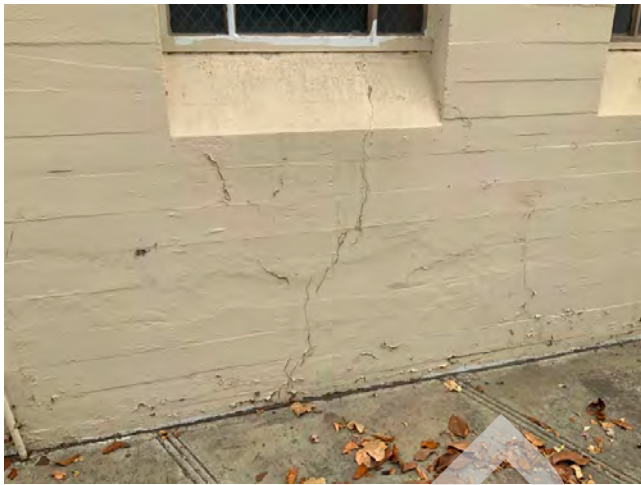
193. North exterior wall cracking paint

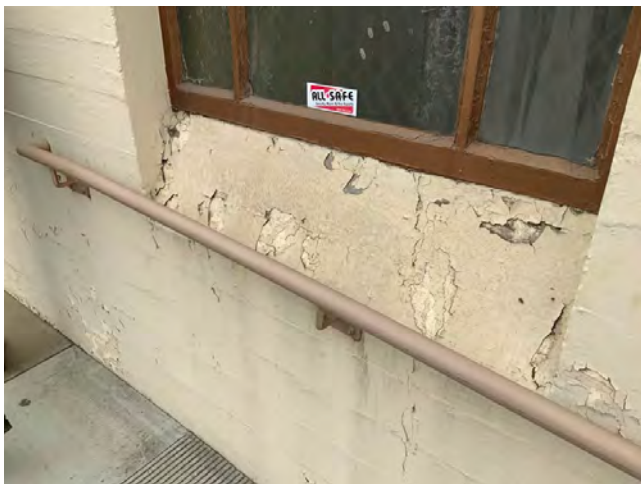
195. Deteriorating exterior
