# **HISTORIC STRUCTURE REPORT**

# **38 Soledad Street**

**March 2025**

TEF Design  
Groundwork Preservation, LLC  
Howard Carter Associates, Inc.

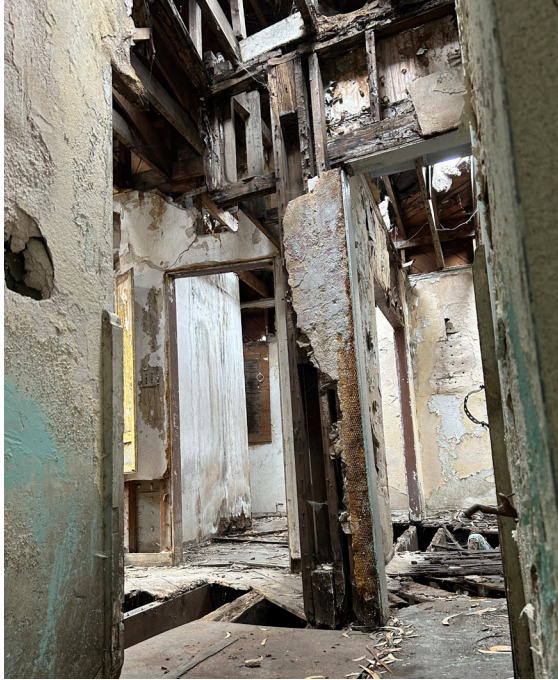
The majority of the second floor is inaccessible due to a lack of structural integrity; however, limited visibility from the stairway landing provides some insight into the condition (Figure 2.10). Several rooms are visible, including a kitchen with many of the wood cabinets and tile backsplash extant but in extremely poor condition (Figure 2.11), a winding hallway, and at least two rooms. The floor and ceiling finish appears to have been plaster and some floors may have been wood. Historic accounts state that the second floor contained a kitchen, living room, den, five bedrooms, and two full bathrooms. Additionally, there was access to the roof from the second floor where tenants dried their laundry on the metal drying racks visible at the north façade. It is also possible that doorways in the lightwells provided exterior access between different rooms on the second floor, although this can't be confirmed. Much of the plaster finish has deteriorated from water damage, revealing the wood wall framing behind. Portions of the roof are severely damaged and/or have failed. The building also experienced a fire in the second-floor apartment in 2018 that caused an unknown amount of damage.<sup>58</sup>

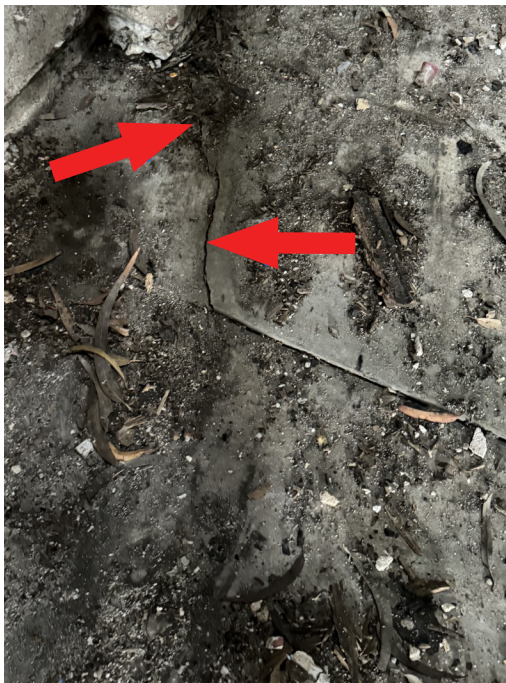
Figure 4.2 Photo of minor damage to the concrete floor slab near the north wall, Howard Carter Associates, Inc, 2024.

Overall, the slab appears to be in good condition. There is evidence of slab movement at one location along the north wall with a crack in the slab on grade and a small displacement of the slab upward (Figure 4.2).

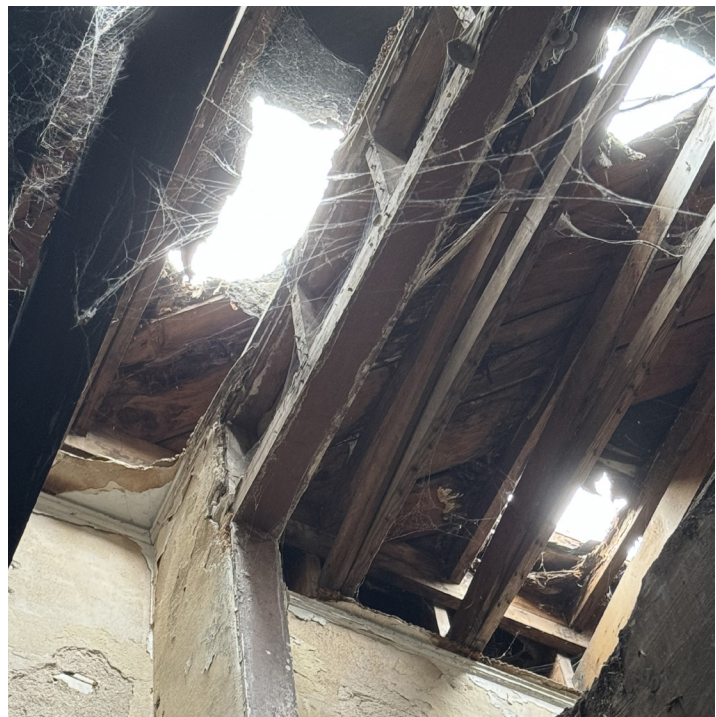
Figure 4.5 Photo of roof wood truss framing and failing roofing above, Howard Carter Associates, Inc, 2024.

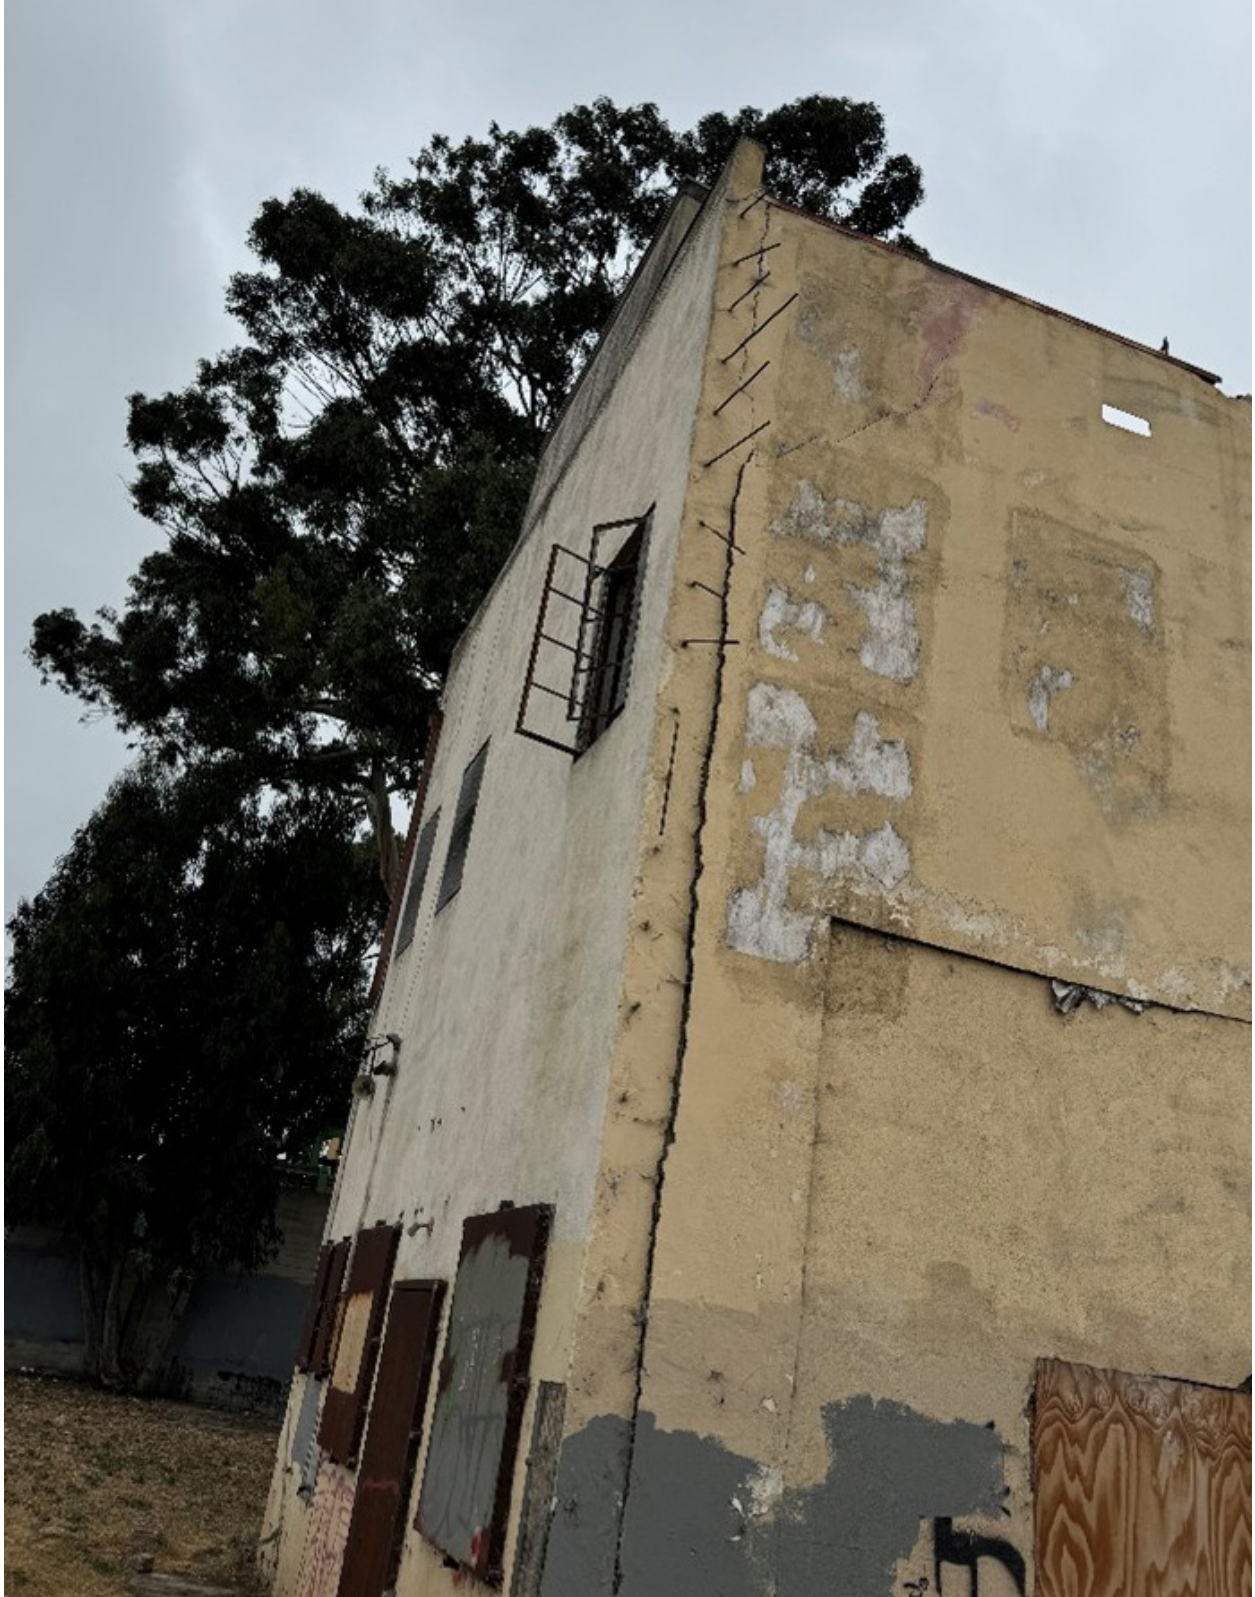
Figure 4.6 Photo of full height crack in stucco at southwest junction of concrete wall and wood framed wall, Howard Carter Associates, Inc, 2024.

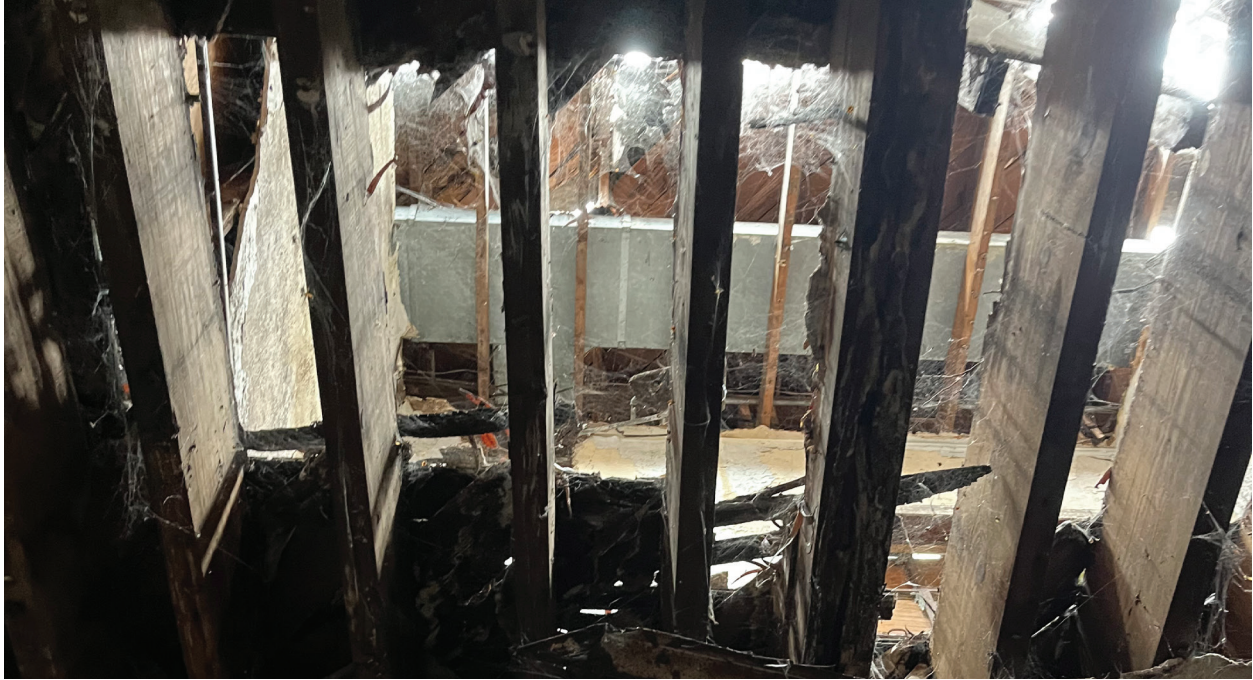
Figure 5.2 View of second floor framing and open roofing above from ground floor interior, TEF Design, 2024.

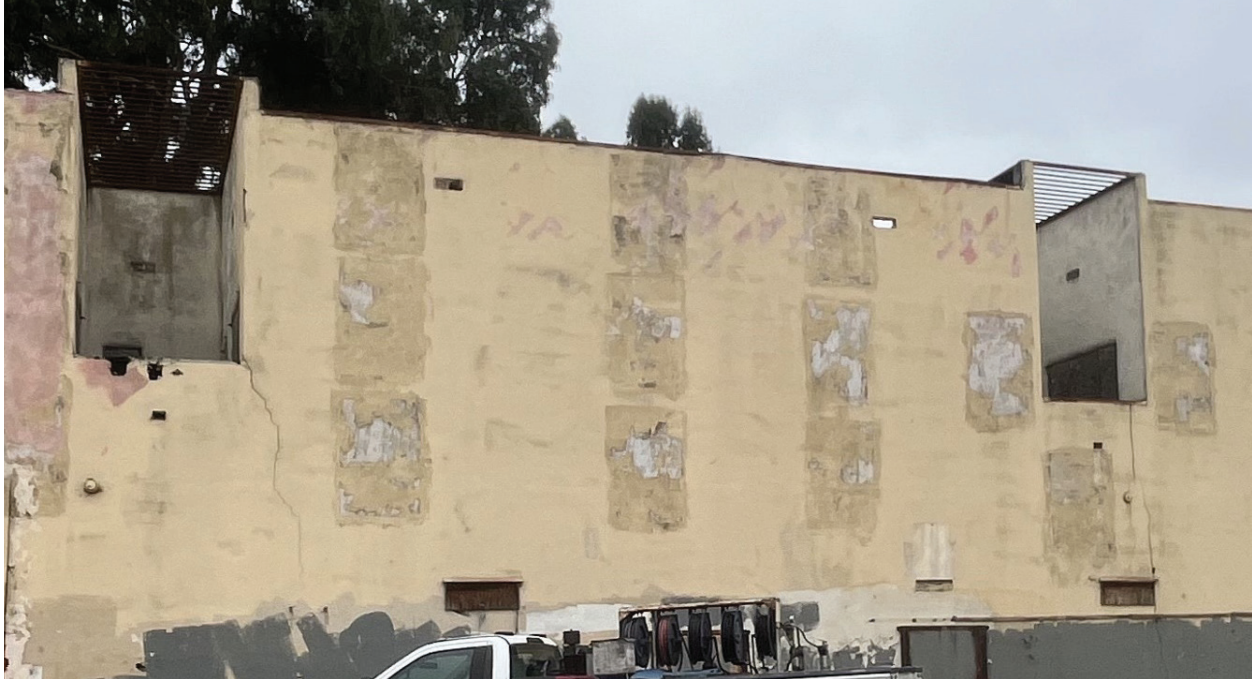
Figure 5.3 Large rectangular openings through the parapet wall of the south facade and lightwell walls may provide drainage for the flat roof of the building, TEF Design, 2024.

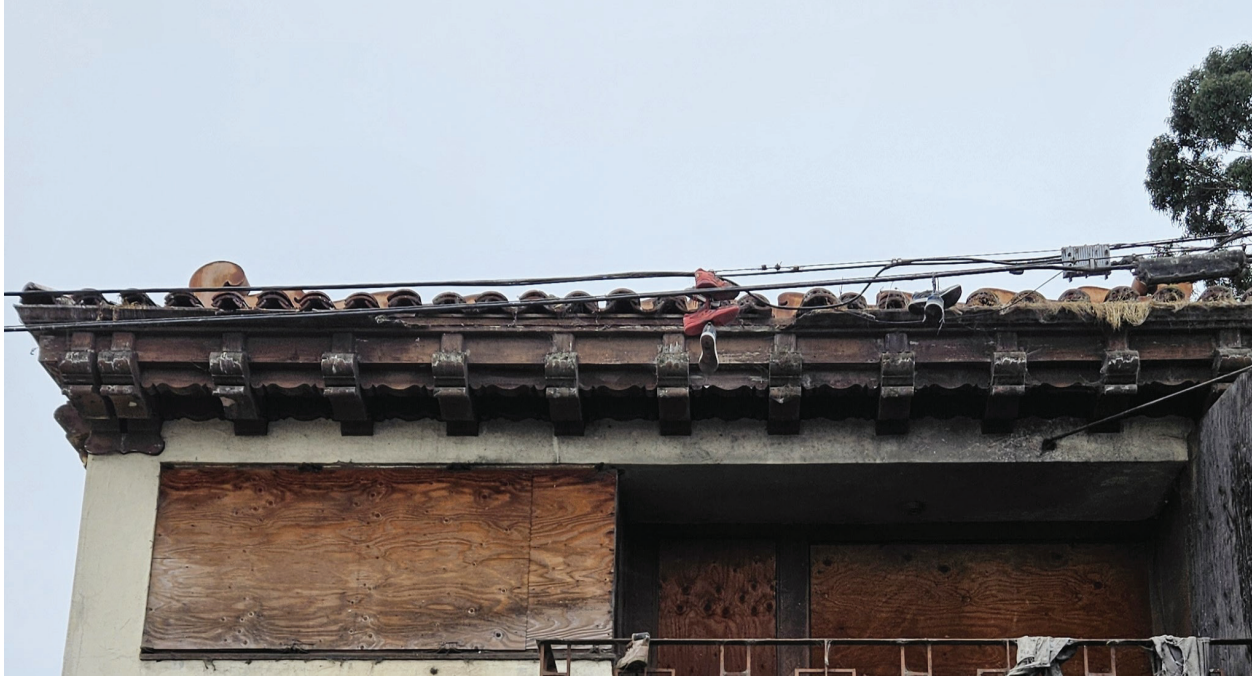
Figure 5.7 The barrel clay tile roof on the east facade is in poor condition. The decorative metal gutter is missing a large portion and has many plants growing from it, TEF Design, 2024.

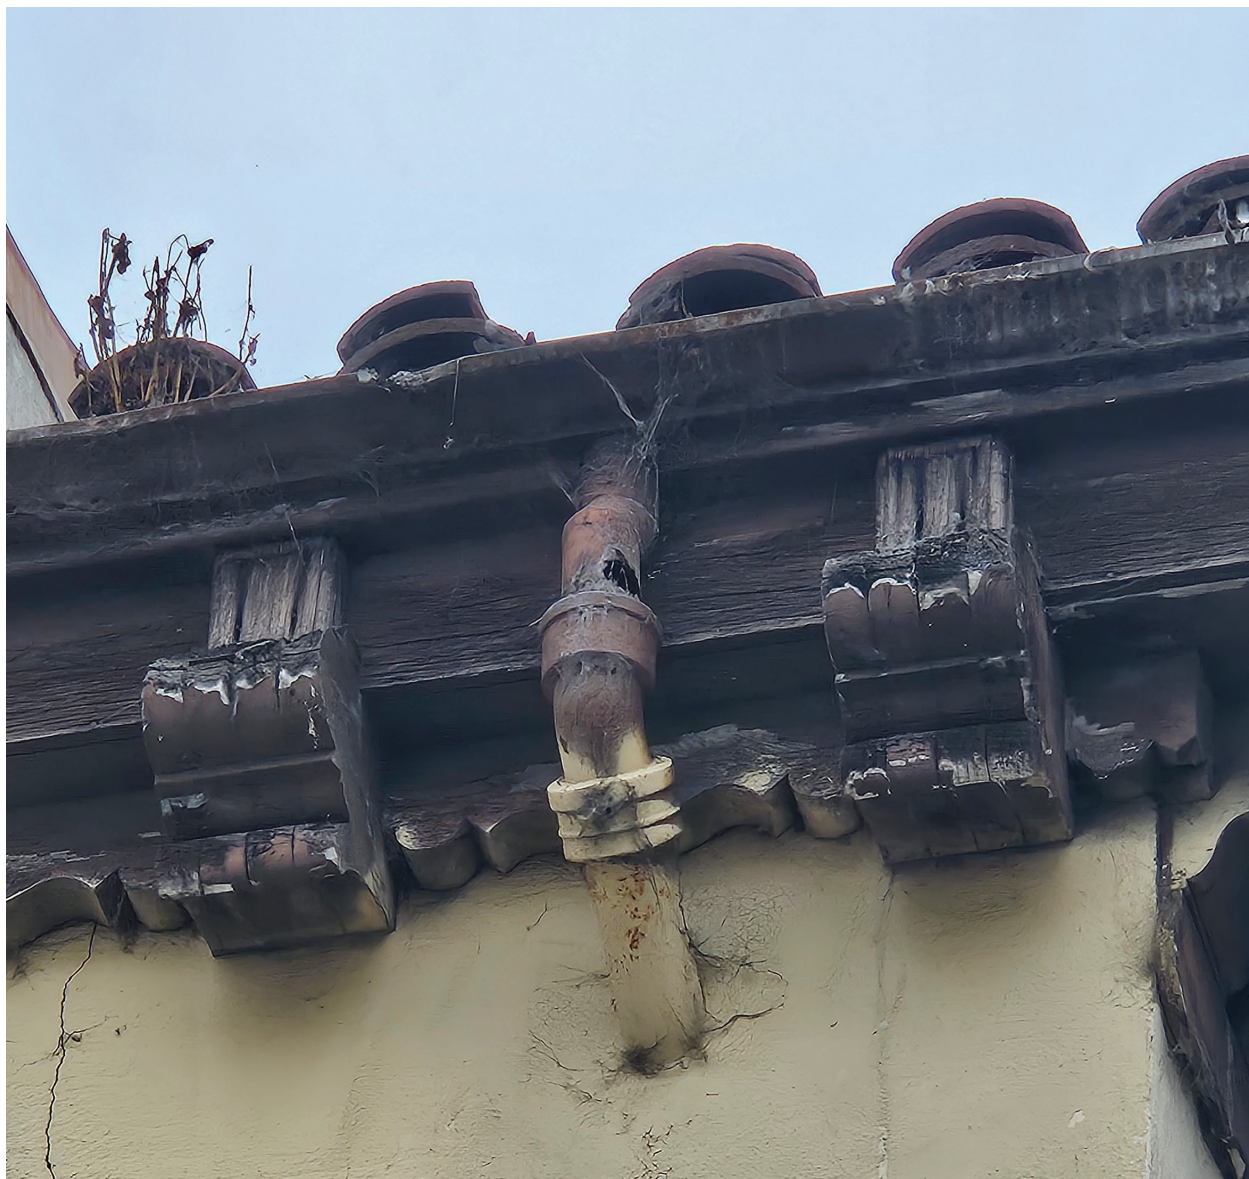
Figure 5.8 On the south side of the clay tile hipped roof, tiles are broken and shifted. The downspout at this facade is rusted with a large hole, TEF Design, 2024.

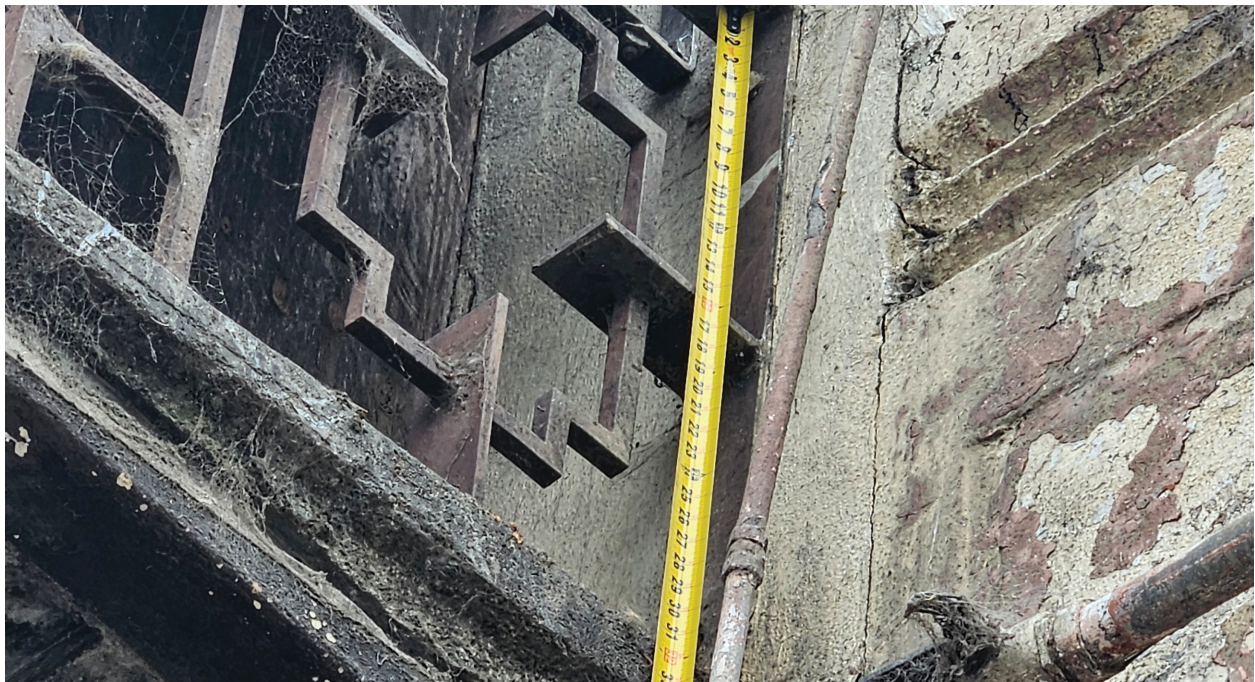
Figure 5.12 The decorative metal railing at the balcony is only 32 inches high, TEF Design, 2024.

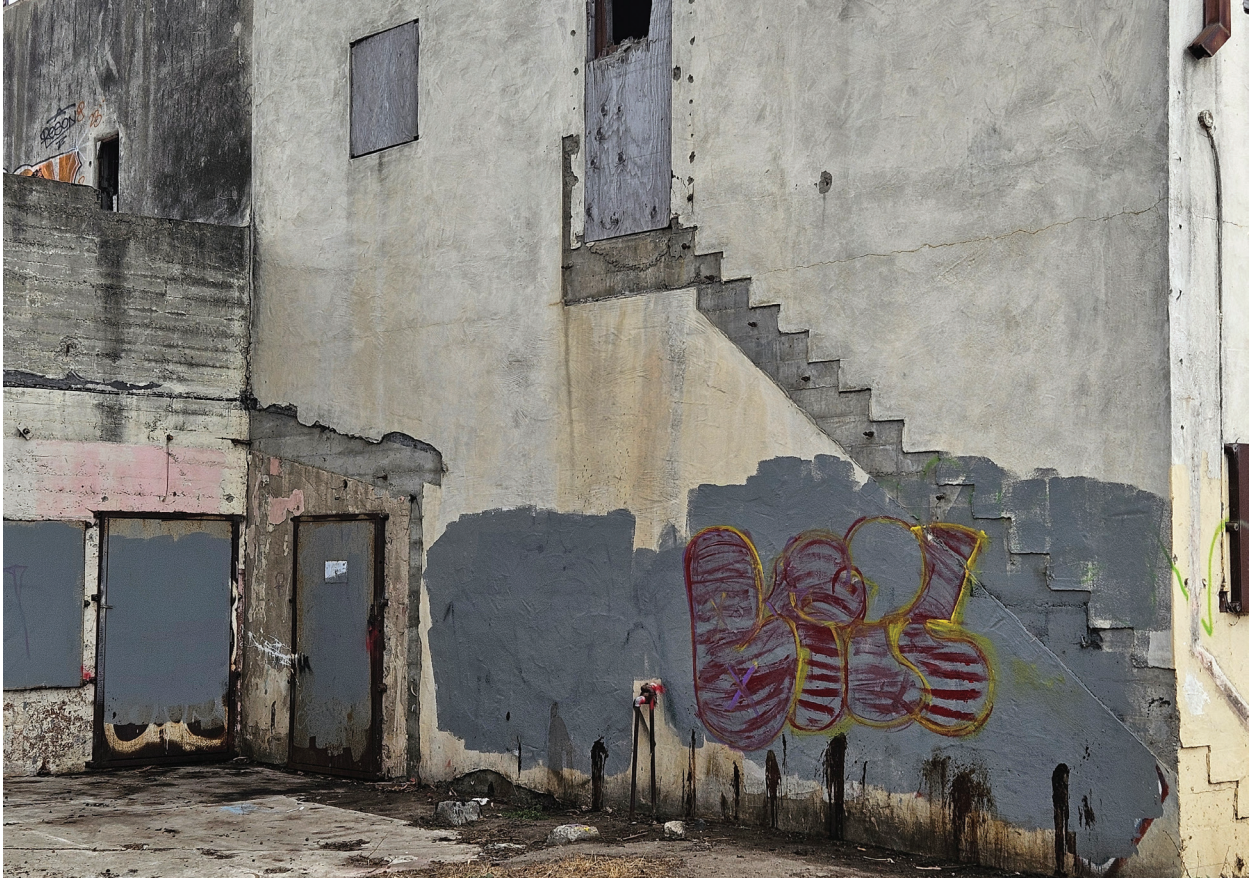
Figure 5.13 Portions of the stucco at the west end of the north facade are missing where previously attached architectural components have been removed, TEF Design, 2024.

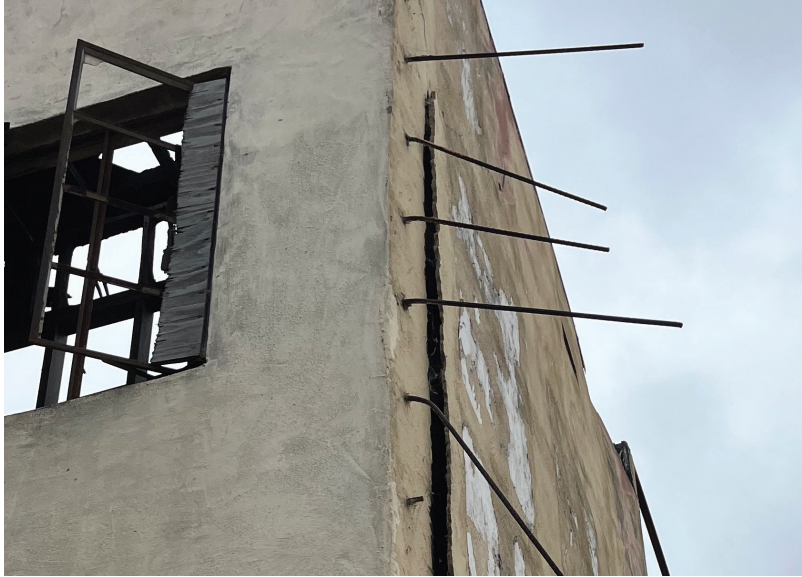
Figure 5.15 The stucco has pulled away from the wall and reinforcement protrudes at the south west corner, TEF Design, 2024.

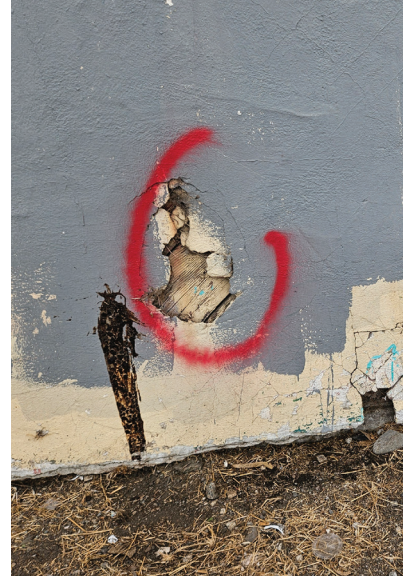
Figure 5.16 Detail view of stucco deterioration at the south facade, TEF Design, 2024.

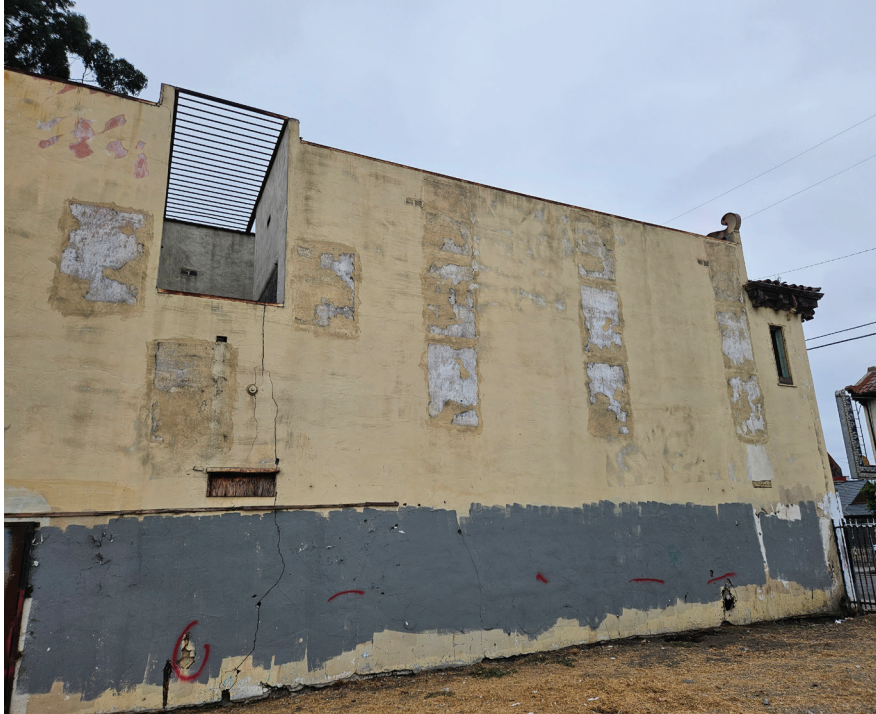
Figure 5.19 This view of the east end of the south facade reveals many additional areas of failing stucco, TEF Design, 2024.

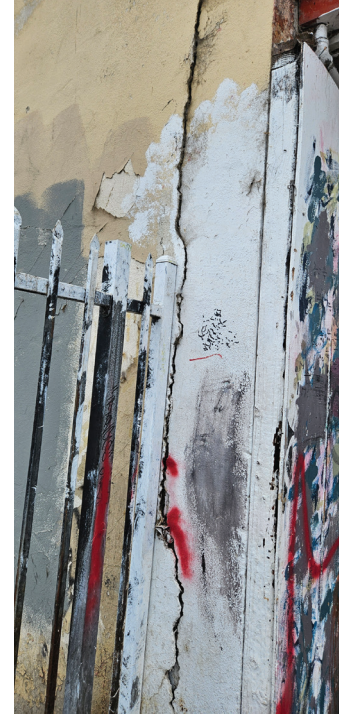
Figure 5.20 Detail view of cracking in exterior stucco at the east end of the south facade, TEF Design, 2024.

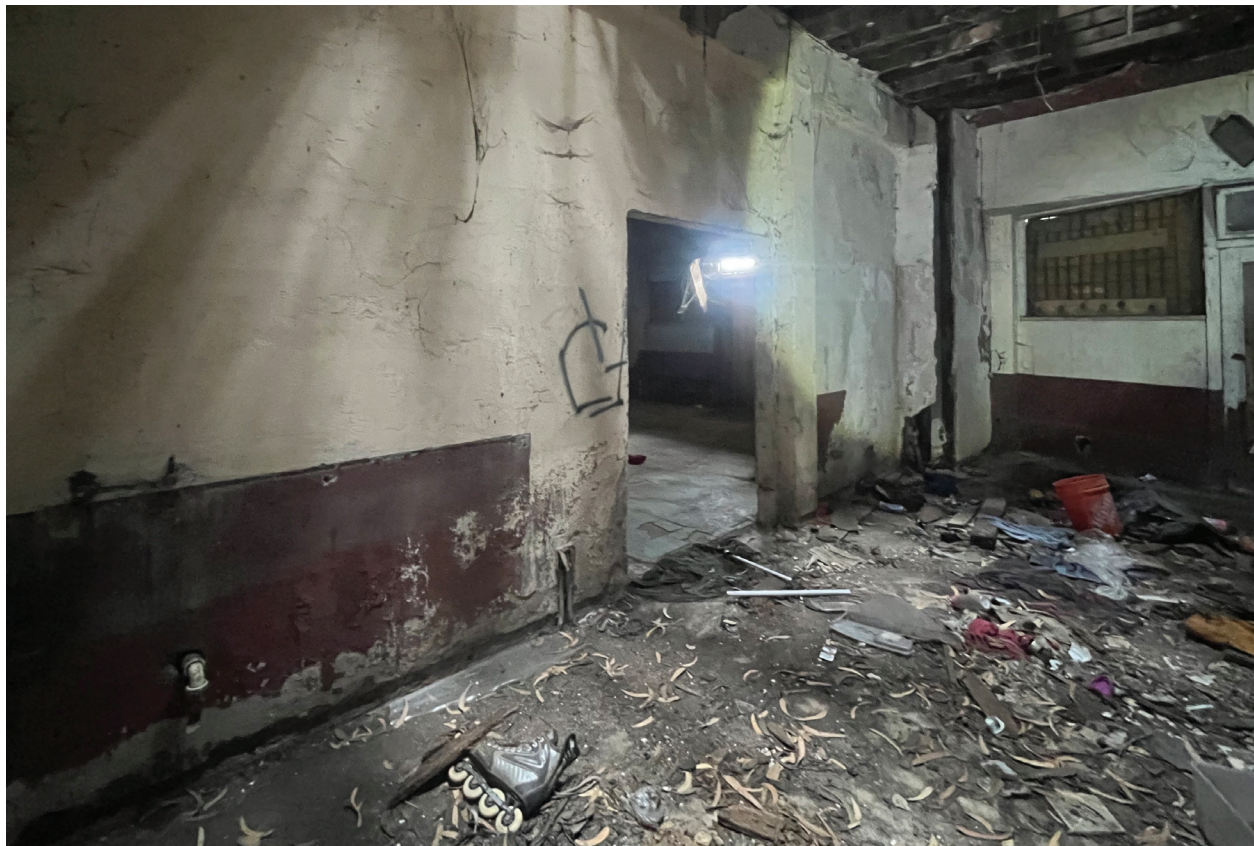
Figure 5.21 Trash and detritus has particularly accumulated at the northeast corner of the ground floor, Groundwork Preservation, LLC, 2024.

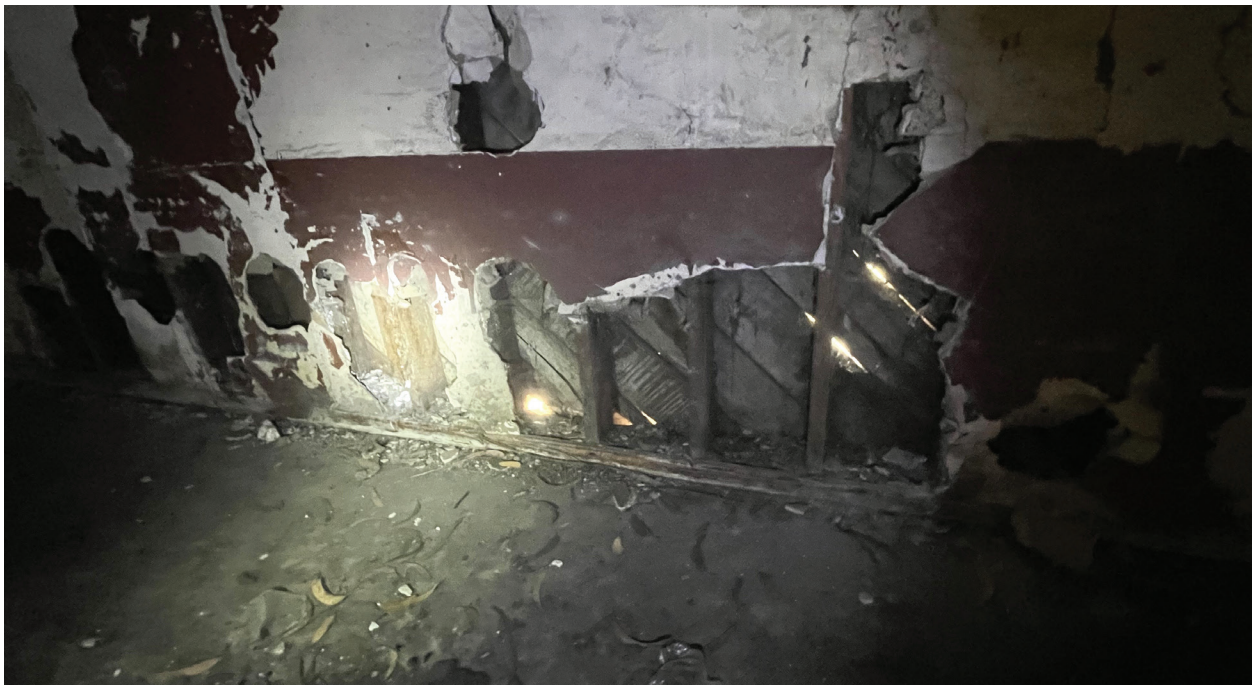
Figure 5.23 Large sections of gypsum board have been damaged along the south elevation, Groundwork Preservation, LLC, 2024.

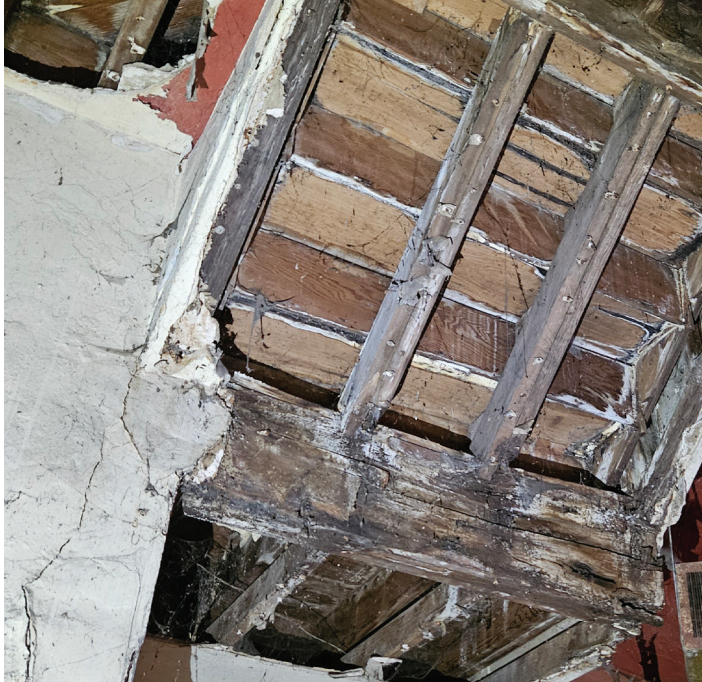
Figure 5.24  
The landing at the stair to the second floor is unsupported at the outer corner. The framing is deteriorated from water intrusion, TEF Design, 2024.

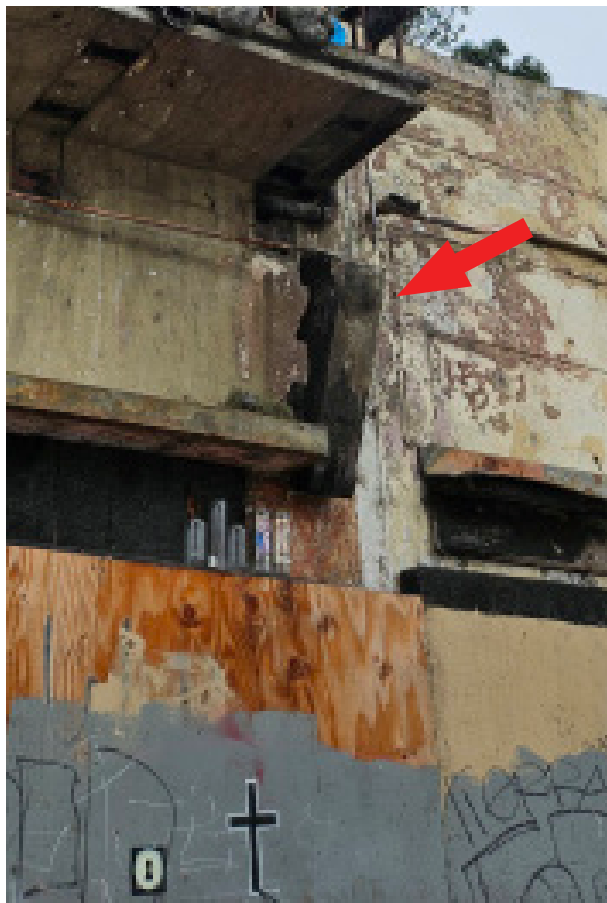
Figure 8.1 A wood corbel below the east facade second floor balcony is detached and presents a fall hazard, TEF Design, 2024.

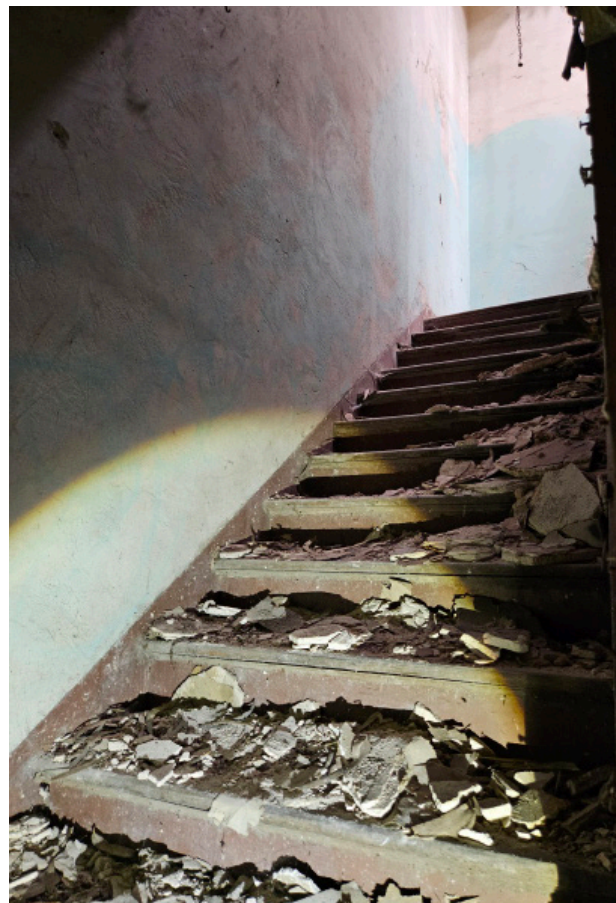
Figure 8.2 View of the stairs in poor condition leading to the second floor, TEF Design, 2024.
