This report presents the results of our Closed-Circuit Television (CCTV) inspections performed to address the conditions of sanitary sewer mains and manholes in various locations throughout the City of Salinas. The CCTV inspections were conducted on large diameter sewer mains ranging from 12" to 30" diameter pipes and were completed using Pipeline Assessment Certification Program (PACP) standards.

The City of Salinas retained Mark Thomas to inspect and analyze the condition of approximately 5,300 linear feet of sanitary sewer mains and 23 manhole structures.

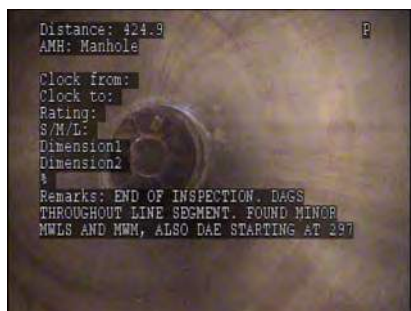
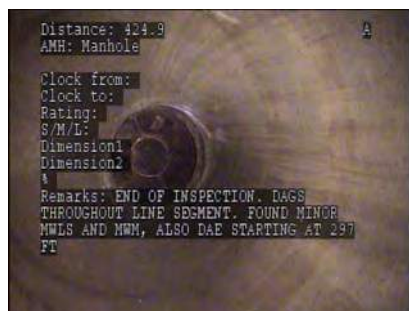
END OF INSPECTION.  
 DAGS THROUGHOUT  
 LINE SEGMENT.  
 FOUND MINOR MWLS  
 AND MWM, ALSO DAE  
 STARTING AT 297 FT

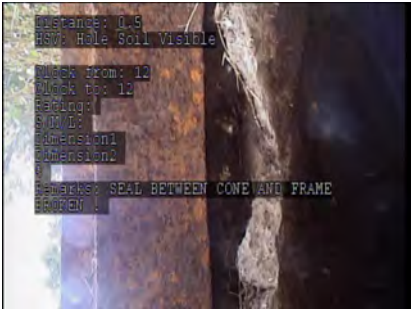
| Distance | Length | Code | Reversed | Clock Pos. | Severity | Rating | Category | Comment |
|---|---|---|---|---|---|---|---|---|
| 0.5 | HSV | | No | 12 / 12 | | | Structural | CMI- SEAL BETWEEN CONE AND FRAME BROKEN . |

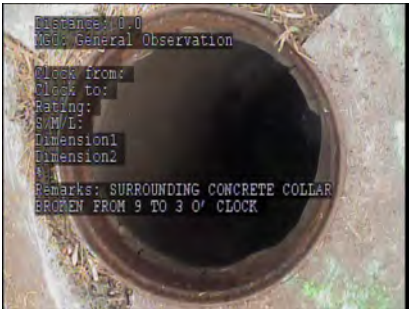
| Distance | Length | Code | Reversed | Clock Pos. | Severity | Rating | Category | Comment |
|---|---|---|---|---|---|---|---|---|
| 0.0 | | MGO | No | / | | | | SURROUNDING<br>CONCRETE COLLAR<br>BROKEN FROM 9 TO 3<br>O' CLOCK |

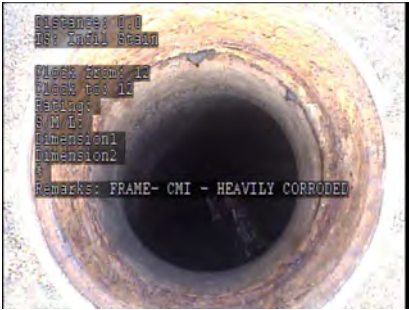
| Distance | Length | Code | Reversed | Clock Pos. | Severity | Rating | Category | Comment |
|---|---|---|---|---|---|---|---|---|
| 0.0 | | IS | No | 12 / 12 | | | | FRAME- CMI - HEAVILY CORRODED |

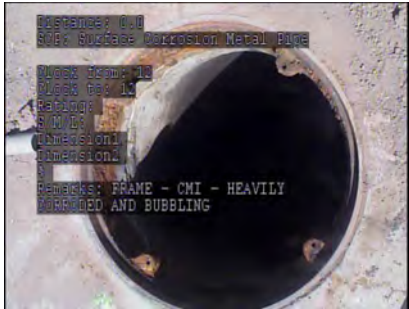
| Distance | Length | Code | Reversed | Clock Pos. | Severity | Rating | Category | Comment |
|---|---|---|---|---|---|---|---|---|
| 0.0 | | SCP | No | 12 / 12 | | | Structural | FRAME - CMI - HEAVILY CORRODED AND BUBBLING |

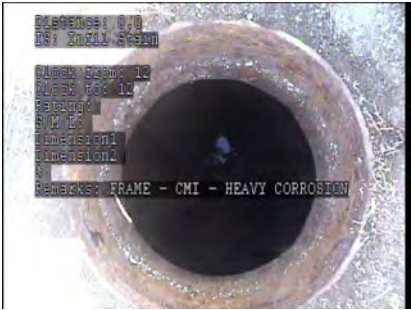
| Distance | Length | Code | Reversed | Clock Pos. | Severity | Rating | Category | Comment |
|---|---|---|---|---|---|---|---|---|
| 0.0 | | IS | No | 12 / 12 | | | | FRAME - CMI - HEAVY CORROSION |

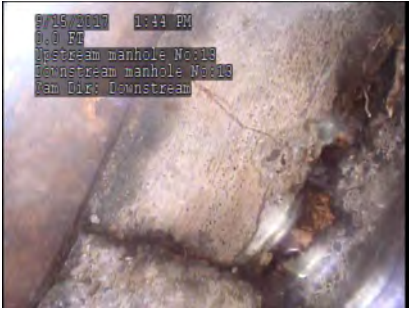
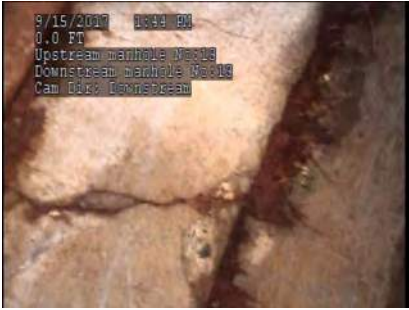
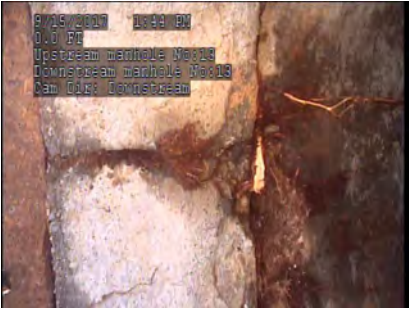
| Distance | Length | Code | Reversed | Clock Pos. | Severity | Rating | Category | Comment |
|---|---|---|---|---|---|---|---|---|
| 0.5 | B | | No | 12 / 12 | | | Structural | RING BROKEN |

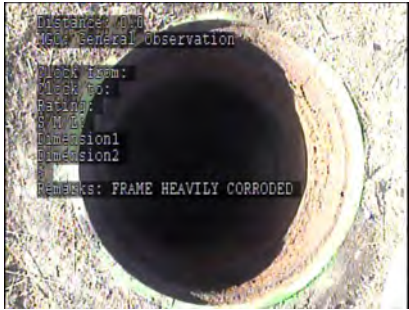
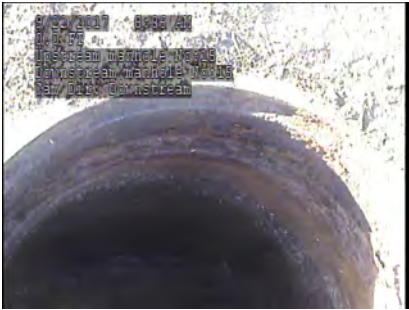
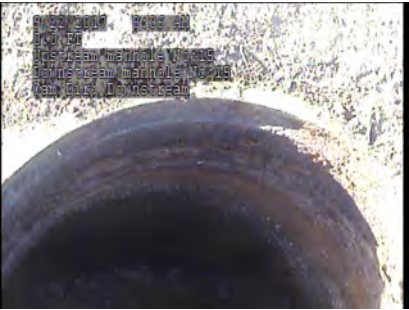
| Distance | Length | Code | Reversed | Clock Pos. | Severity | Rating | Category | Comment |
|---|---|---|---|---|---|---|---|---|
| 0.0 | | MGO | No | / | | | | FRAME HEAVILY CORRODED |

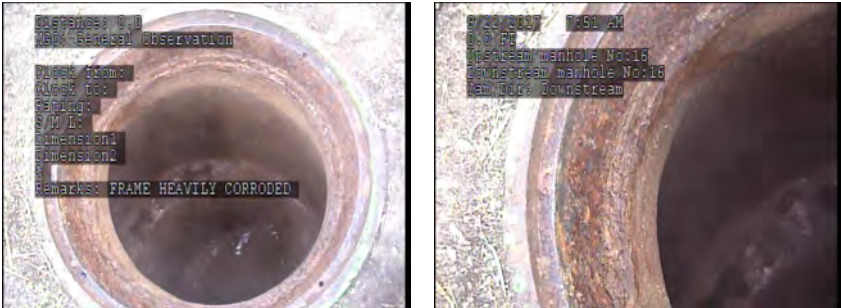
| Distance | Length | Code | Reversed | Clock Pos. | Severity | Rating | Category | Comment |
|---|---|---|---|---|---|---|---|---|
| 0.0 | | MGO | No | / | | | | FRAME HEAVILY CORRODED |

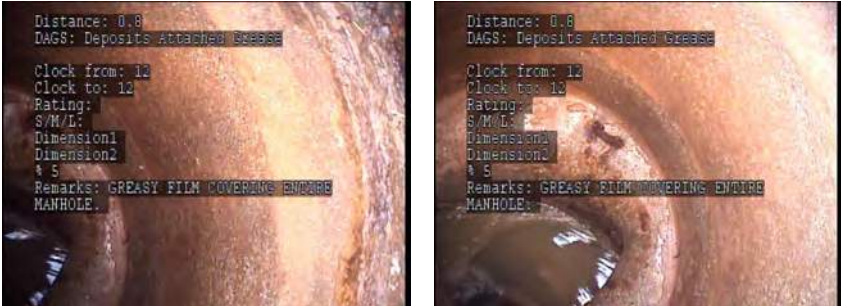
| Distance | Length | Code | Reversed | Clock Pos. | Severity | Rating | Category | Comment |
|---|---|---|---|---|---|---|---|---|
| 0.8 | | DAGS | No | 12 / 12 | | | O&M | GREASY FILM COVERING ENTIRE MANHOLE. |

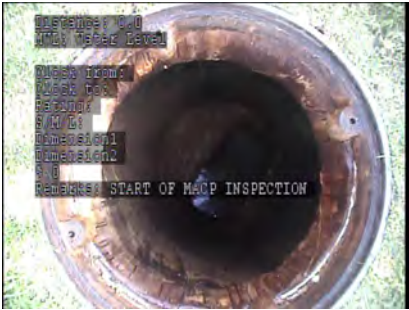
| Distance | Length | Code | Reversed | Clock Pos. | Severity | Rating | Category | Comment |
|---|---|---|---|---|---|---|---|---|
| 0.0 | MGO | | No | / | | | | FRAME CORRODED /<br>MANHOLE HAS<br>FIBERGLASS LINER |

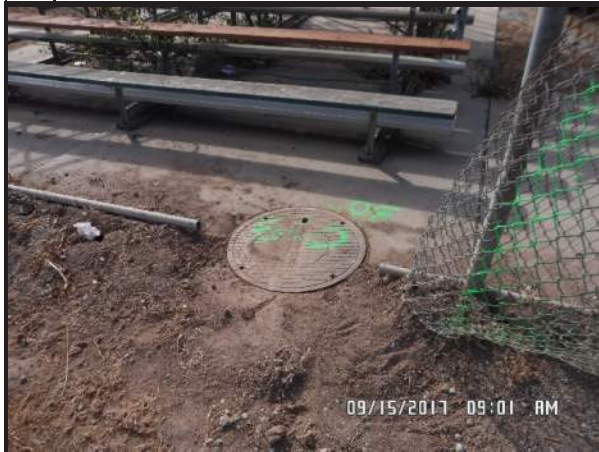
Photo SSMH – 10

The frame and chimney area for SSMH 10 are both heavily corroded. Other than the issues with the chimney area, the manhole is structurally sound.
