Re: Borgomini West San Luis Project  
115 & 119 West San Luis St.  
Salinas, CA.

As requested, I have provided a field inspection to assess the structural integrity of the existing garages & accessory building of the above-referenced project. The inspection was performed by visually inspecting the exterior of the structures. The following was noted.

## 115-119 W. San Luis Street-Salinas

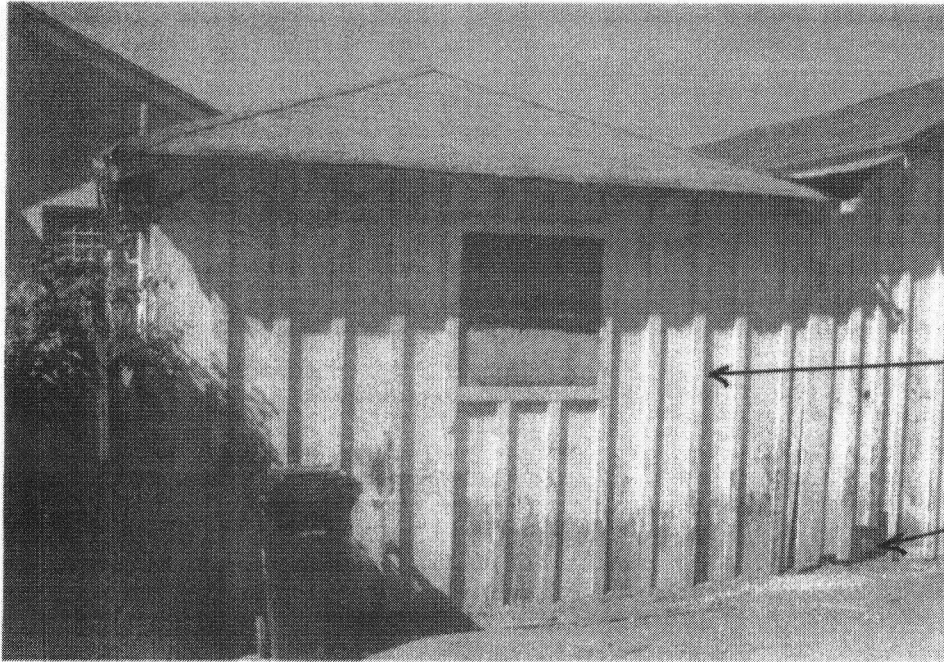
No. 1

All structures are old and in a debilitated state. There is evidence of damaged lumber, such as dry-rot. The damage occurs primarily at the bottom of the wall where the wood touches the soil, see attached pictures.

Single Wall Construction

Dryrot Damage

To summarize my findings, all structures are substandard, have little or no structural value, do not comply with current building codes & standards, show evidence of deterioration and damage and should be demolished.

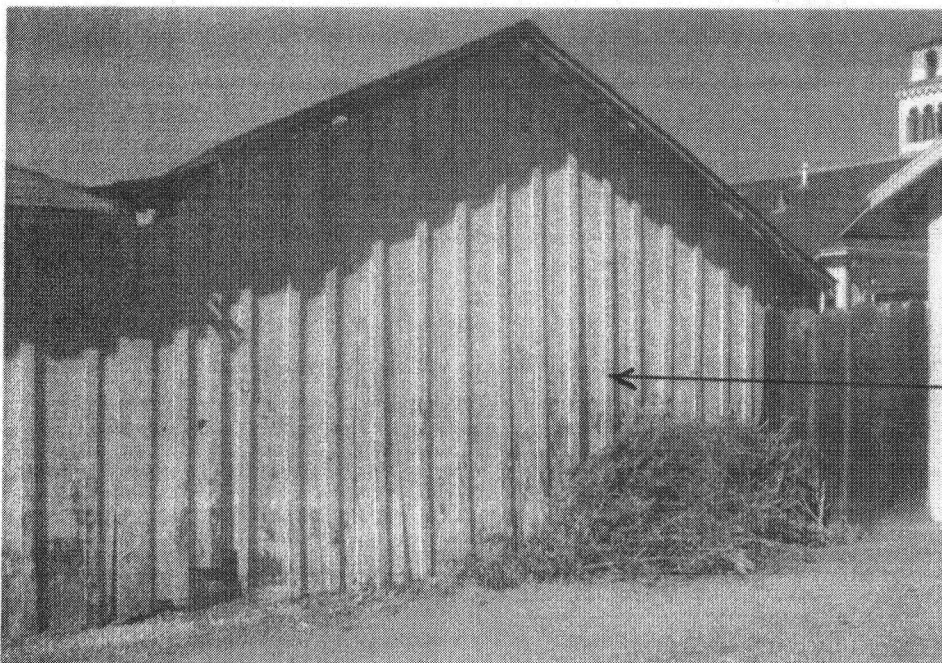
No 2

The roof is framed with 1 x - sheathing & 2 x - rafters. All walls are single-wall construction, 1 x 12 vertical boards with 1 x 4 battens. All roof framing and all wall framing do not comply with current building codes and construction standards. The walls have little or no shear strengths to resist lateral loads from wind and earthquakes.

Single Wall Construction  
1 x 4 Batten over 1 x 12  
Boards

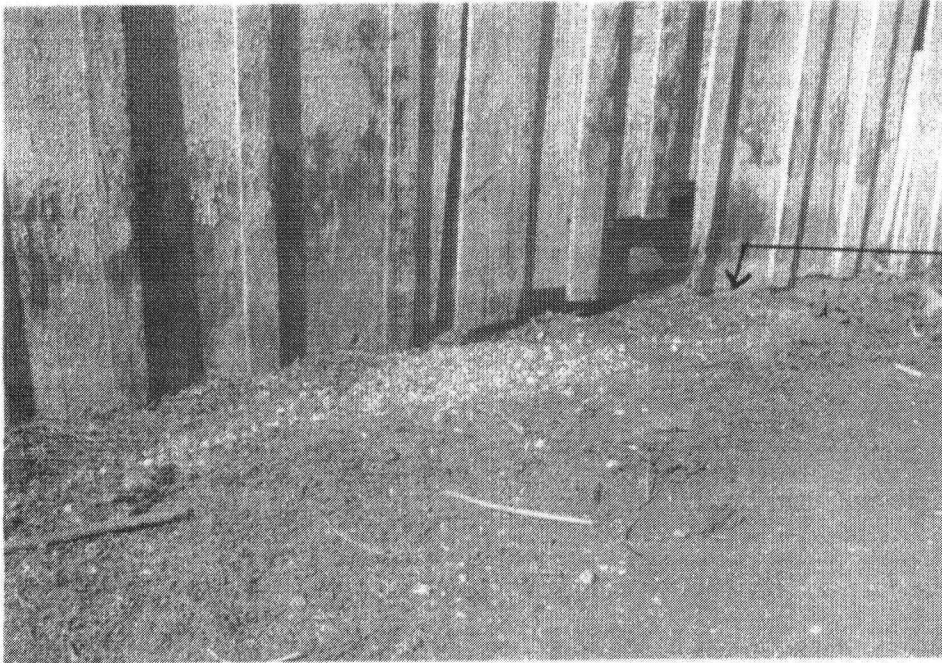
No. 3

Wood to Earth Contact  
Dryrot Damage

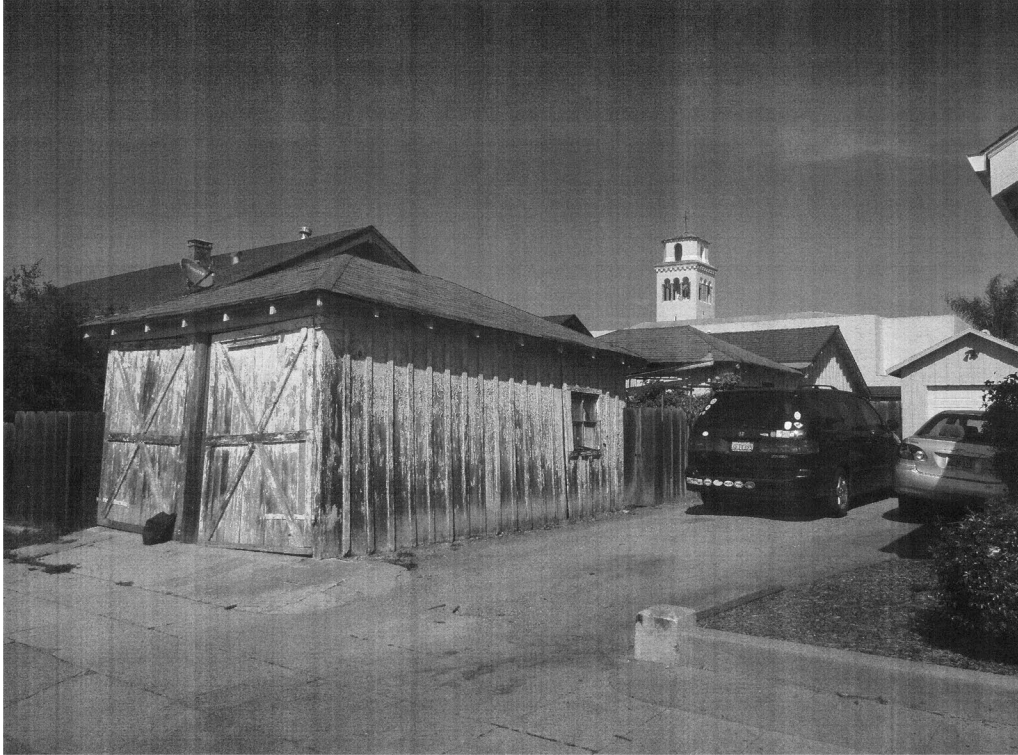
Photo#1. Looking NE at the deteriorated garage & storage sheds along the rear (south) parcel line of the subject properties, Kent Seavey, May, 2019.

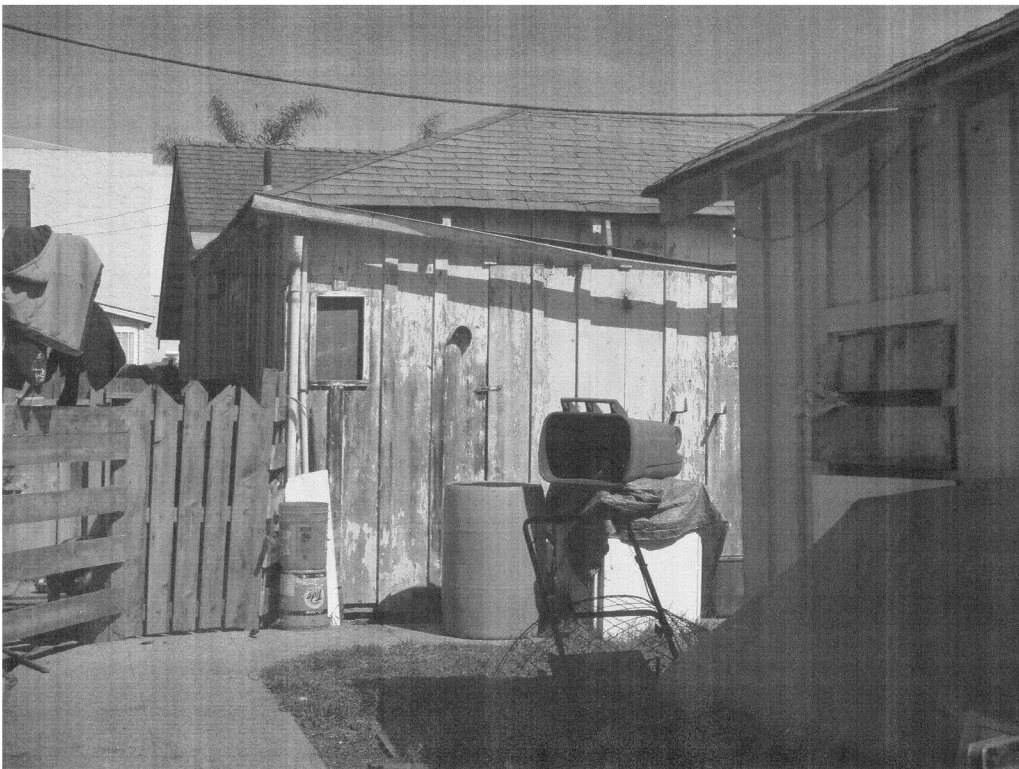
Photo #2. Looking east at the two deteriorated storage sheds just behind (south) the subject properties, Kent Seavey, May, 2019.
