Salinas Historic Resources Board

37-39 Soledad Street Project Update

March 02, 2026

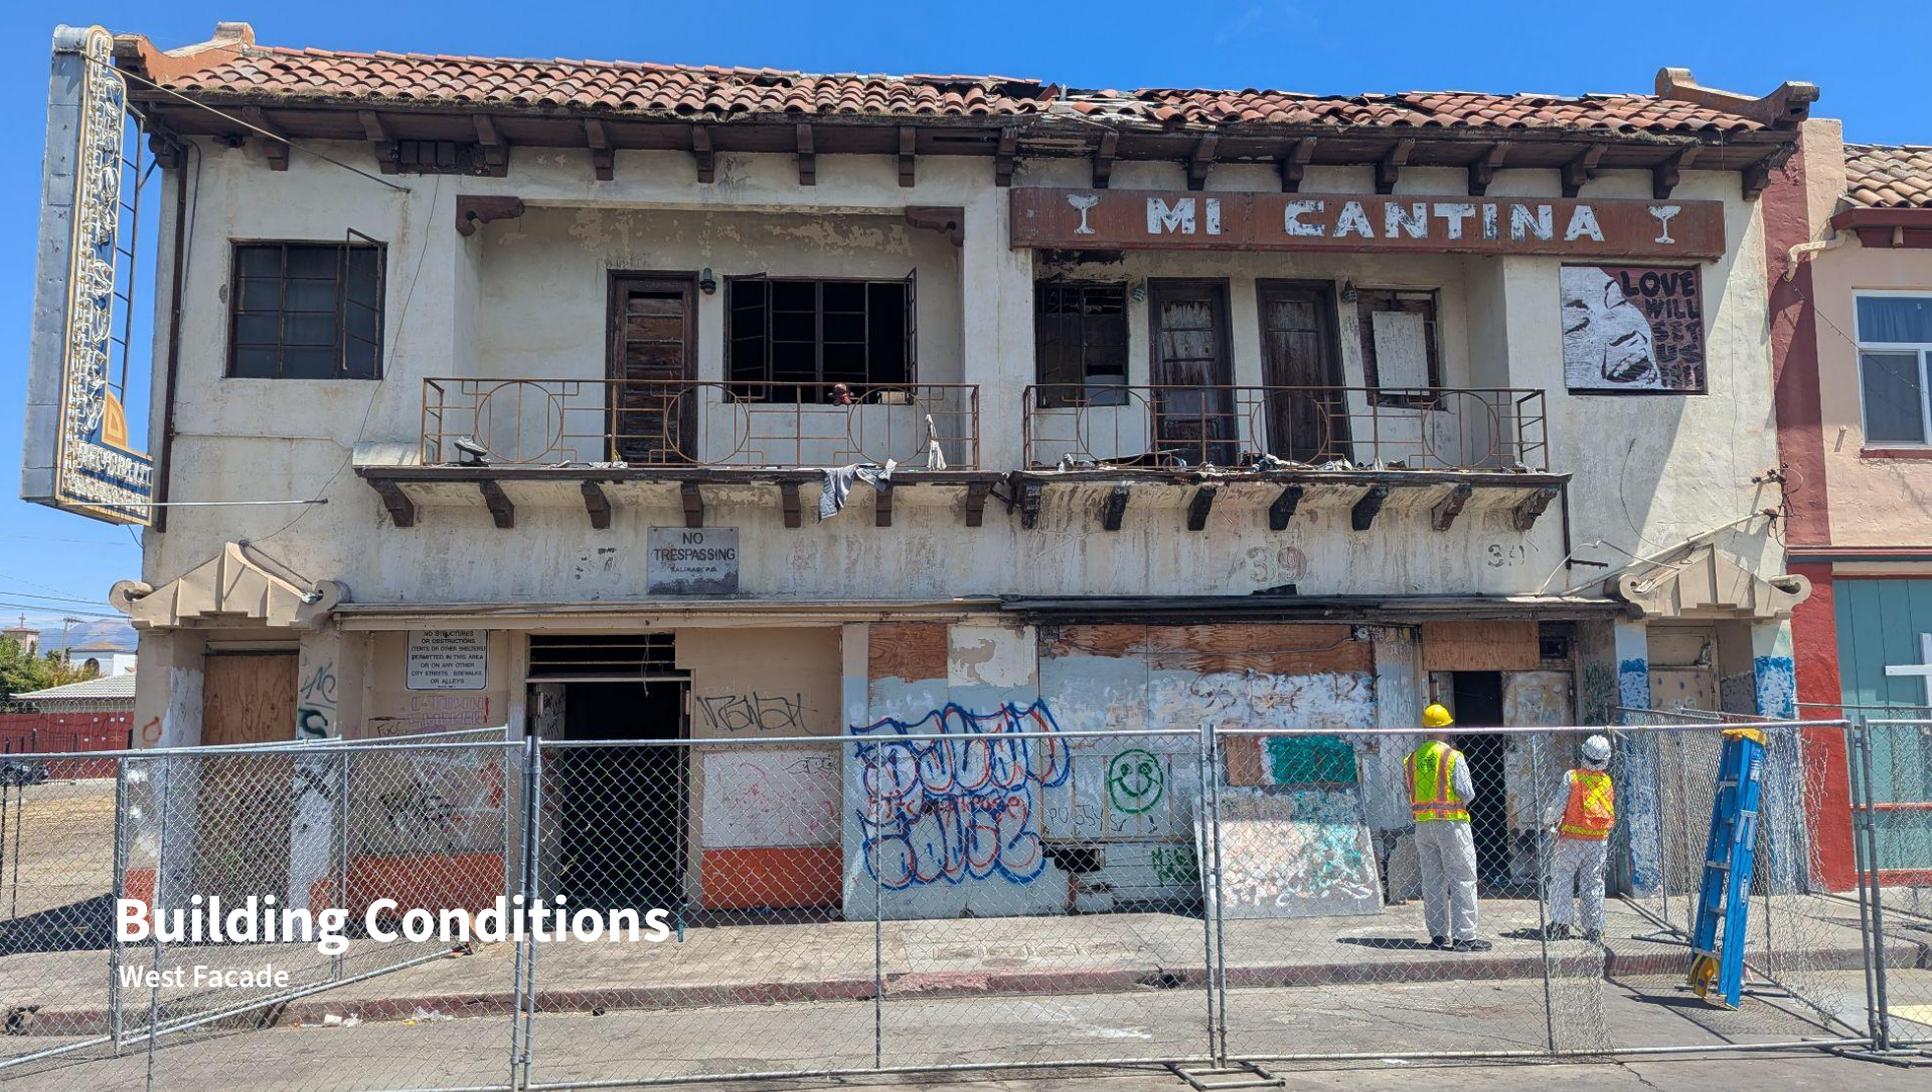
West Facade

Building Conditions

Investigation of Fire Damage at West Façade (Critical)

Engage a licensed structural engineer or testing agency to investigate the following:

- Extent of damage and critically failed structural components at the west façade, including:
 - Wall and storefront framing
 - Balconies and alcoves
 - Parapet Pent Roof
- Structural Engineer (with input from qualified historical architect) to design a permanent structural repair of the front façade (see section 8.5 for recommendations to address critical conditions).
- **Associated Recommended Scope:** Engage a qualified historical architect to investigate conditions of components that are currently covered and make recommendations for their restoration or replacement in kind.

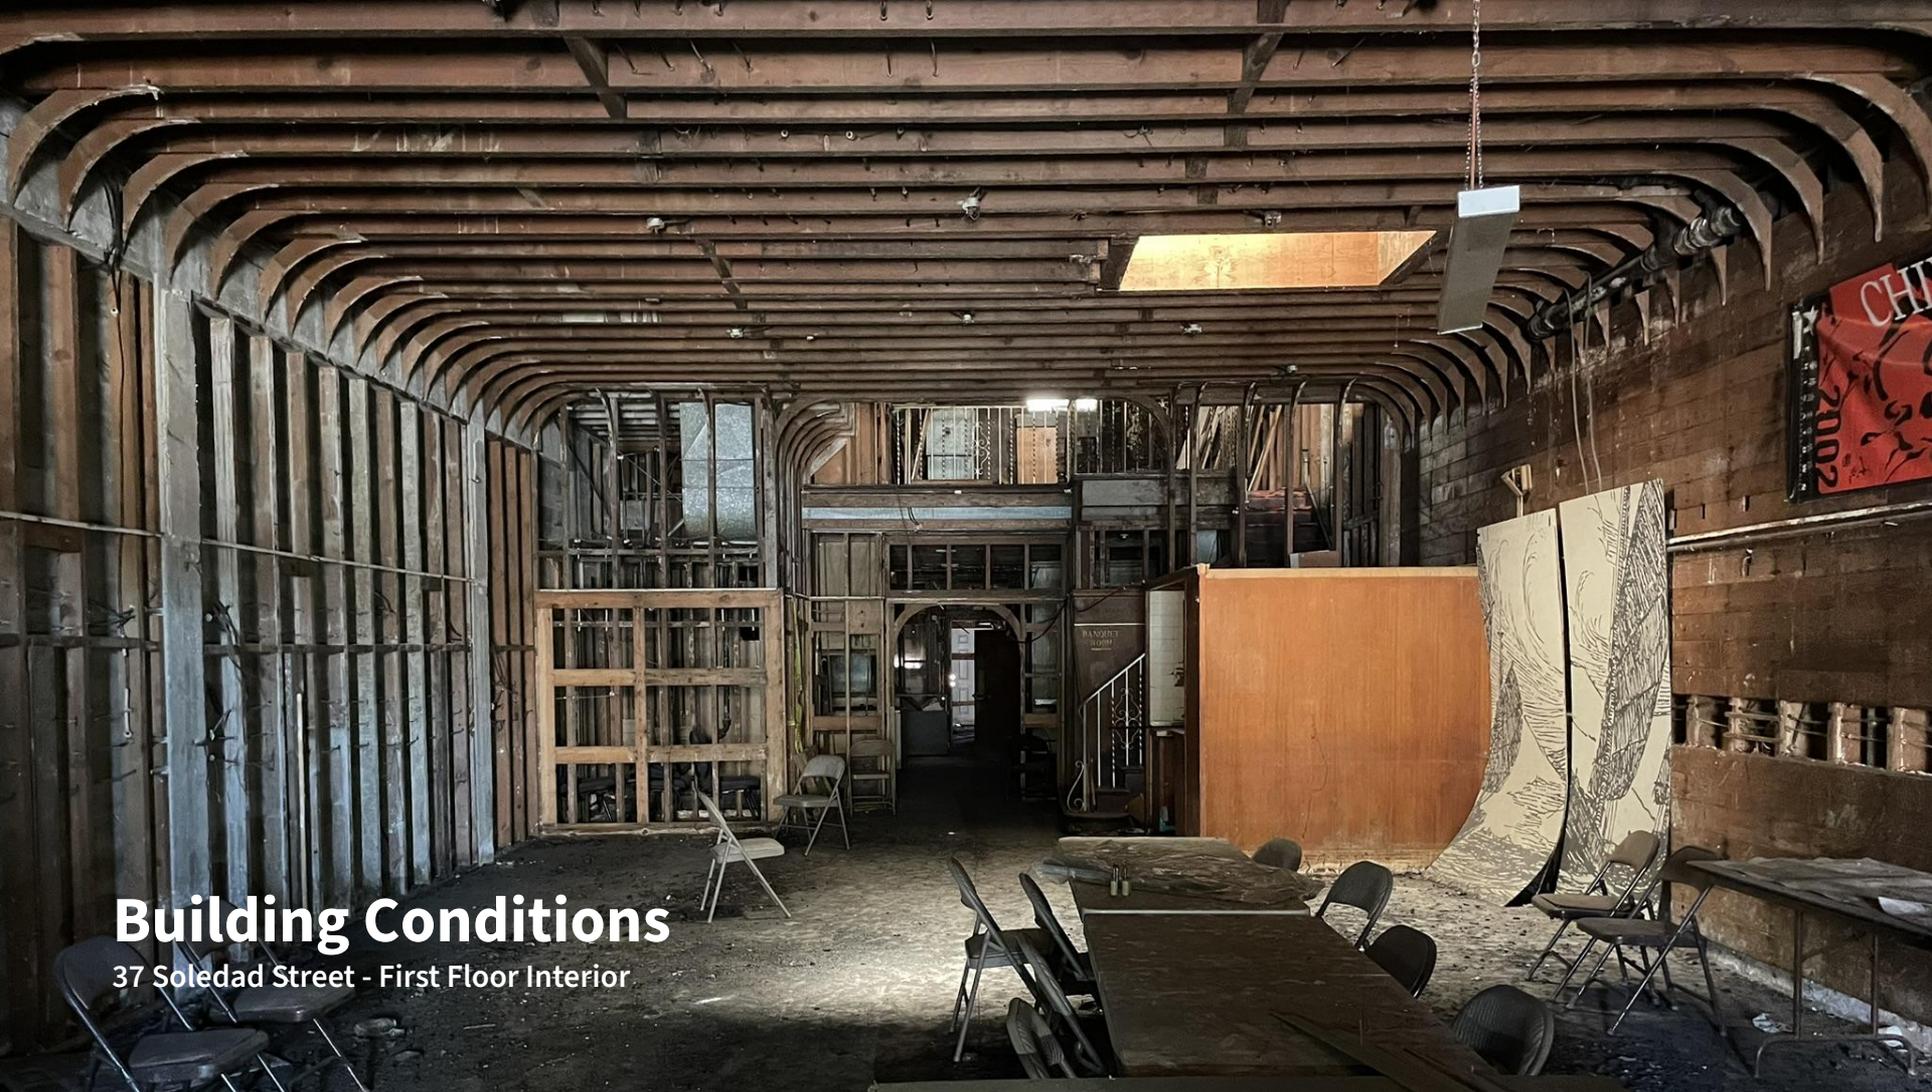
37 Soledad Street - First Floor Interior

Building Conditions

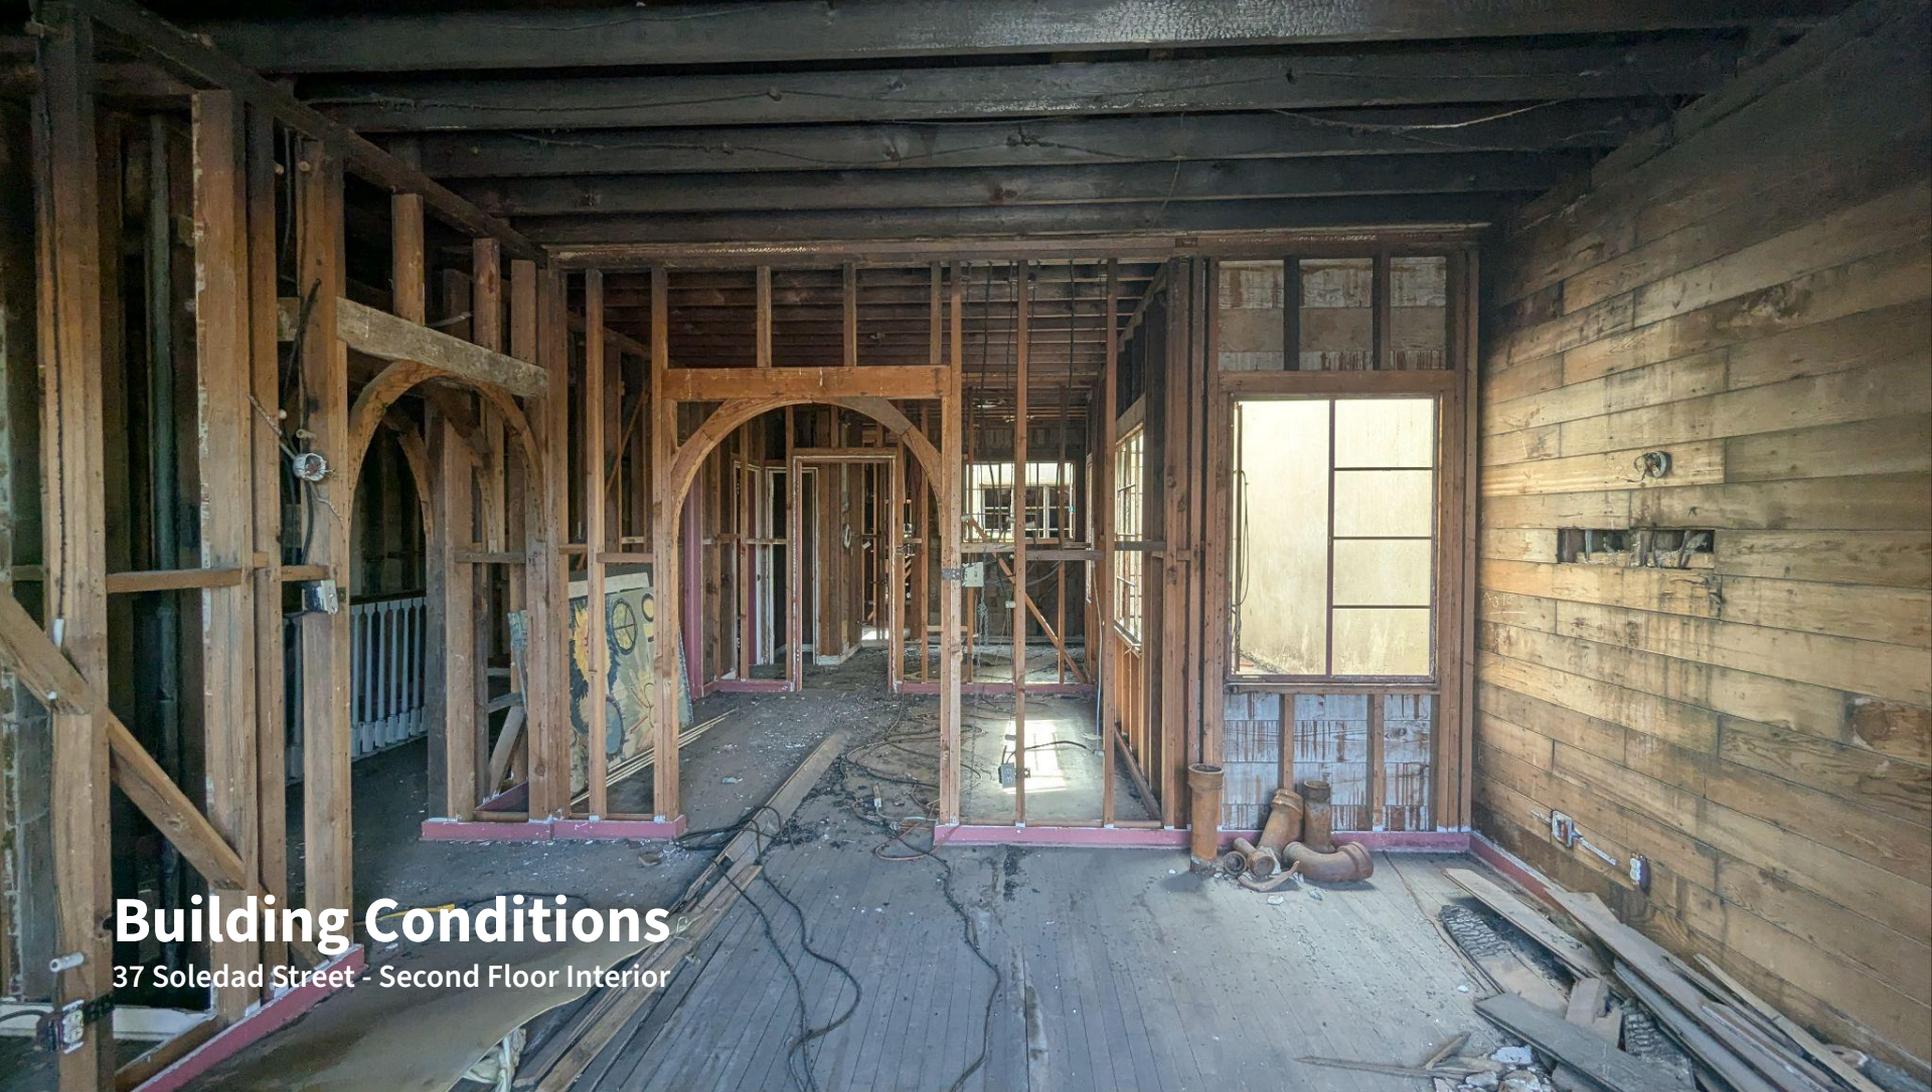
37 Soledad Street - Second Floor Interior

Building Conditions

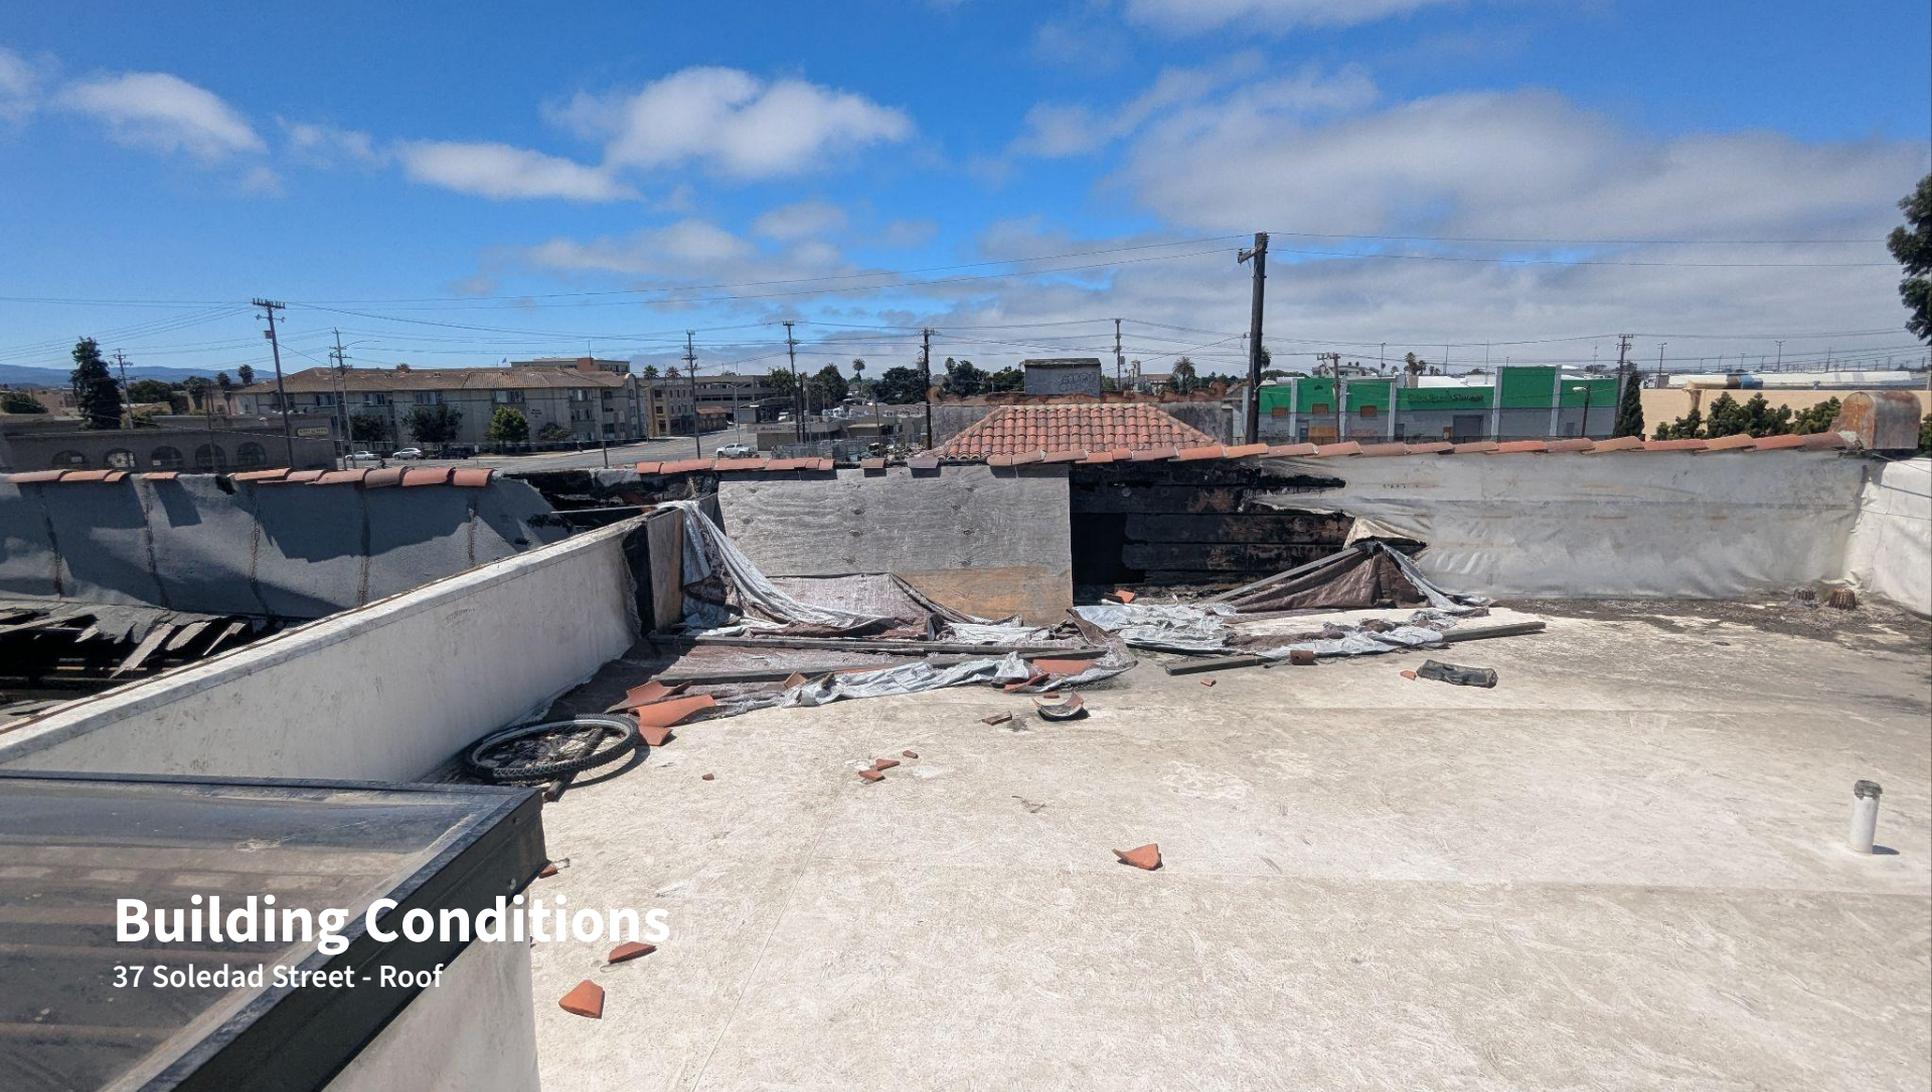
37 Soledad Street - Roof

Building Conditions

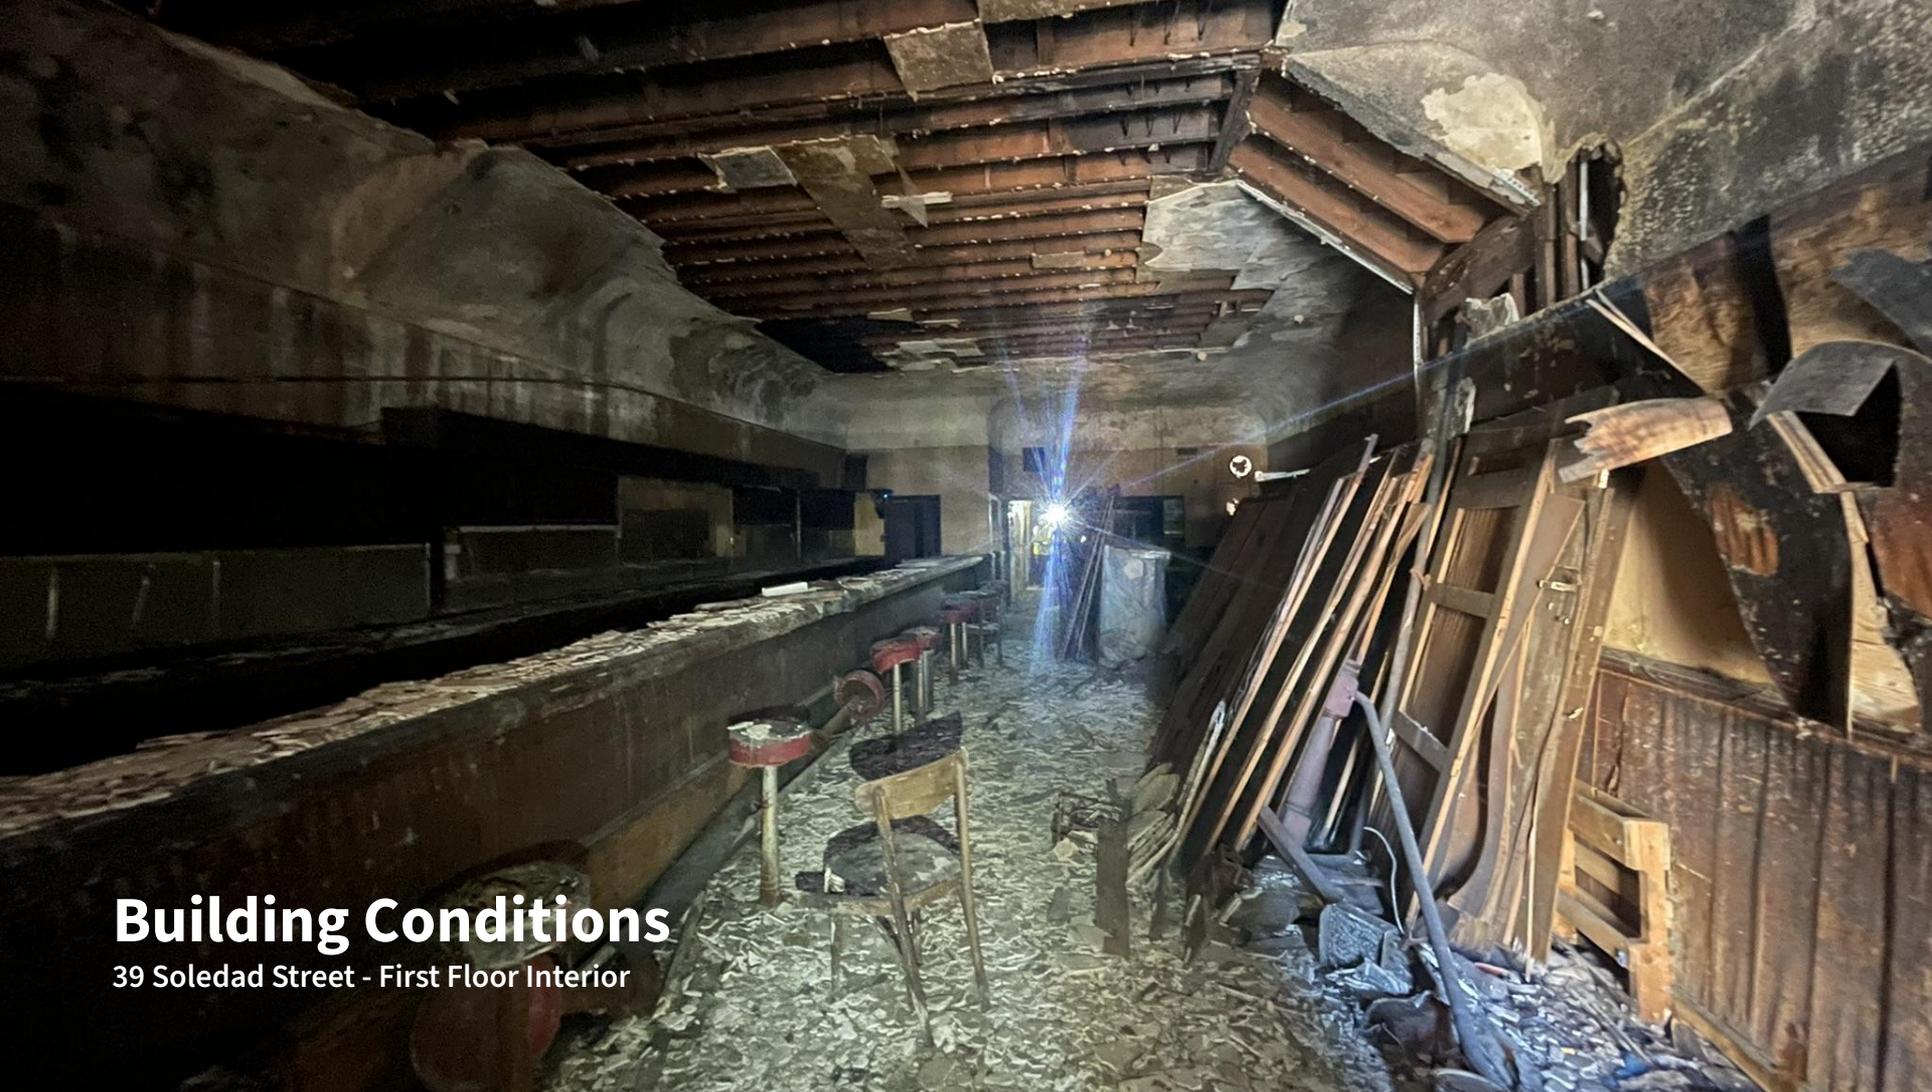
39 Soledad Street - First Floor Interior

Building Conditions

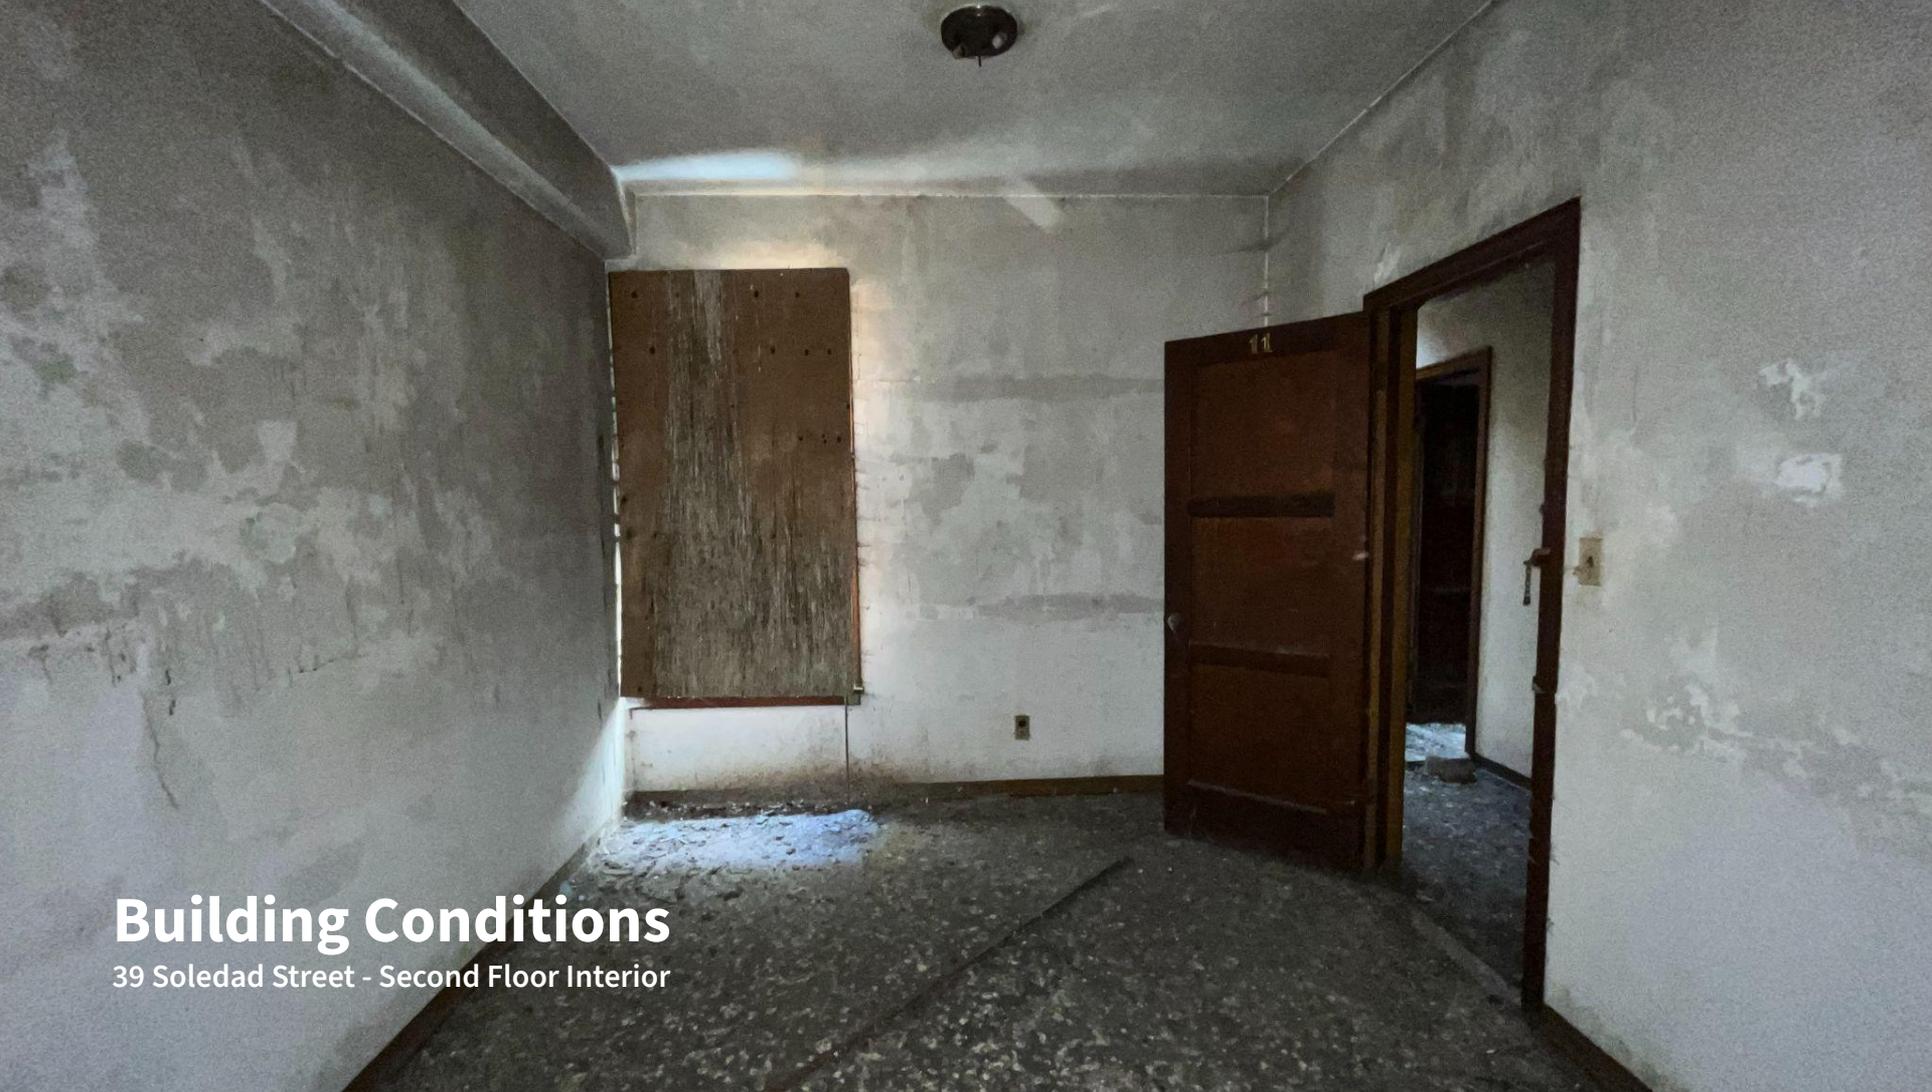
39 Soledad Street - Second Floor Interior

Building Conditions

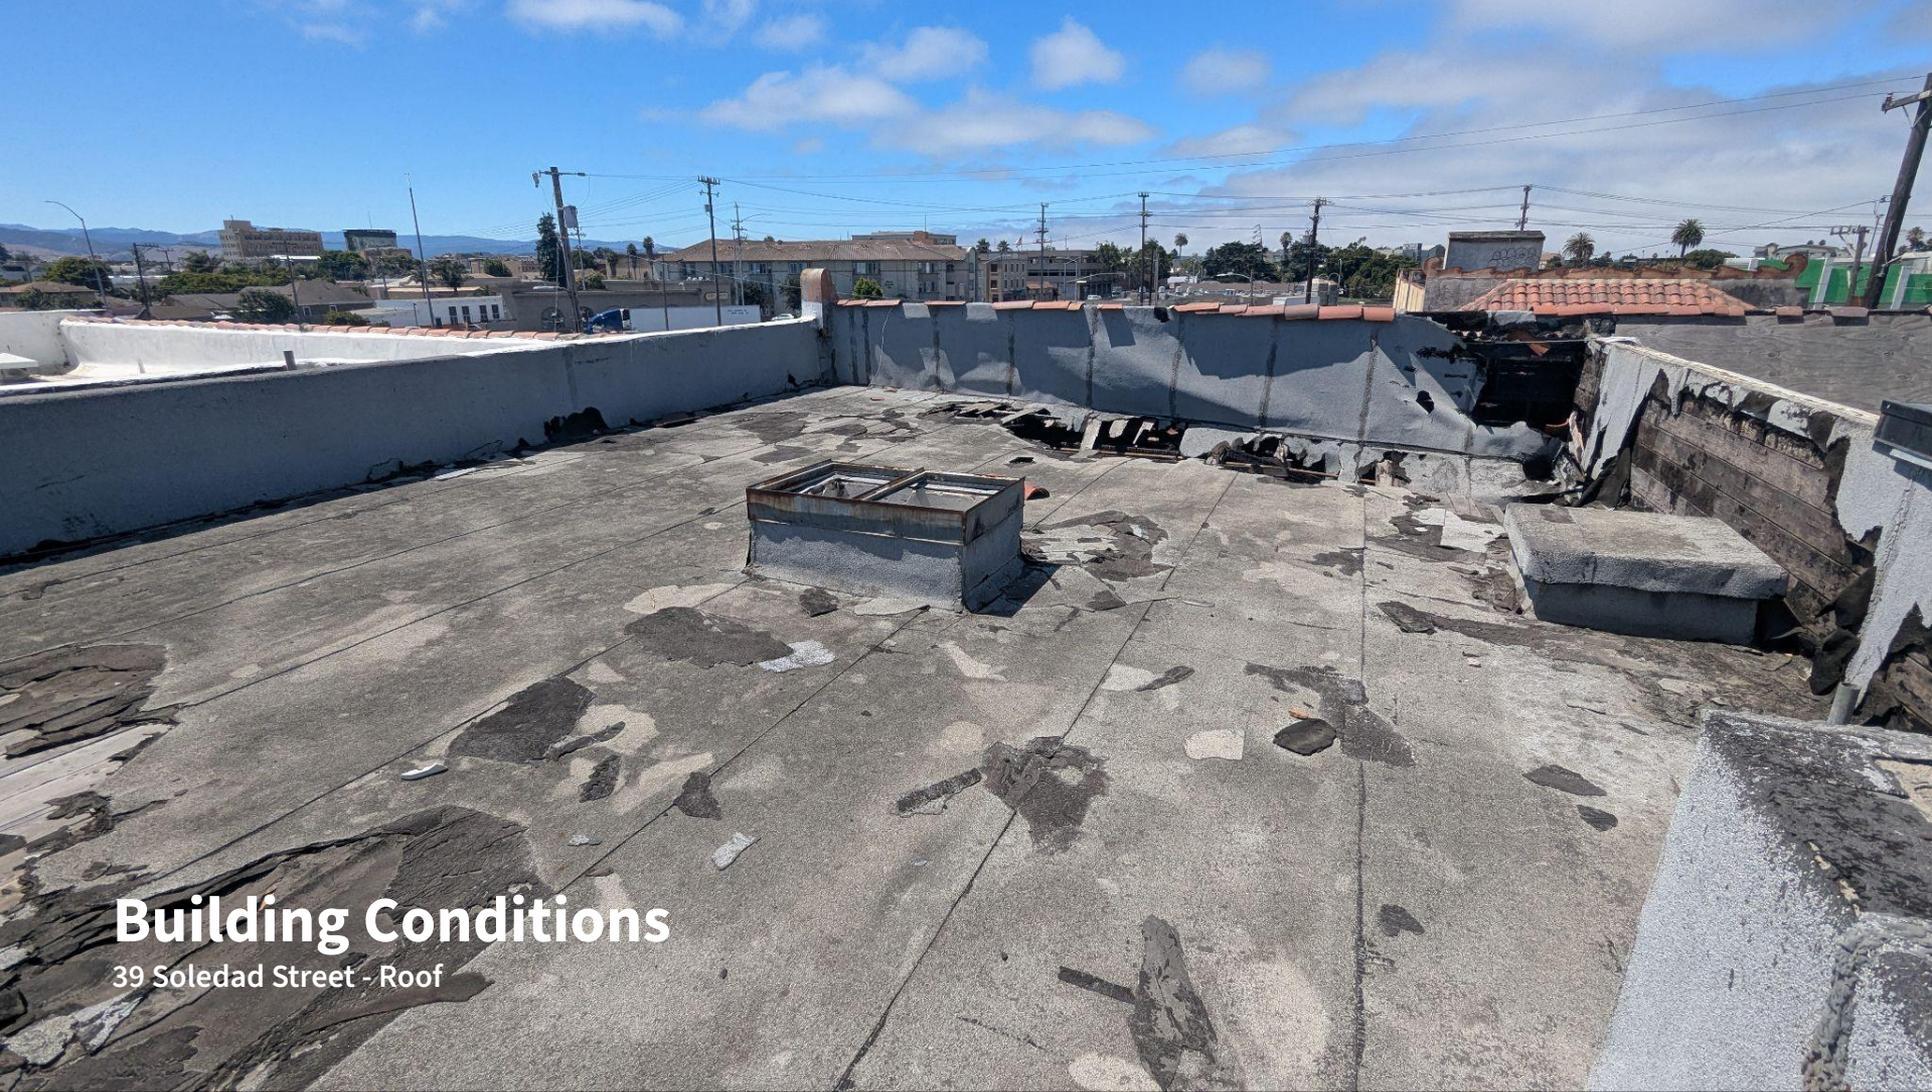
39 Soledad Street - Roof

Building Conditions
