**APPELLANTS' BRIEF ON APPEAL OF
A NOTICE AND ORDER TO REPAIR
OR ABATE DATED 4/12/18 RELATED
TO 241 MAIN ST., SALINAS, CA 93901
(APN 002-234-031)**

TITLE: Fox Theater *NOT URM*

BUILDING TITLE: Fox Theater

SUMMARY OF STRUCTURAL DEFICIENCIES

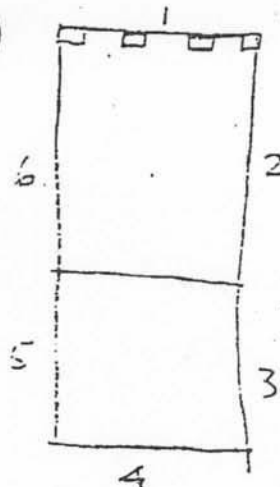
WALL: #1

OPEN 1ST FLOOR W/ APPARENTLY, 4 LARGE COLS.

SOLID CONC WALL ABOVE WHICH MEASURES

21" THICK @ PROJECTION ROOM

PARAPET: NONE HEIGHT 4' ± MAX.

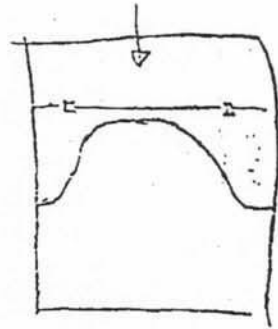
FLOOR BALCONY

TRUSSED W/ LIGHT FRAMING

SUPPORT OF BALCONY

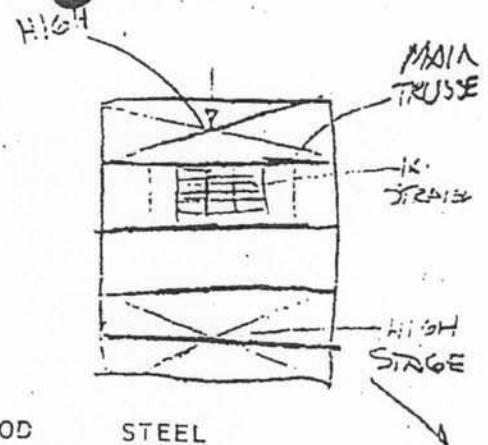
JOISTS: WOOD STEEL CONCRETE UNKNOWN NONE
LIGHT STICK FRAMED

BEAMS: WOOD STEEL CONCRETE UNKNOWN NONE
LARGE TRUSSES

LEDGER: NONE UNKNOWN YES, BUT NOT
ATTACHED TO WALL

Req'd: New plywood diaphragms at roof & balcony.

Ledgers/Chords & Ledger Bolts.

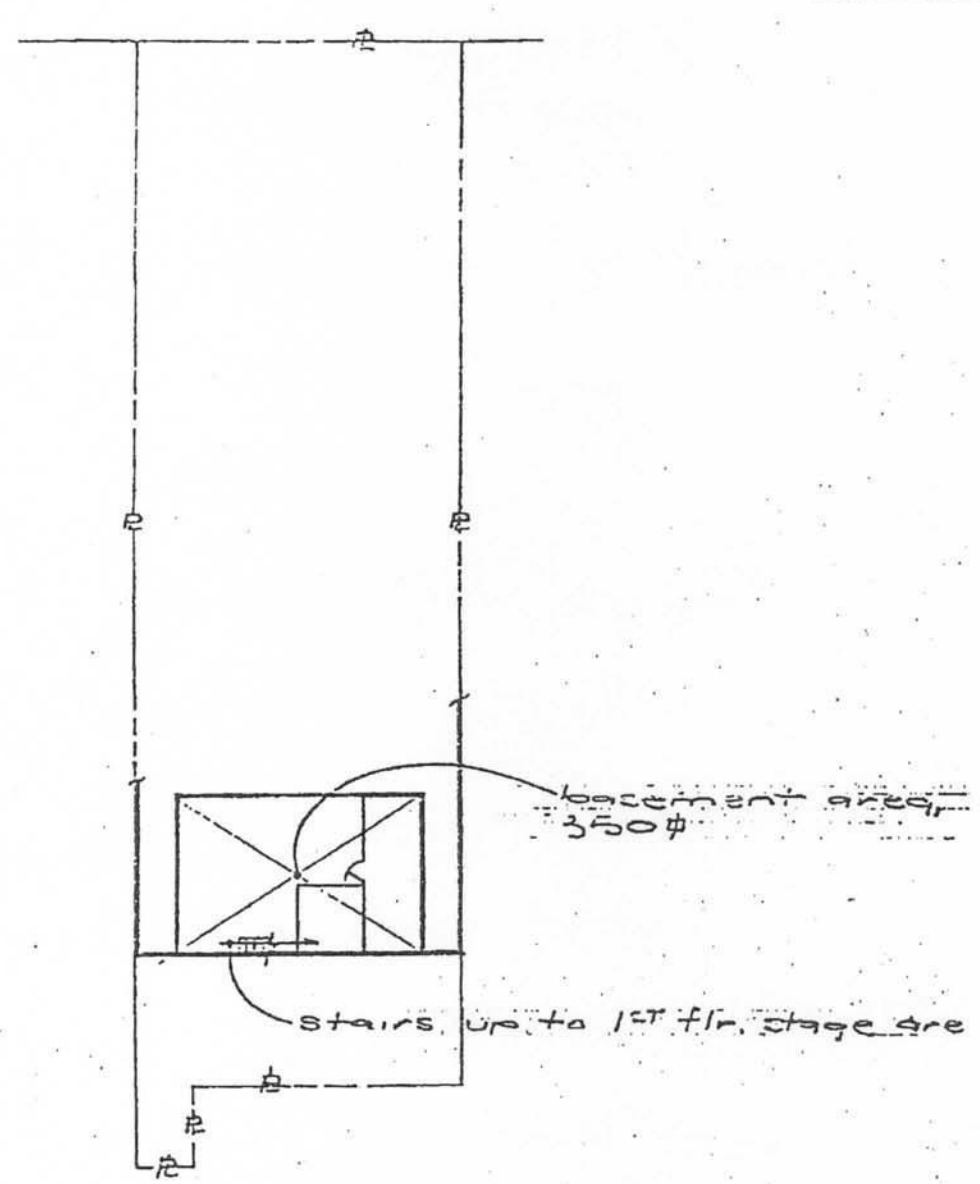
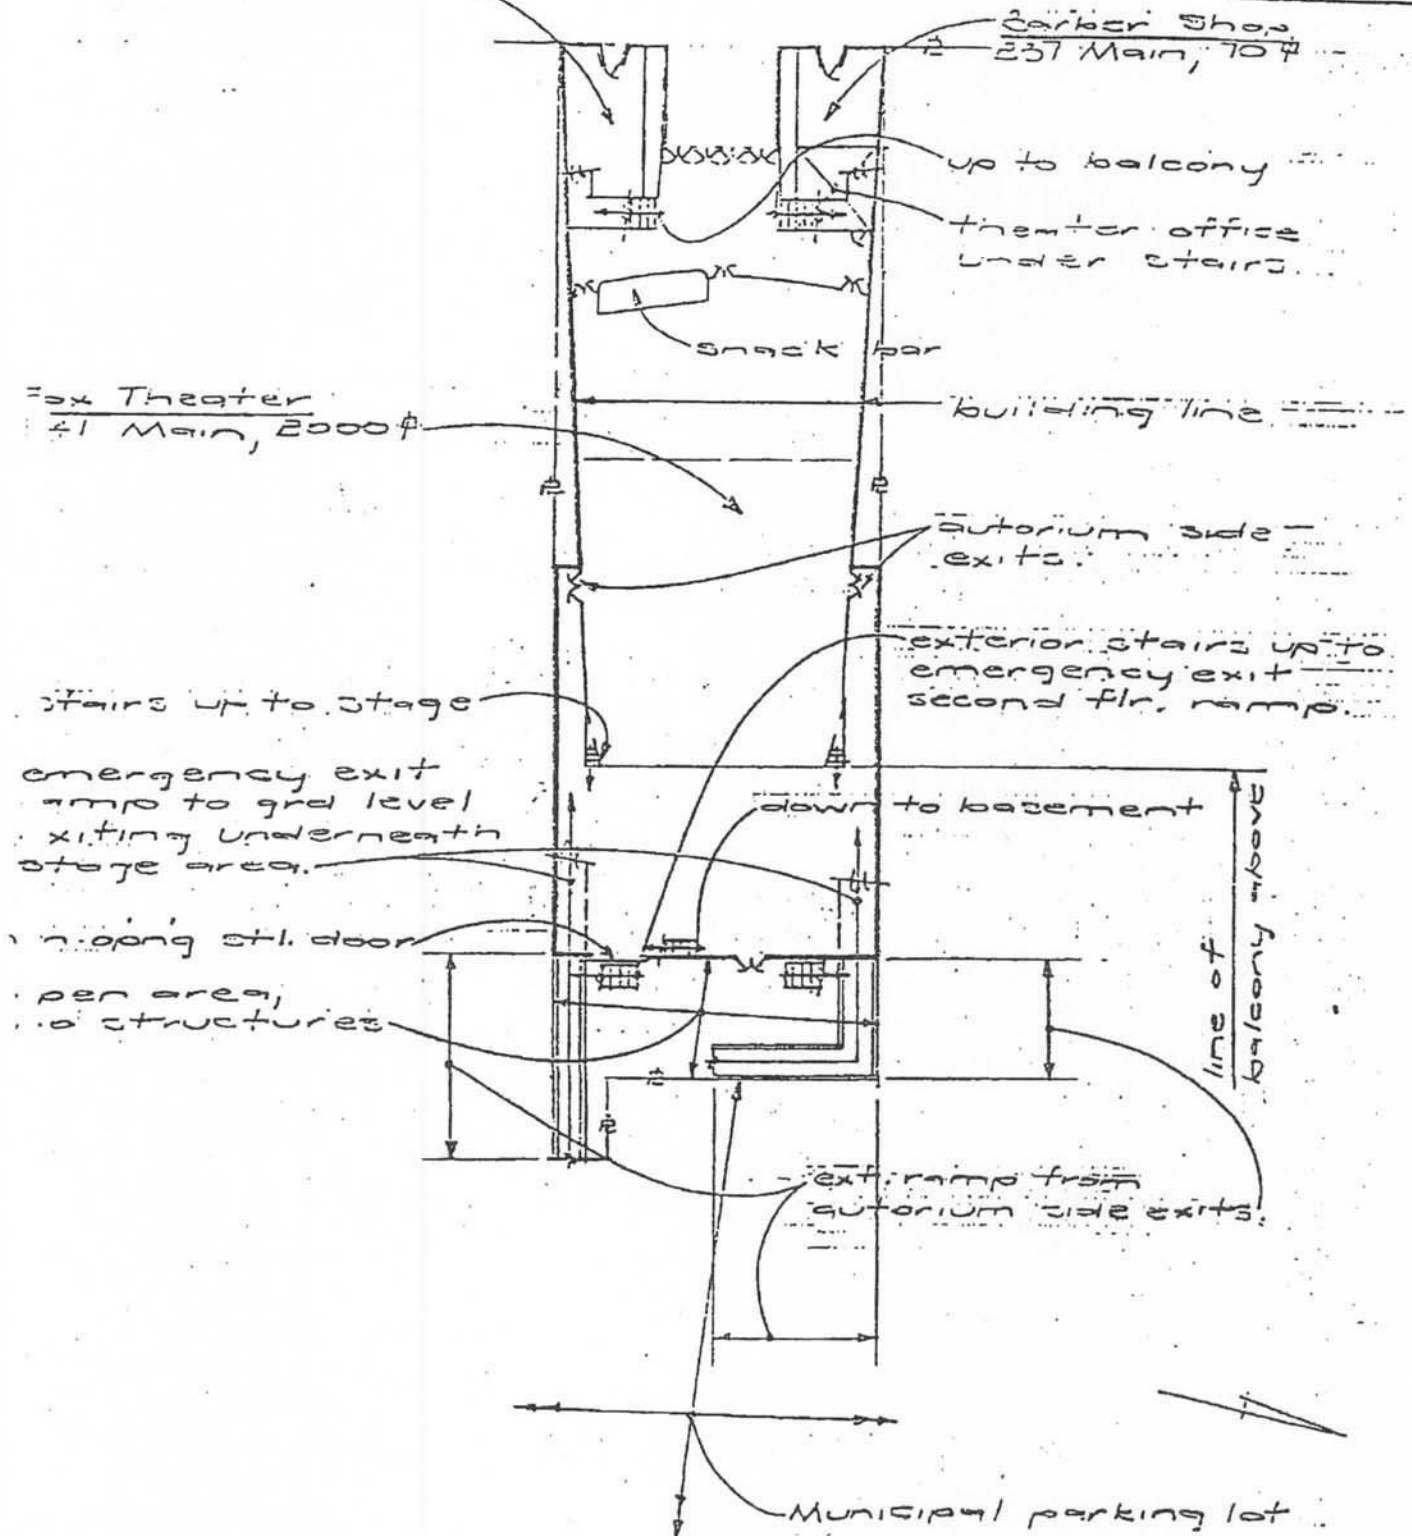
E-9

This building has walls constructed of concrete, probably reinforced. Since it is beyond the scope of this investigation to determine the strength, size & spacing of the reinforcing and the strength of the concrete, a meaningful analysis at this time is impossible. Because of the occupancy (theater), a thorough investigation under gravity & seismic loads should be made.

The following work should be done to correct obvious deficiencies.

As part of detailed rehab design take cores of concrete, determine reinf.
