State of California — The Resources Agency  
DEPARTMENT OF PARKS AND RECREATION  
**PRIMARY RECORD**

\*Resource Name or #: (assigned by recorder) 147 Central Ave.

Salinas Historic Resources Survey

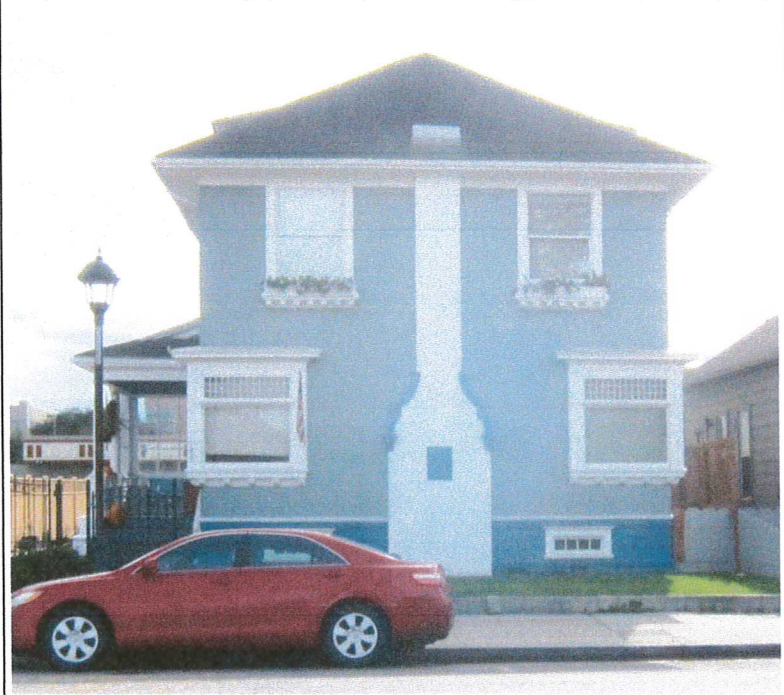
A two-story redwood-framed residence, rectangular in plan. The exterior wall cladding is a narrow horizontal clapboard. The hipped roof is covered with composition shingle and has paired hipped dormers in the roof plane of the left side elevation. On this elevation, a raised, partially glazed entry porch is supported on turned wood columns whose bases are enclosed by a solid porch rail with applied geometric detailing. Fenestration is basically 1/1 double-hung sash with leaded glass in most upper lights. Two such windows on the first floor of the north elevation flank a shaped brick chimney and have tiny balconies with shaped baulsters. Extended and square fixed-corner windows with tiny multipaned units above further articulate this elevation.

P5b. Description of Photo: (View, date, accession #) North Elevation, 2016

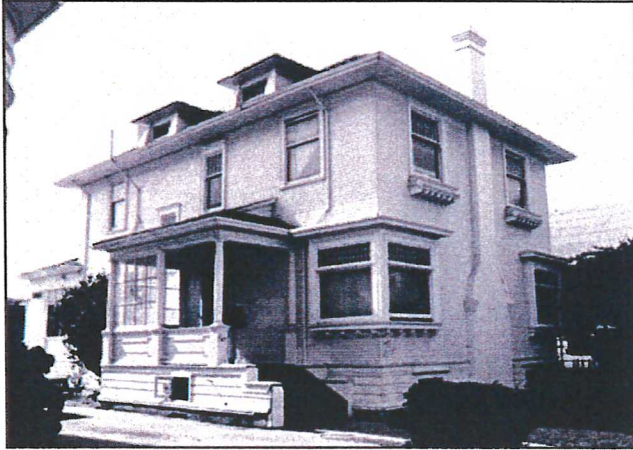
**Figure 1.** Circa 1988 image of the north and east elevations.

The chimney on the north elevation has been shortened at the roofline. Despite this alteration, the building maintains sufficient character-defining features to establish its historic integrity.
