Appendix A: Air Quality and Greenhouse Gas Assessment Study

East Laurel Drive Sidewalk Project City of Salinas

Biological Report

East Laurel Drive Sidewalk Improvement
Salinas, CA

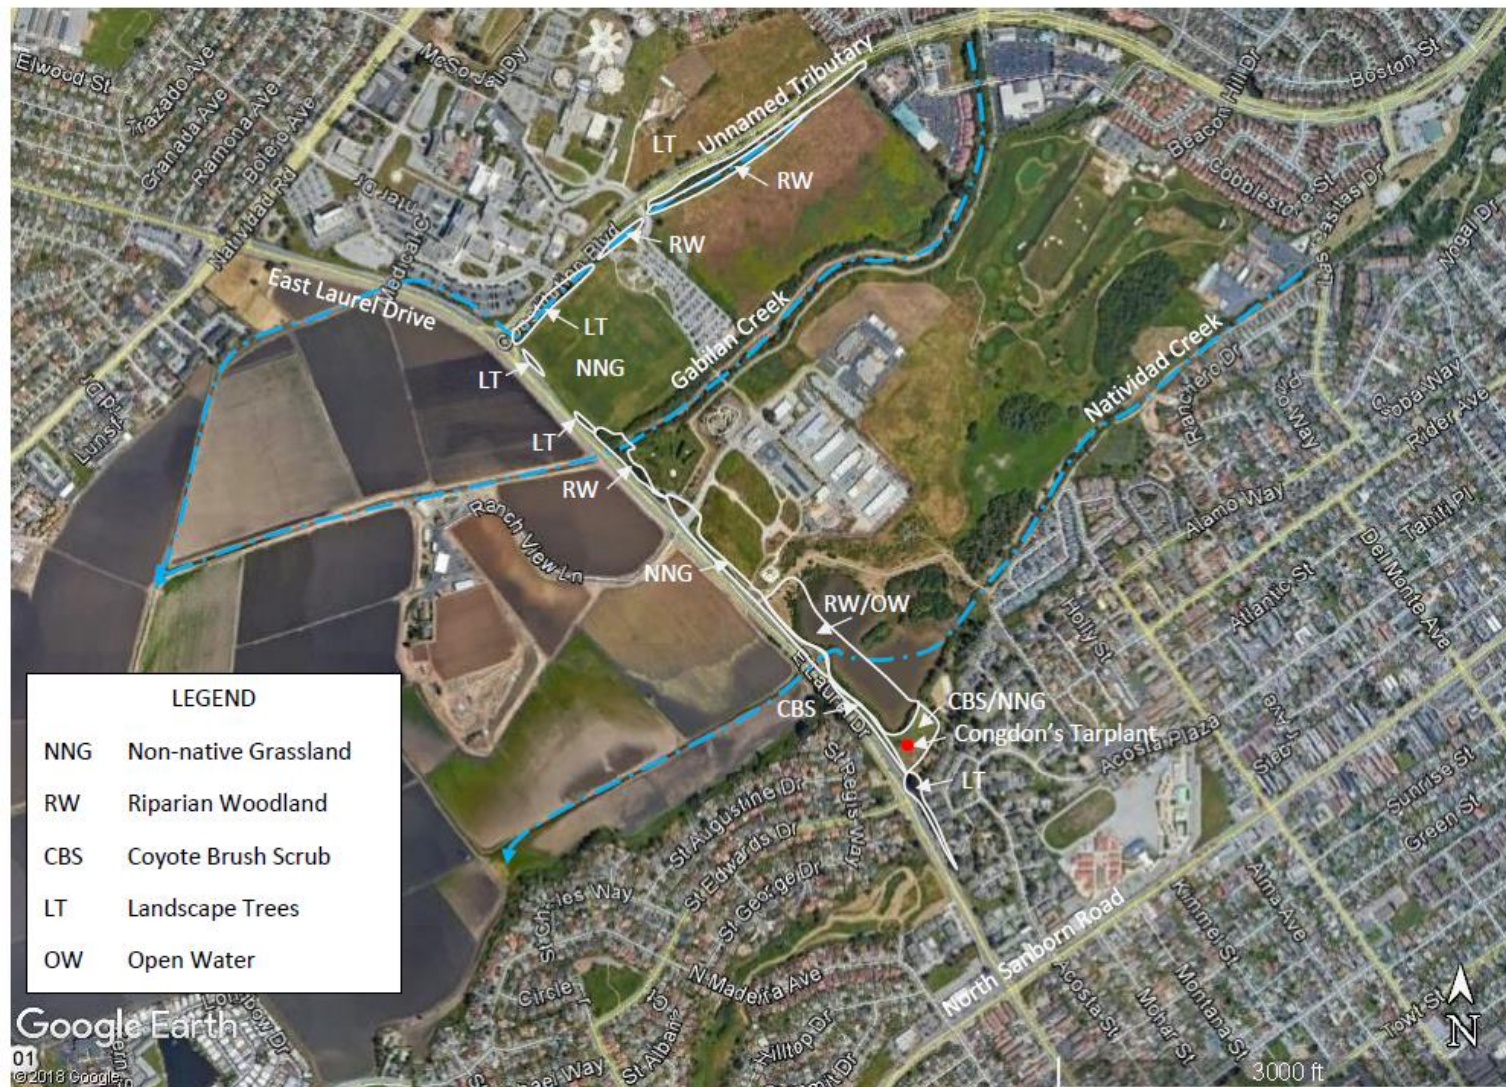
Figure 3. Distribution of Vegetation Types

The project area supports non-native grassland, with ruderal (weedy) areas. This vegetation occurs within the Constitution Soccer Fields (southwest of intersection of Constitution Boulevard and East Laurel Drive), irrigated turf within the Veterans Memorial Park, along portions of the embankment of the East Laurel Drive, and undeveloped adjacent to East Laurel Drive, as depicted on Figures 4 and 5. The condition of grassland areas is depicted in Figures 3 and 4.

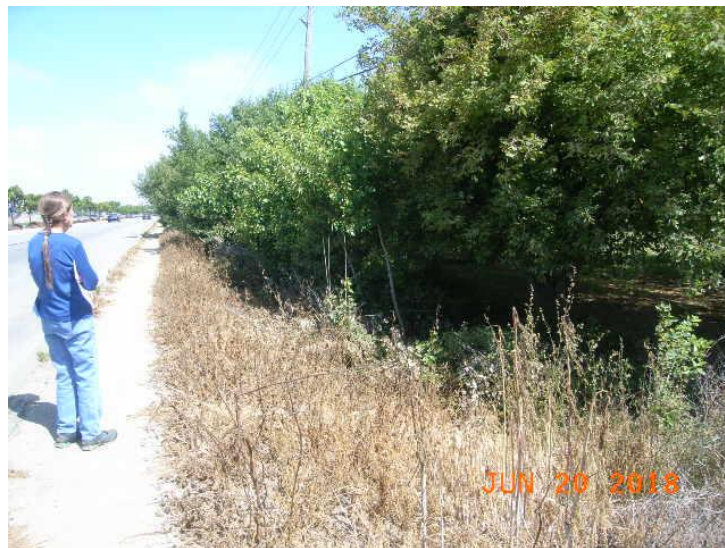
Figure 6. Riparian woodland along East Laurel Drive near Gabilan Creek

Riparian woodland along East Laurel Drive near Gabilan Creek and along the edge of the Natividad Creek detention pond is depicted in Figures 6 and 7, respectively.

In general, riparian habitats are one of the highest value habitats for wildlife species diversity and abundance in California. Factors which contribute to the high wildlife value include the presence of surface water, the variety of niches provided by the high structural complexity of the habitat, and the abundance of plant growth. The value of the riparian habitat along the project site to wildlife is moderated by the relatively narrow corridor, high human use of the surrounding developments, roads, and seasonal water. Common wildlife species that may inhabit this riparian habitat include Pacific treefrog (*Hyla regilla*), bullfrog (*Rana catesbeiana*), Wilson's warbler (*Wilsonia pusilla*), Bewick's wren (*Thryomanes bewickii*), red-shouldered hawk (*Buteo lineatus*), raccoon (*Procyon lotor*), and opossum (*Didelphis virginiana*).

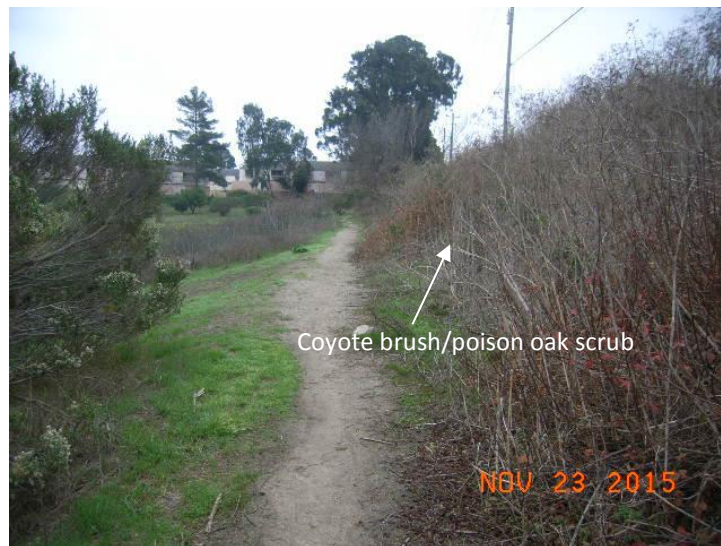
Figure 8. Coyote brush/poison oak scrub along embankment of East Laurel Drive

Some portions of the embankment of East Laurel Drive support a dense growth of coyote brush and poison oak, with lesser amounts of California blackberry. Non-native plant species are also present, such as poison hemlock (*Conium maculatum*), wild radish (*Raphanus sativa*), fennel (*Foeniculum vulgare*), and bristly ox-tongue (*Picris echioides*). The character of this scrub vegetation is depicted in Figure 8.

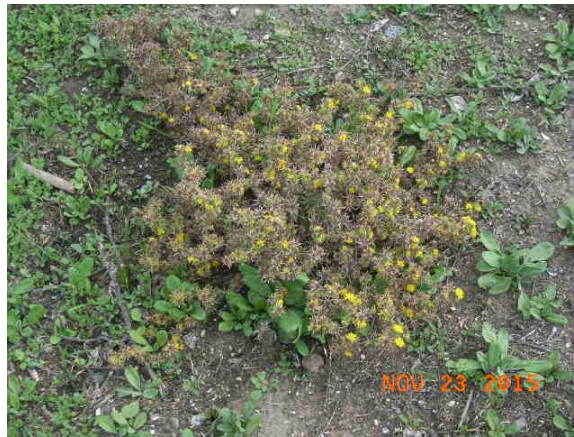
Figure 10. Congdon's tarplant growing in grassland/scrub area south of Natividad Creek pond and east of East Laurel Drive project area

Congdon's tarplant grows in annual grasslands, typically in areas with high seasonal moisture. The blooming period is typically from June to October. Because Congdon's tarplant is an annual species, its population can vary from year to year depending upon weather conditions (e.g., rainfall, temperature), as well as human and natural disturbances within the species' habitat. Seeds are known to persist in the soil seedbank and germinate under favorable conditions. The species responds well to site disturbances that remove thatch and create open areas that are conducive to seed germination and plant growth. The species is depicted in Figure 10.

This species is known from the greater Monterey Bay region, with several occurrences recorded in the CNDDDB from the Salinas area. The closest recorded colony is located south of the Natividad Creek detention pond where the species grows on a low, flat floodplain east of East Laurel Drive. Another colony of this species is known from the Gabilan Creek floodplain, upstream of the project site near the intersection of Independence and Constitution Boulevard.

Congdon's tarplant was observed on the Natividad Creek pond floodplain. The tarplant was observed growing amid grassland and coyote brush scrub on a low terrace approximately 75 feet east of the proposed project site. The approximate location of this colony is depicted on Figure 2.

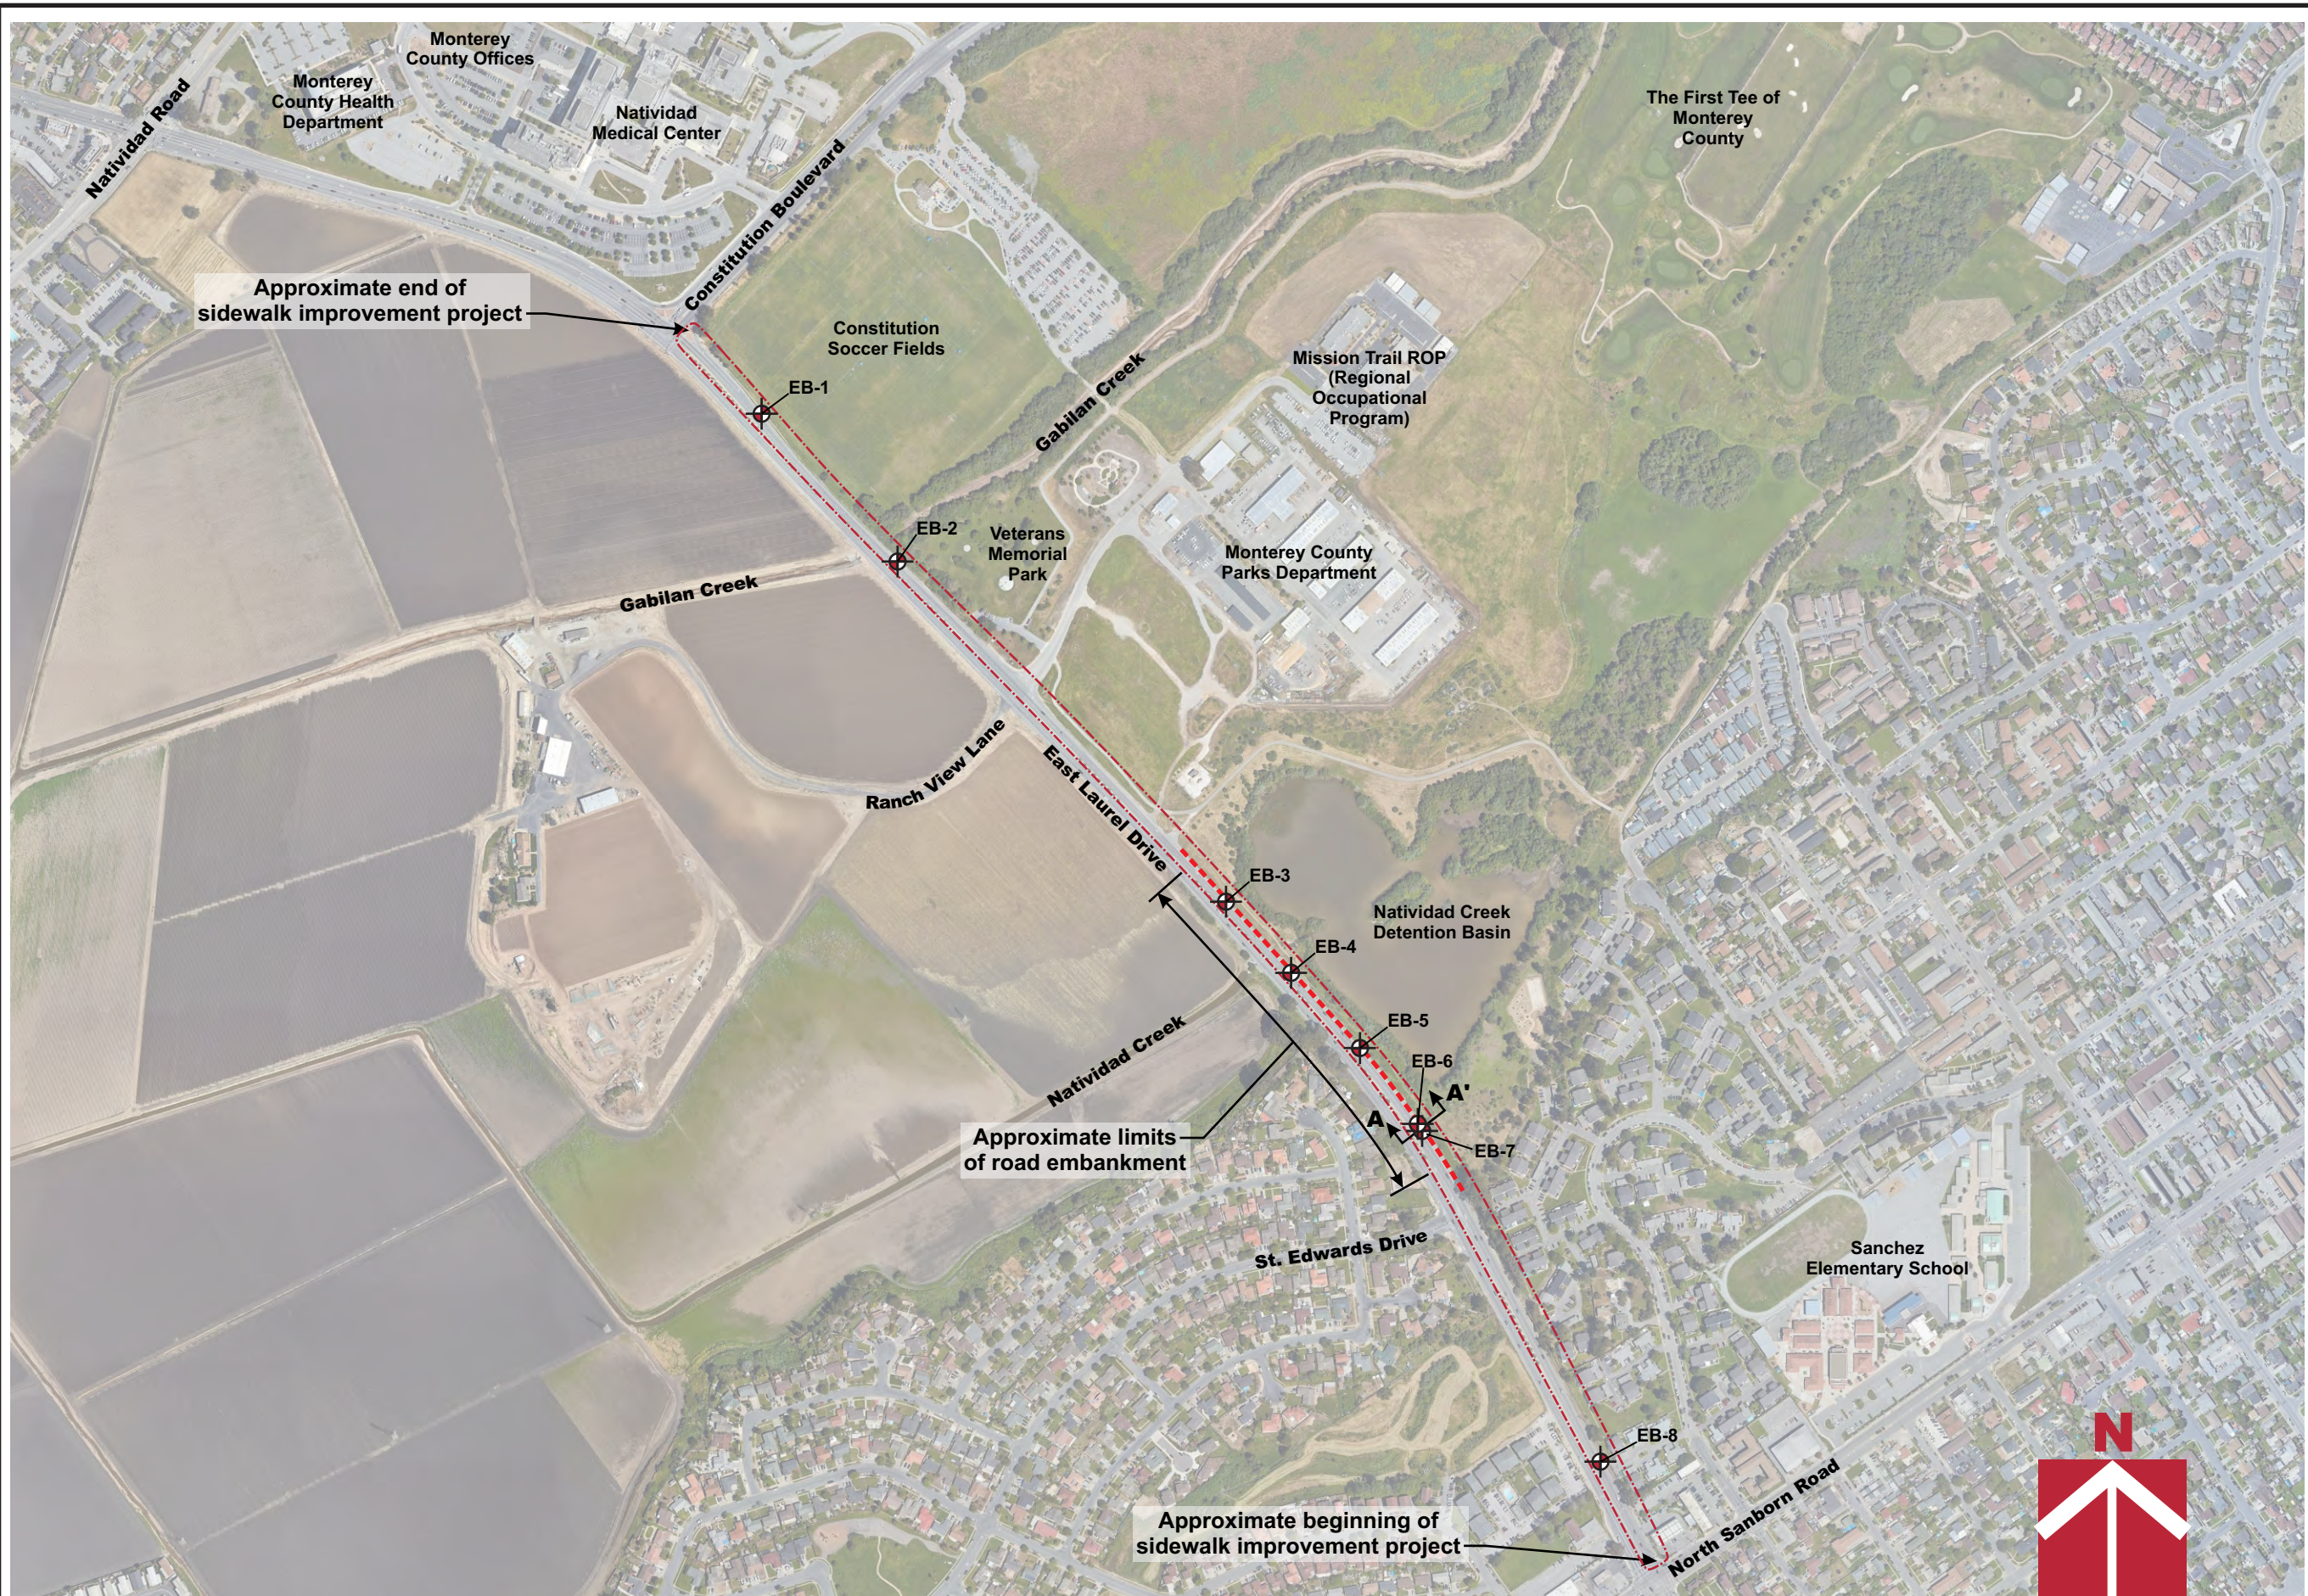
--- Approximate limits of Boardwalk
(Limits of improvements from K&H plans dated June 2018)

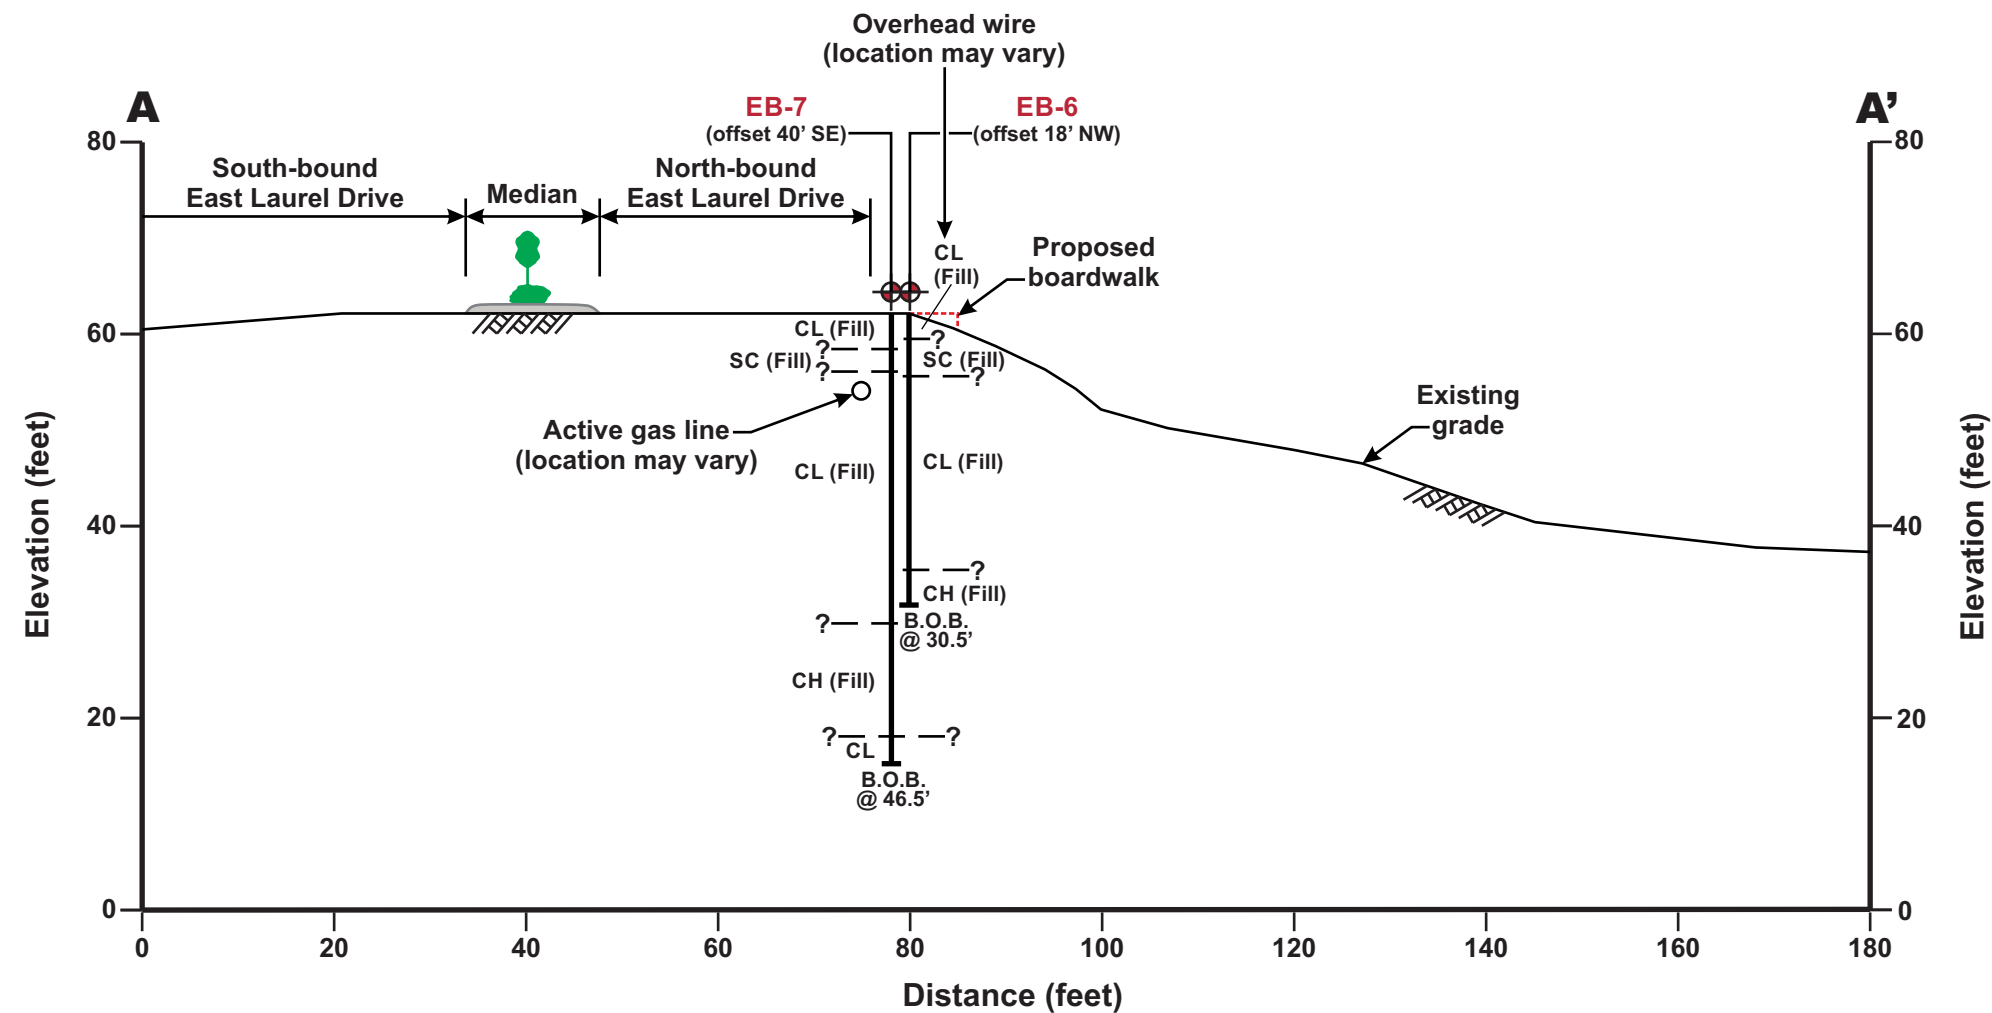
Symbols

- CL Lean Clay
- CH Fat Clay
- SC Clayey Sand
- Approximate location of exploratory boring (EB)

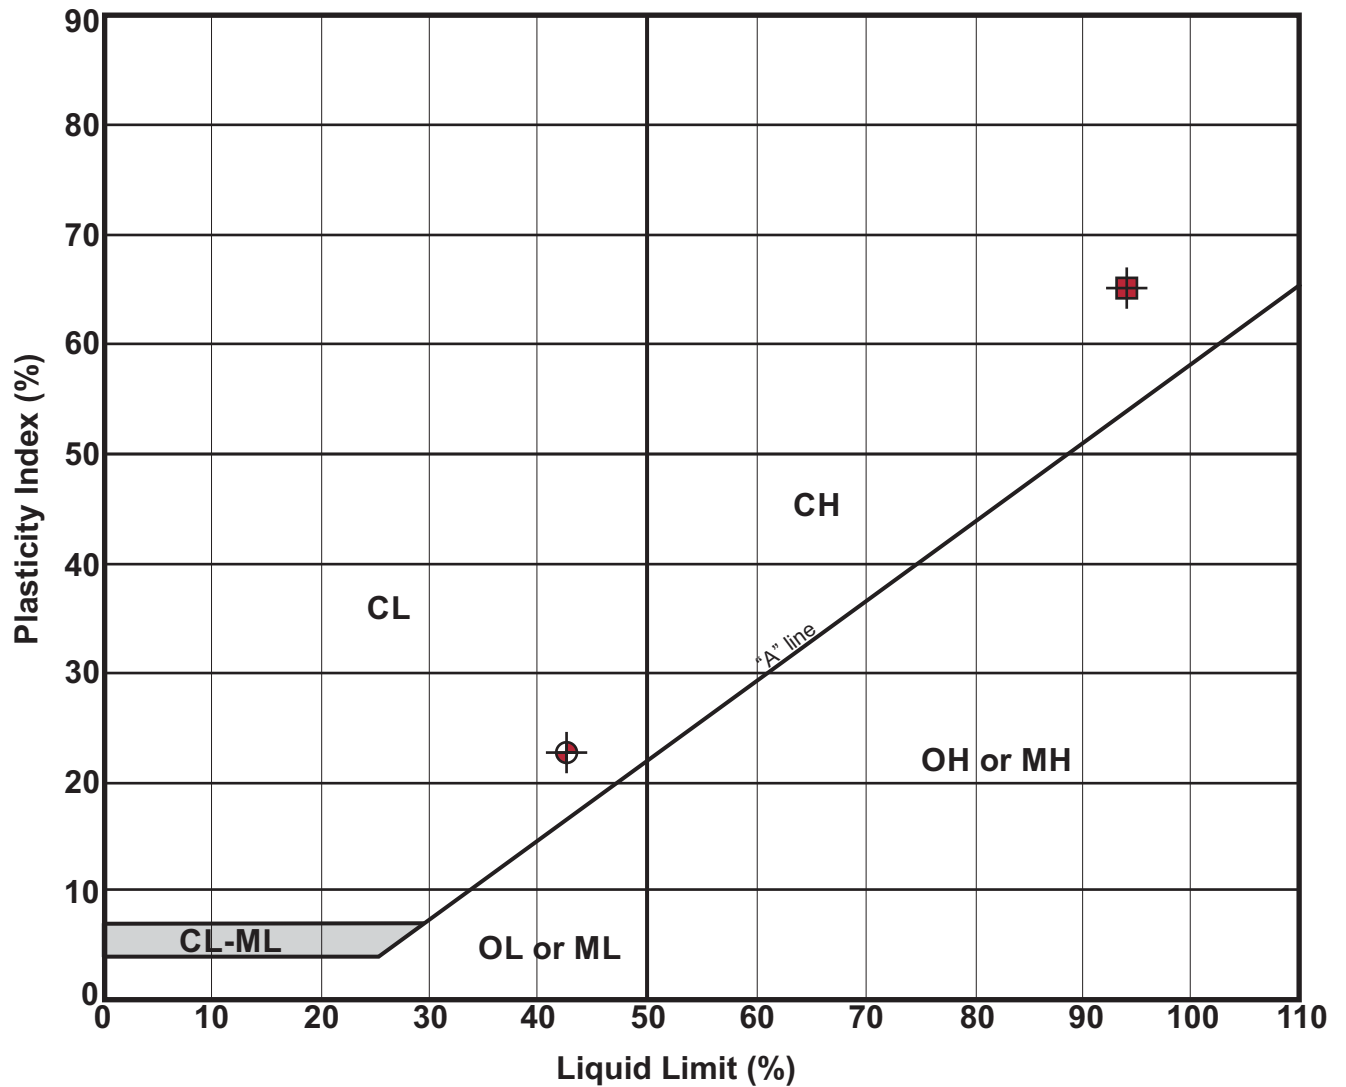
Plasticity Index (ASTM D4318) Testing Summary

Symbol	Boring No.	Depth (ft)	Natural Water Content (%)	Liquid Limit (%)	Plastic Limit (%)	Plasticity Index	Passing No. 200 (%)	Group Name (USCS - ASTM D2487)
	EB-4	2.0	11	43	21	22	---	Lean Clay with Sand (CL) [Fill]
	EB-7	40.5	37	94	28	66	---	Fat Clay (CH)
