Historic Structures Report

37-39 Soledad Street

City of Salinas, California | February 2026

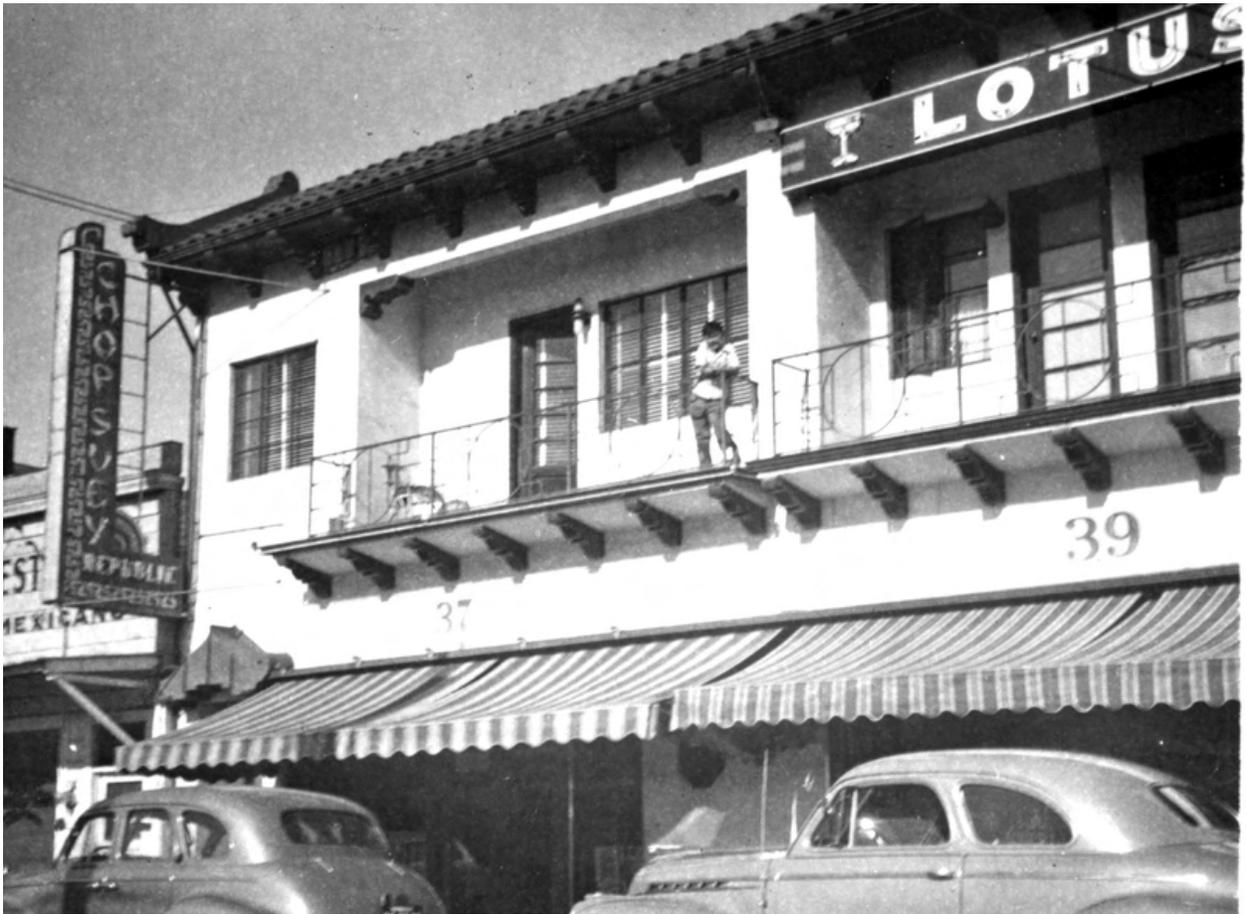
Figure 1.18 (Bottom) 37-39 Soledad Street, Ca. 1940s, ACES Archive, 2024.435.20E.

- Consider installing a retractable canvas awning over sidewalk (similar to historic awning, see Figure 1.17), hung from the underside of the storefront soffit.

First floor storefront: retractable canvas awning	Consider installing a retractable canvas awning over sidewalk (similar to historic awning, figure 1.17), hung from the underside of the storefront soffit.	Recommended
Mosaic tile sidewalk & “REPUBLIC CAFE” mural	Clean with low-pressure, warm water spray. Replace cracked or broken tiles in place to match original.	Recommended
Exterior cement plaster	Sound the existing cement plaster exterior that is over structurally stable framing/ concrete to determine condition. Remove unsound cement plaster and patch to match adjacent. Clean exterior cement plaster to remain with low-pressure, warm water spray. Repair cracks and paint in light color match (or approximate) original color.	Recommended
Façade and components	Paint facade and components in color scheme more in keeping compatible with the original, with light colored walls and dark colored accents.	Recommended

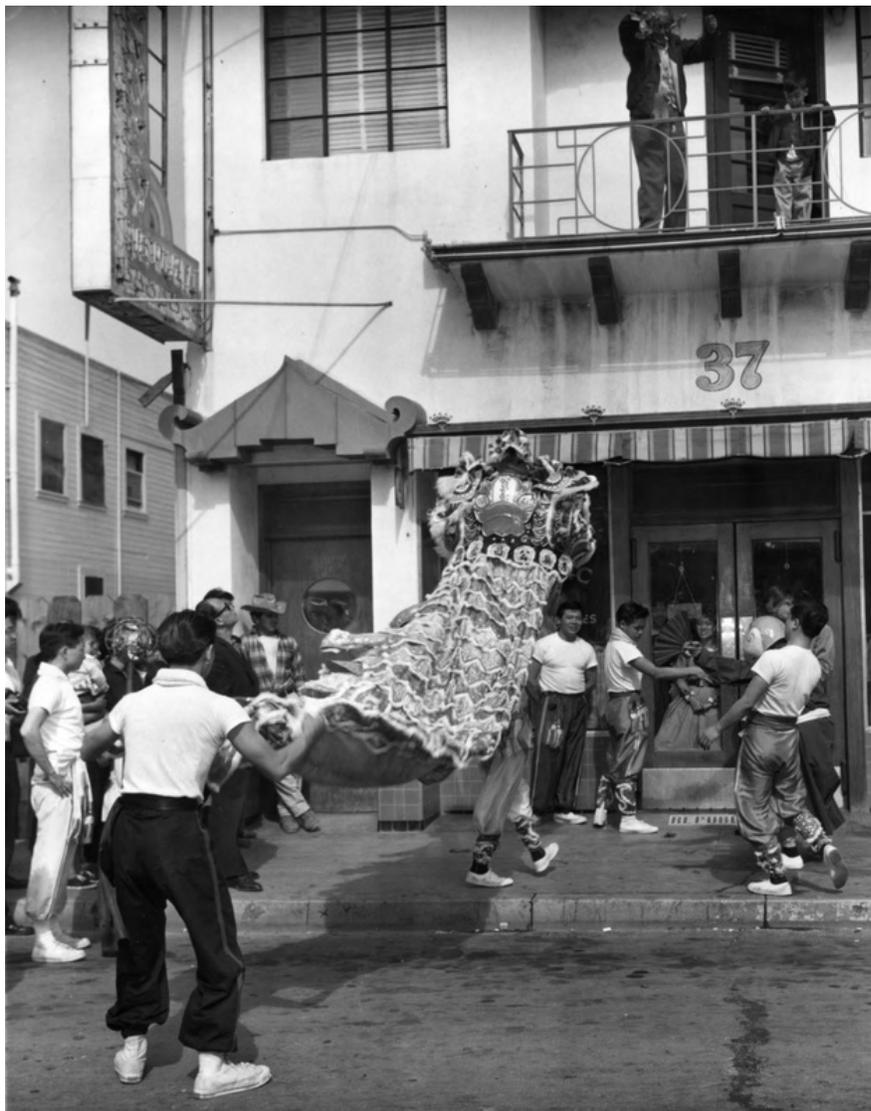
Figure 1.20 (Left) Bing Kong celebration on Soledad Street in front of the Republic Cafe, 1959, ACES Archive, 2006.685.22.

- There are a pair of wood frame, glazed storefront doors with transom above at each storefront entry (currently covered with plywood). The doors and transom at 39 are in poor condition, are missing glazing and have been damaged by fire at the interior. The doors at 37 are similarly in poor condition, with missing glazing and damage at wood components from various attachments. The original transom appears to have been removed and replaced with an inappropriate metal vent in its place, in fair condition. The transom appears to have been in-swinging hopper windows (Figure 1.20).

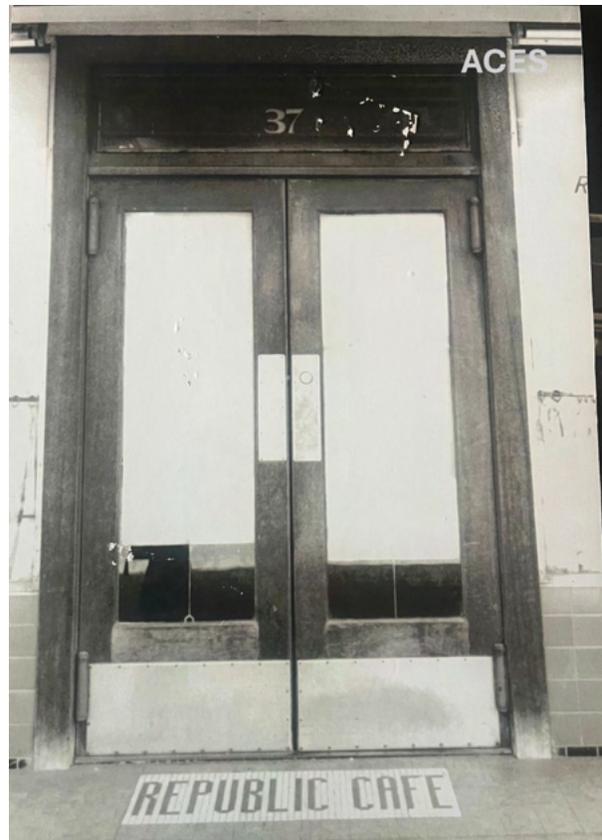
Figure 1.29 37 Soledad/Republic Café door and mosaic entryway, 1977. Photograph by Wellington Lee, ACES Archive, 2024.651.22.

A ceramic, brightly-colored tile bulkhead extends across the base of the façade, outlining the original storefront configuration visible in historic photographs (Figure 2.13, also see Figures 1.29 and 1.32). A portion has been removed or has fallen off, revealing the wood backer board behind at 39 Soledad.

The recessed storefront at the 37 Soledad opening remains and a pair of flush wood glazed storefront doors are extant, covered with plywood (See Figure 1.29 for historic photograph). The original glazed transom has been removed; the painted metal security bars in the opening remain. The storefront to either side of the doors, and atop the bulkhead has been covered in plywood. The original wood storefront framing appears extant, however the glazing and assumed aluminum sash have been removed.

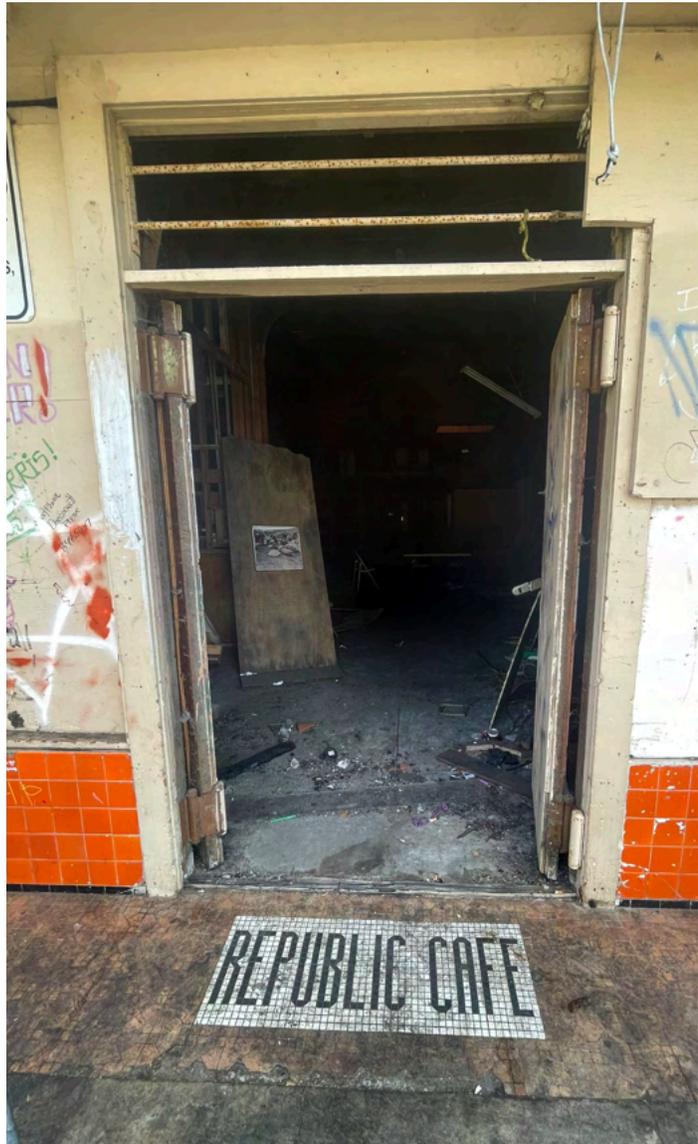
Figure 2.13 Tile bulkhead and mosaic sign of 37 Soledad, facing east, Groundwork Preservation LLC, 2025.

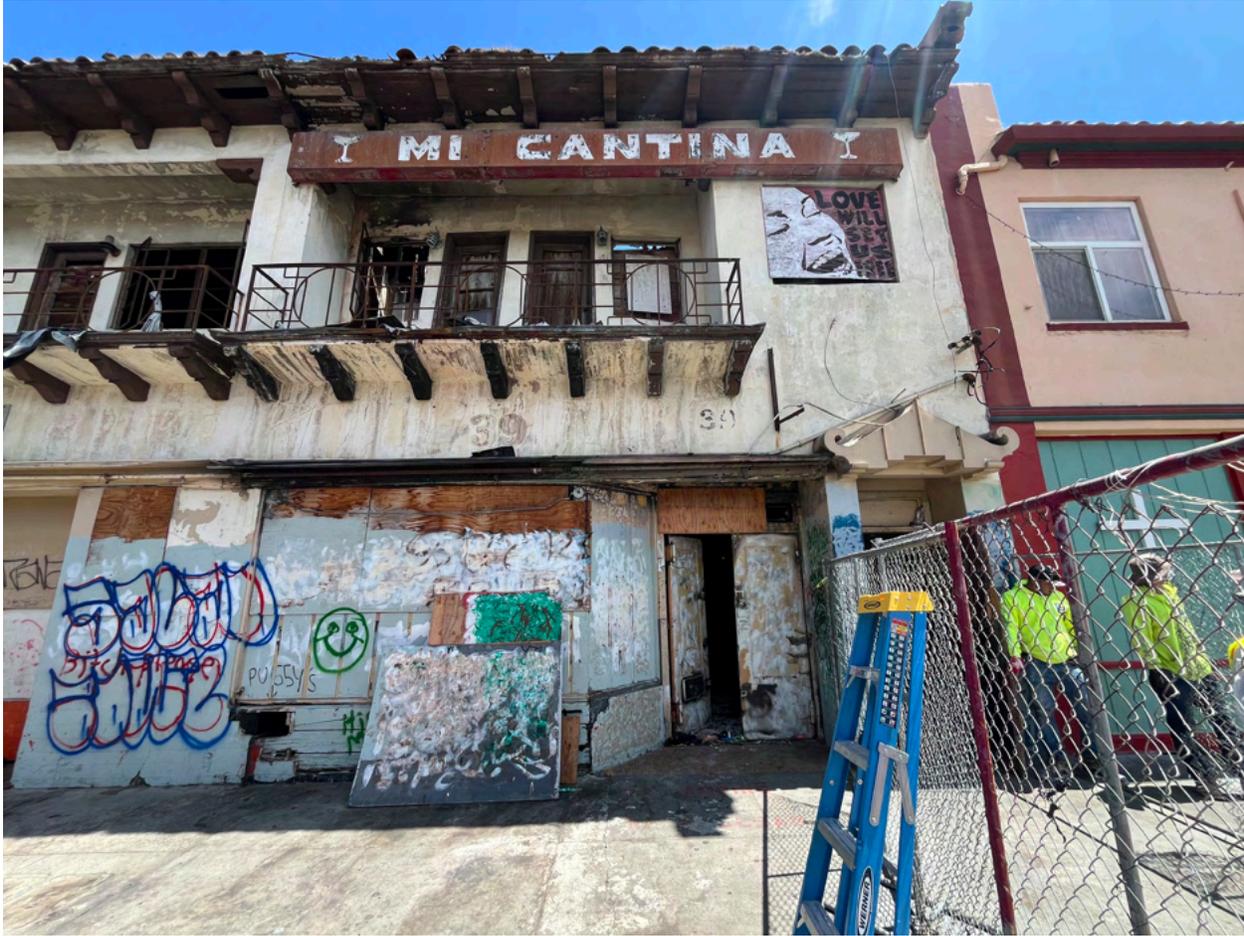
Figure 2.14 Primary façade of 39 Soledad, facing east, Groundwork Preservation, LLC, 2025.

The majority of the 39 Soledad portion of the ground story is obscured by plywood covering, installed over an area damaged by fire (Figure 2.14). An original octagonal window between the two storefronts remains intact beneath the plywood. A recessed entry to the south adjacent to an angled storefront configuration is discernible but currently enclosed with plywood. This area has been heavily damaged by fire. A pair of flush glazed wood storefront doors are located within the storefront recess and covered with plywood. The glazed transom and metal security bars above appear intact but have also been boarded up.

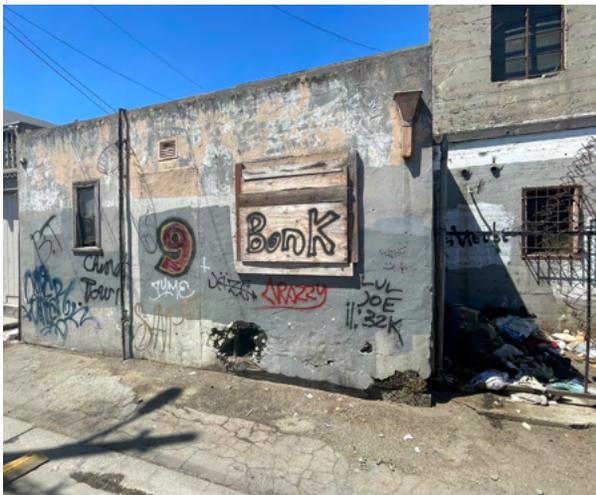
Figure 2.18 (Bottom) Rear (east) facade of 39 Soledad, facing southwest, Groundwork Preservation LLC, 2025.

The rear façade has two window openings: one is covered with wire mesh, and one is boarded up. The façade also includes remnants of a downspout, vents and metal piping (Figure 2.18). The south façade is obscured from the street view by a vertical wood fence and gate (Figure 2.19). This façade contains two entry doors with transom windows obscured by wood screens (Figure 2.23). The west façade faces 39 Soledad and contains two entry doors with transom windows, one is obscured by a wood screen and one is a replacement metal door (Figure 2.24).

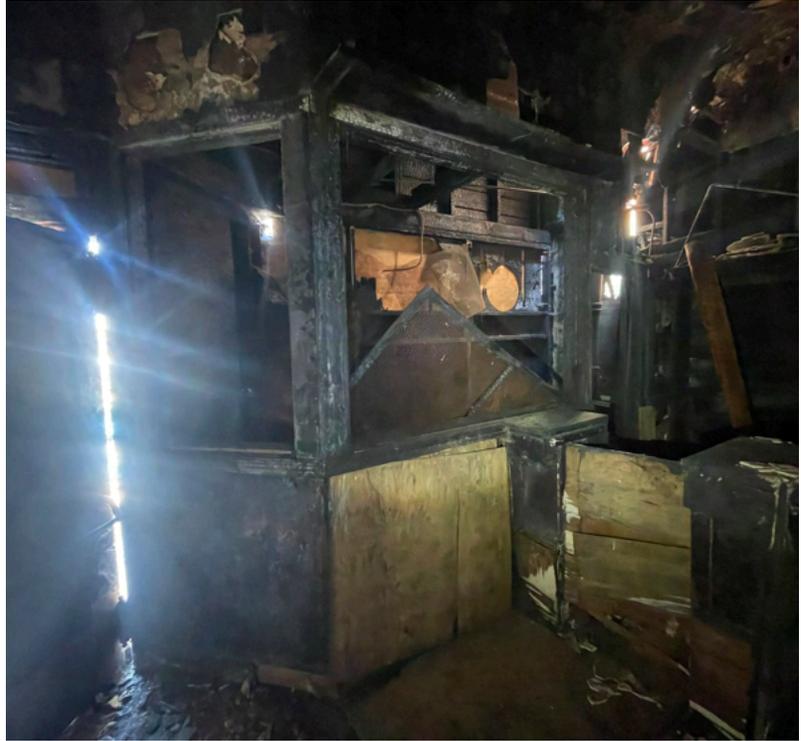
(Top Right) Fire damaged front entrance, looking west, Groundwork Preservation LLC, 2025.

- Replace in kind / rebuild all fire-damaged wood framing
- For wood framing elements with char of less than 10% of the section, remove charred exterior and treat. Any discoloration should be cleaned (via wire brush, smoke sponge, etc.) prior to applying sealant to contain the smoke smell

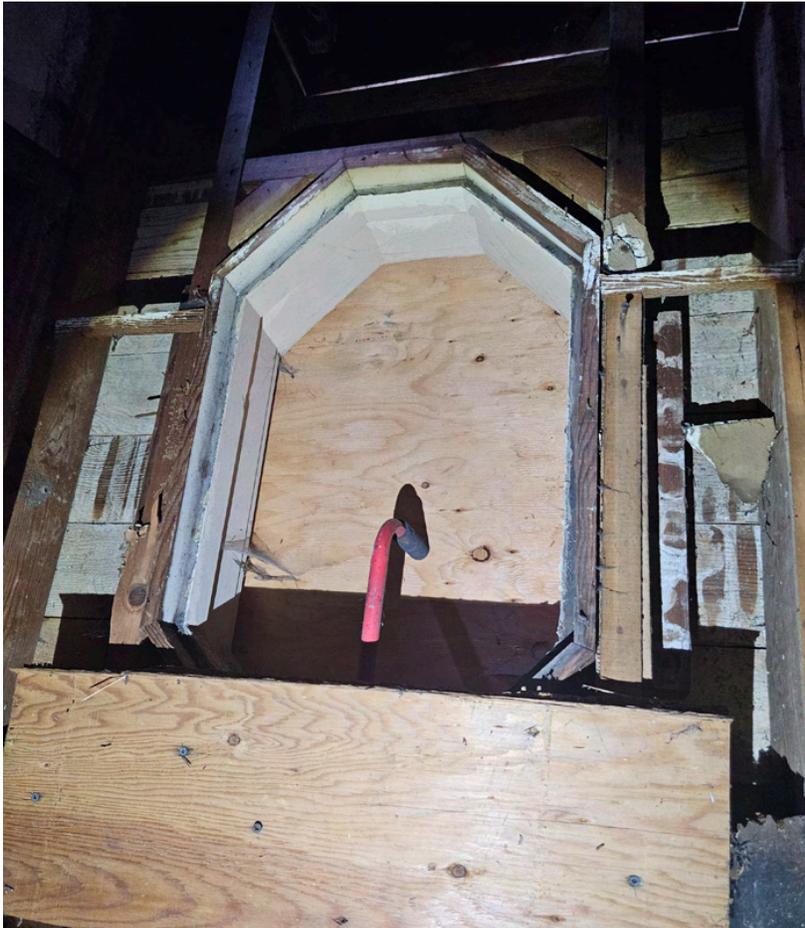
Figure 2.43

(Bottom) Octagonal window on the primary façade from the interior, looking west, Groundwork Preservation LLC, 2025.

- The wood framed narrow octagonal window opening at 37 Soledad (Figure 2.43) is covered with plywood at the front, but the window still exists. It is missing glazing and appears in fair condition.

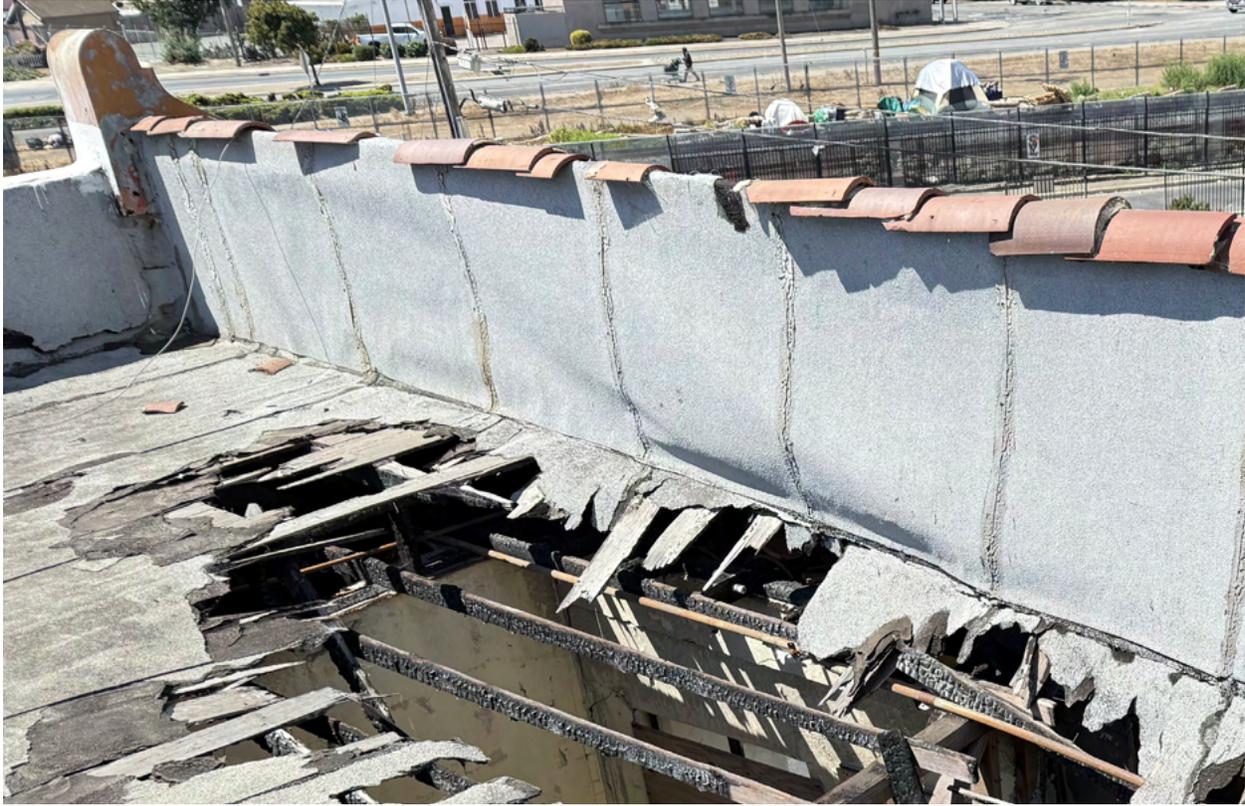
At 37 Soledad, access was made to the ground floor, mezzanine, second floor, third floor, and roof. At 39 Soledad, access was made to the ground floor, upper level, and roof; however, severe fire damage to the roof framing limited the ability to approach the west parapet along the Soledad Street Façade (Figure 4.1).

Figure 4.1 Roof Framing at west parapet (along Soledad Street), Tipping, 2025.

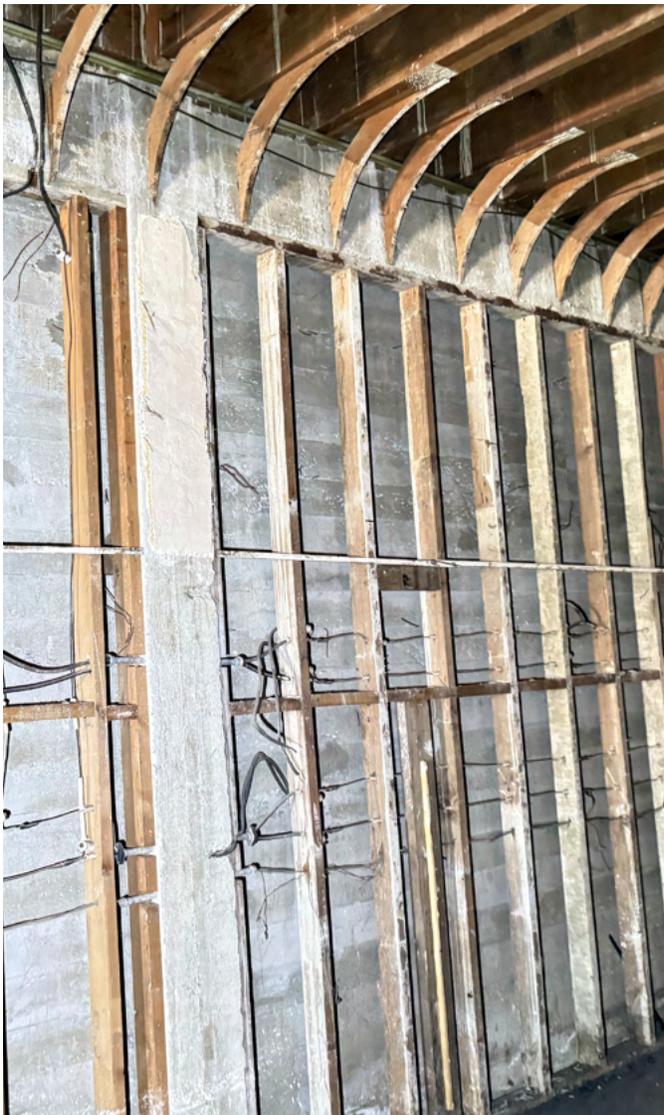
Figure 4.2 Concrete longitudinal wall at 37 Soledad Street (with existing wall furring), Tipping, 2025.

Both 37 and 39 Soledad are constructed with similar materials and assemblies. The building is primarily wood framed with property line concrete walls along the longitudinal axis of the building as well as along the rear (transverse) elevation. During its previous occupancy, it appears these walls were hidden by wood furring walls, portions of which remain (Figure 4.2).

These concrete walls are board-formed and appear to be generally in serviceable condition, though localized rock pockets were observed on the north elevation. Minor cracking is observed at the interior and exterior faces of these walls but excessive signs of settlement cracking or shear cracking from lateral movement is not obvious. The Original Drawings indicate that the typical concrete walls are 6" thick.¹

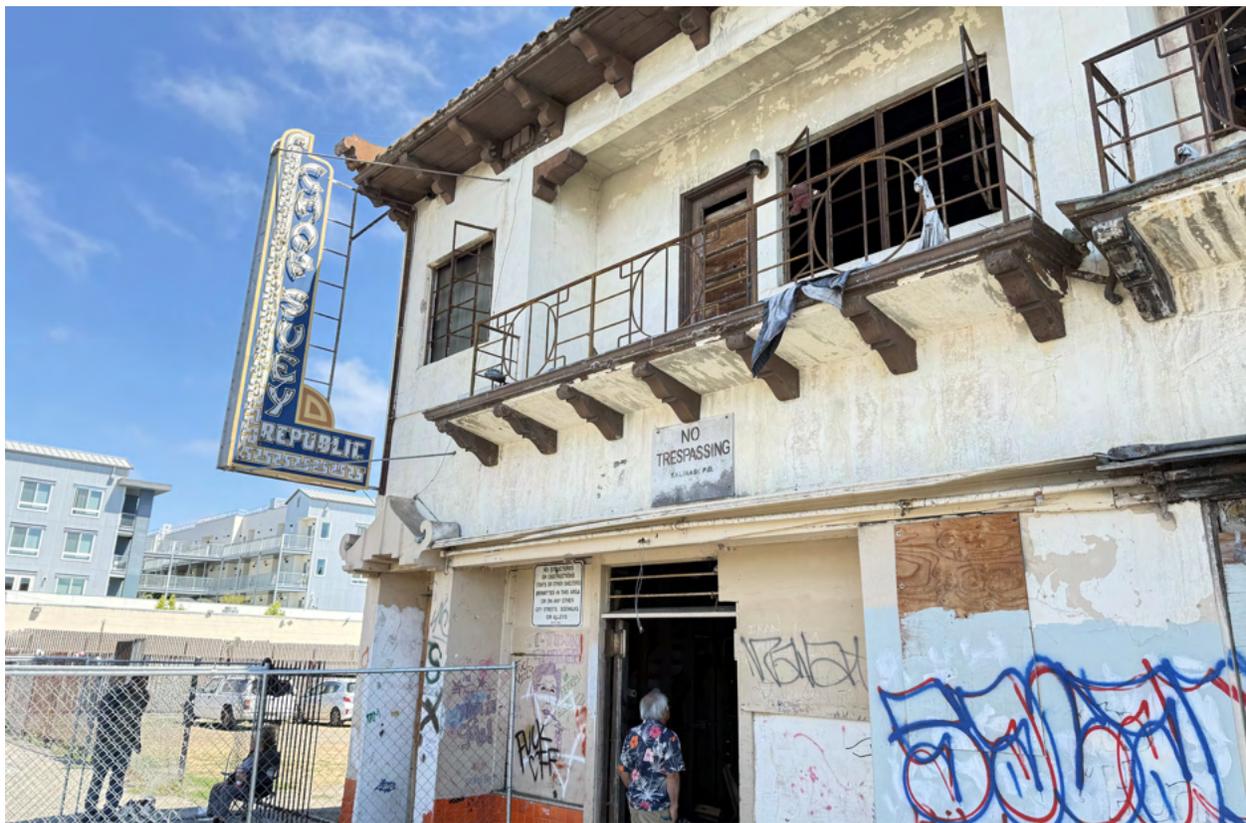
Based on a review of the original building drawings, the 2011 retrofit drawings, and observations on site, we understand that portions of the front (Soledad Street) façade (Figure 4.3) were constructed with structural steel columns and beams encased in concrete fireproofing (Figure 4.4). Vertical column piers and horizontal beams near the floor and roof line provide a skeletal framework to support the entry façade and historic overhangs. Between the concrete elements, significant portions of the setback and infilled wall framing utilize conventional sawn lumber studs.

Figure 4.3 Soledad Street elevation frame constructed with a mix of wood, steel and concrete, Tipping, 2025.

- Add a steel or concrete moment frame and new foundations to strengthen and stiffen the front (Soledad) elevation.

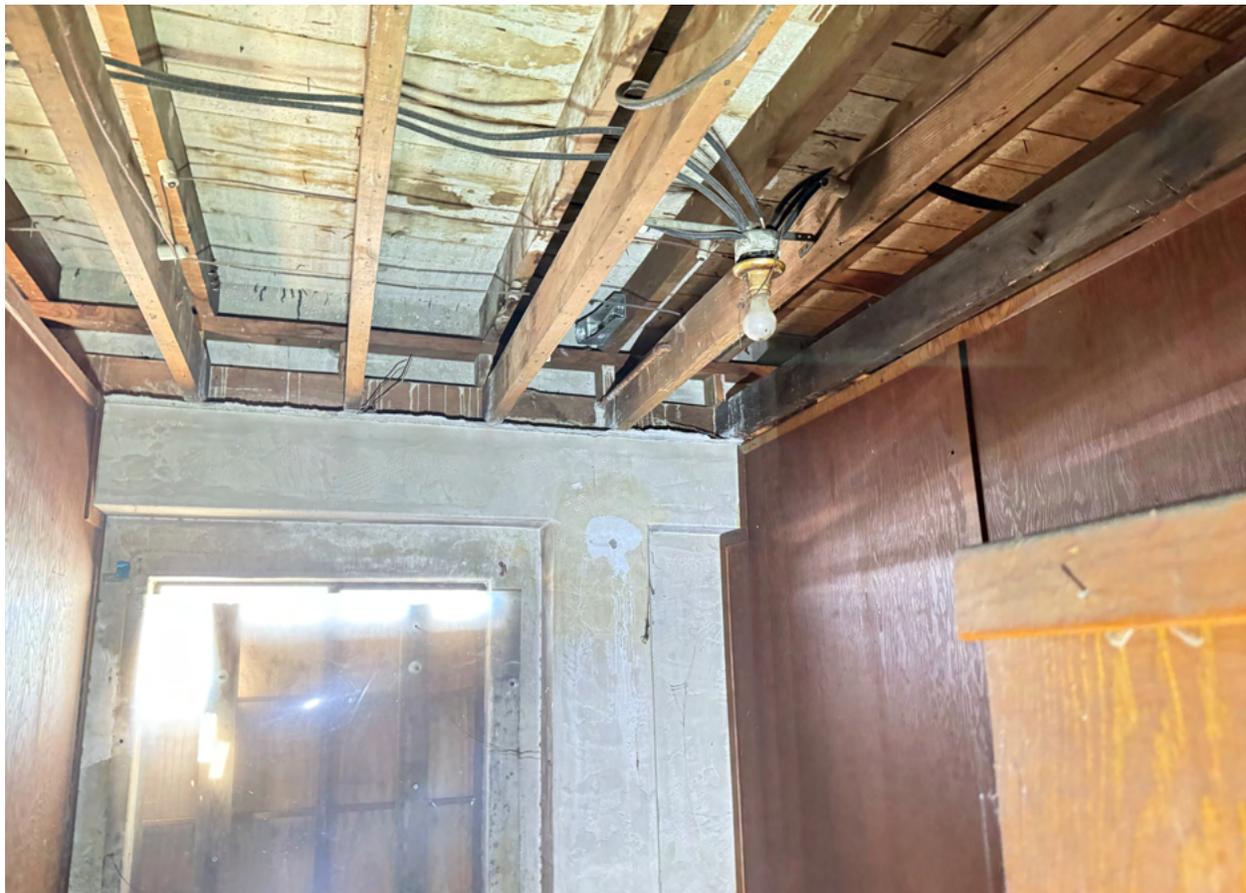
Figure 4.5 Roof and ceiling framing bearing on concrete beam and pilaster at 37 Soledad Street, Tipping, 2025.

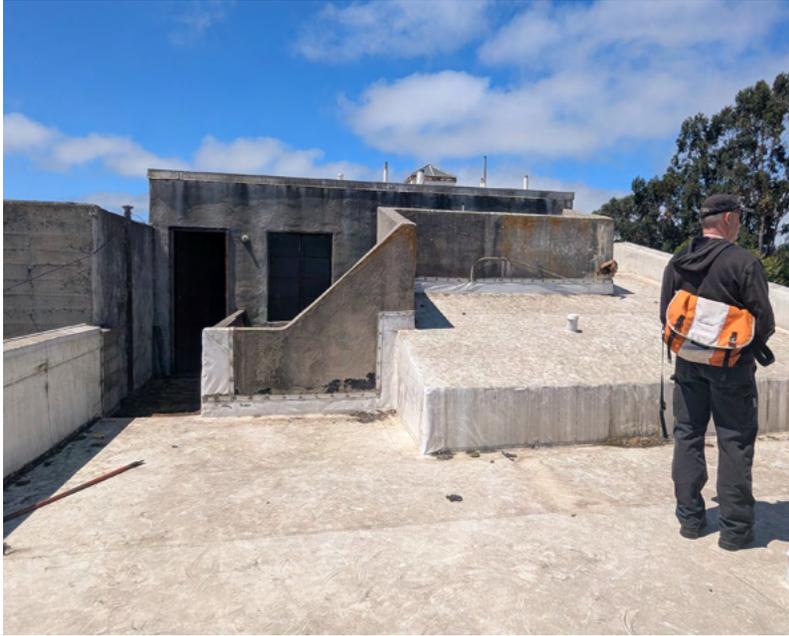
Figure 5.1 (Left) The rear lower roof of 37 Soledad, TEF, 2025.

- At the rear (east) end of the building, a low slope roof (Appendix I, rear flat roof) is accessed via a door from the second level (Figure 5.1). A small portion of the roof outside of this door (adjacent to Lightwell 1 and a sort of walkway to the larger roof), appears not to have been roofed and is in poor condition (Figure 5.2). A low wood framed guardrail has been installed at the north/ lightwell side of this pathway. It does not meet building code guardrail height requirements and is in poor condition.

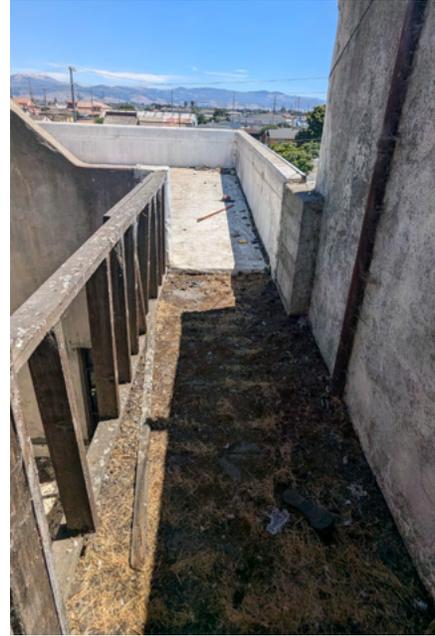
Figure 5.2 (Right) A pathway from the third-floor door to the primary rear roof has not been maintained, TEF, 2025.

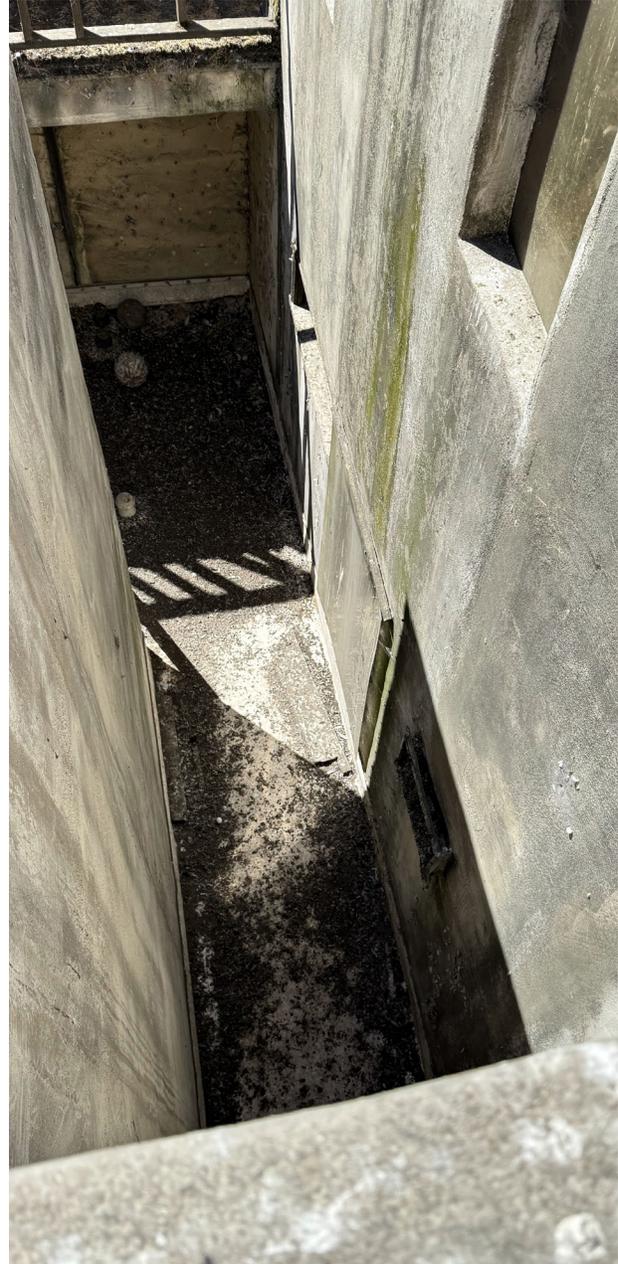
- Lightwell 1 at the building rear has been inhabited by pigeons and has been heavily impacted by bird guano and nesting (Figures 5.3 and 5.4). It is difficult to tell the condition of the TPO roofing but is likely in fair condition. While a roof drain and overflow drain are visible, they likely do not drain. The through wall vents and windows at this opening are all in very poor condition. At the south and west walls, portions of the exterior cement plaster is missing with plywood covering or exposed wood framing. The conditions of these wall areas are extremely poor (Figure 5.5).

Figure 5.4 (Right) Looking south at Lightwell 1, TEF, 2025.

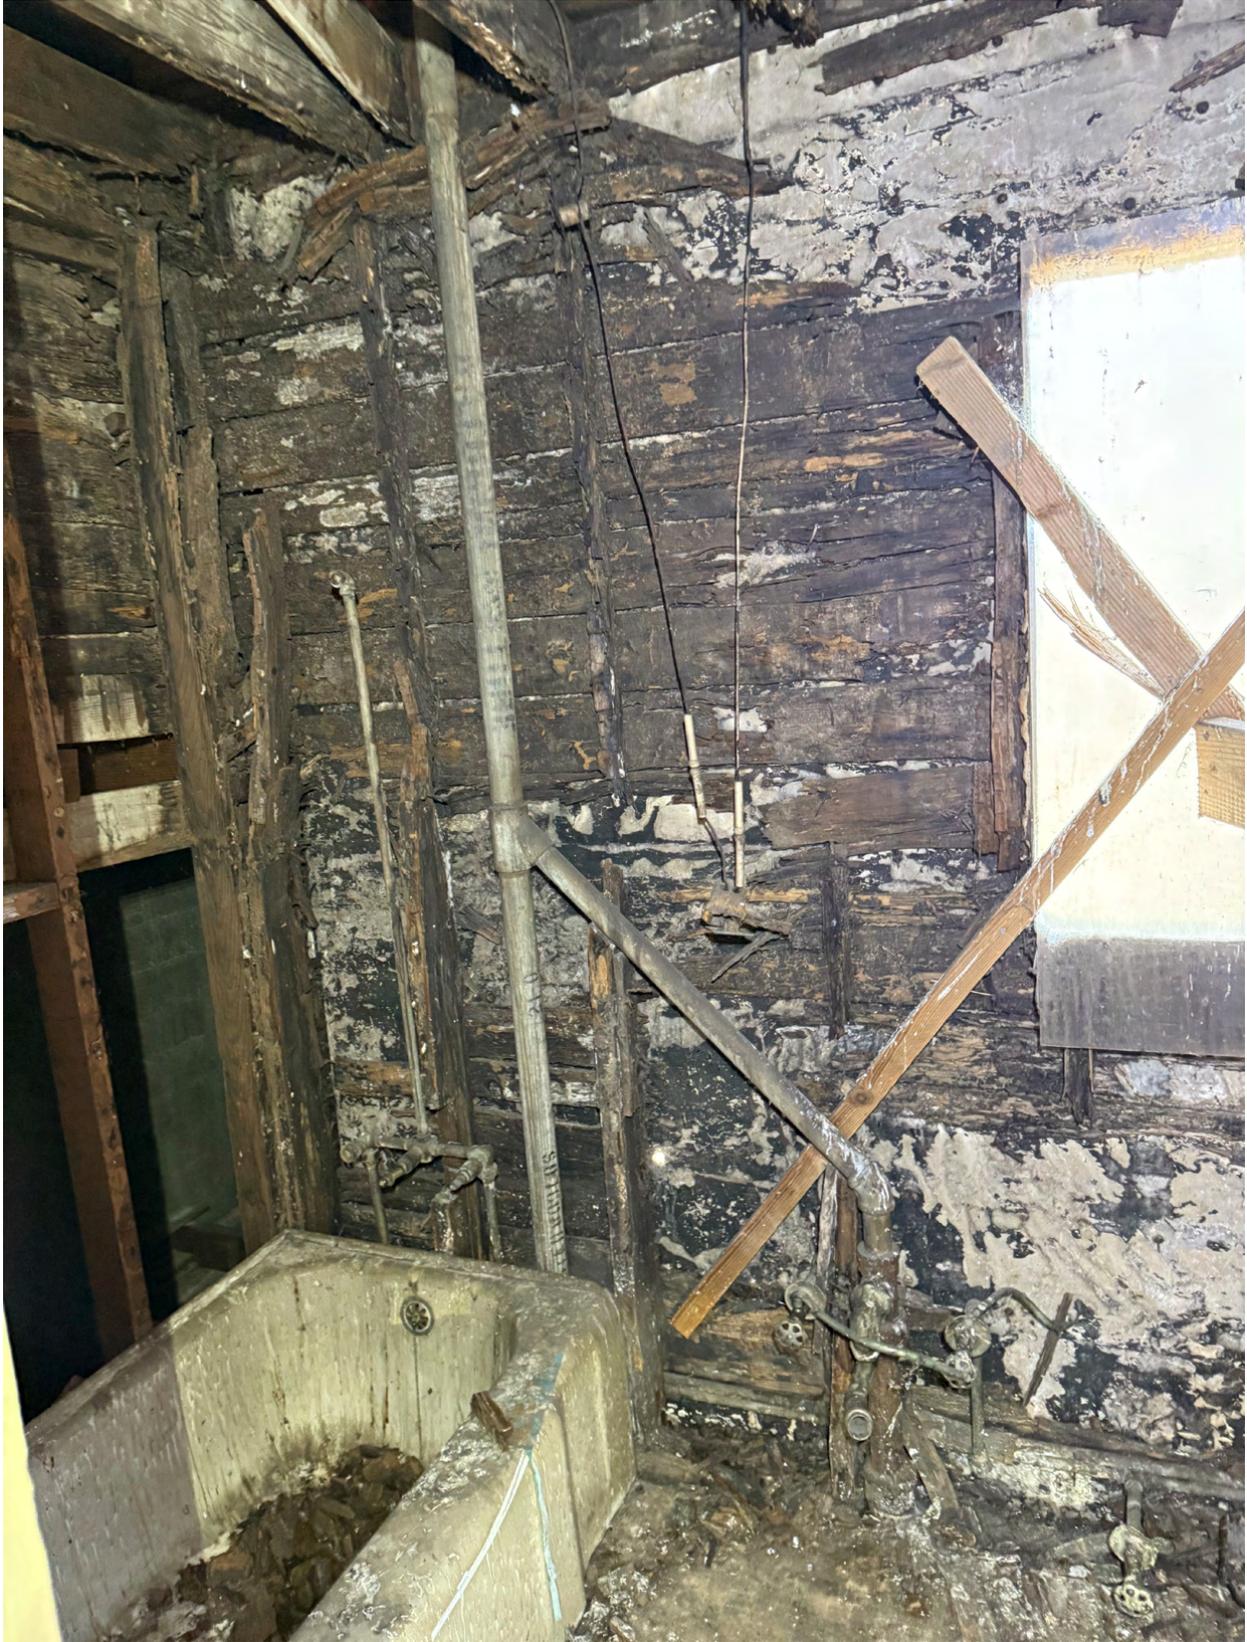
Figure 5.5 Interior view of the west wall of lightwell 1, TEF, 2025.

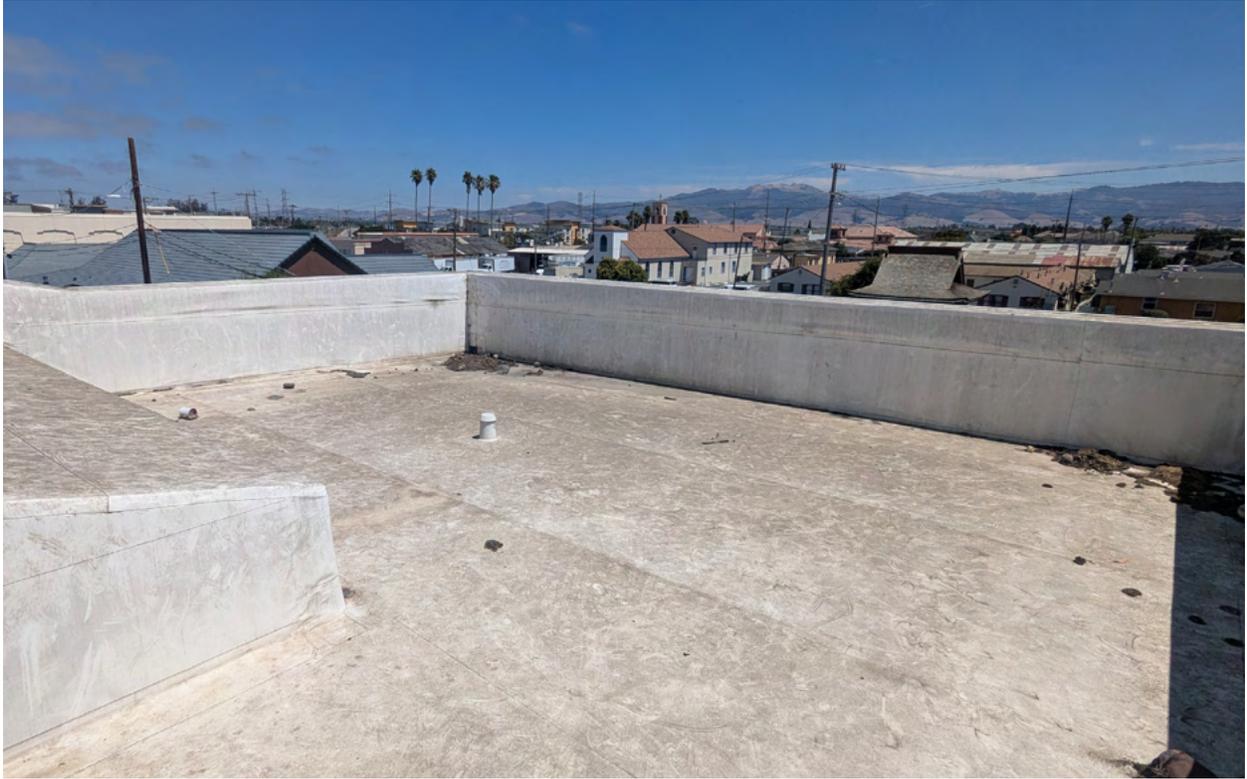
Figure 5.6 (Top) The primary rear low roof at 37 Soledad Street, TEF, 2025.

- The primary rear flat roof is in good condition, but has not been well maintained, with detritus and a buildup of dirt and animal/ human feces (Figure 5.6). A through-wall scupper at the northeast corner may not drain well. An overflow scupper does not exist (Figure 5.7).
- The bare sheet metal conductor head at the rear (east) facade (component of above-mentioned through-wall scupper) is clogged with growing plants. The bare sheet metal downspout is incomplete (Figure 5.8).
- The raised gable roof over the third floor is in good condition. It does not employ gutters at the roof eaves but laps the TPO roofing down over metal flashing over the cement plaster finish (or metal flashing) at each perimeter wall (Figure 5.9).

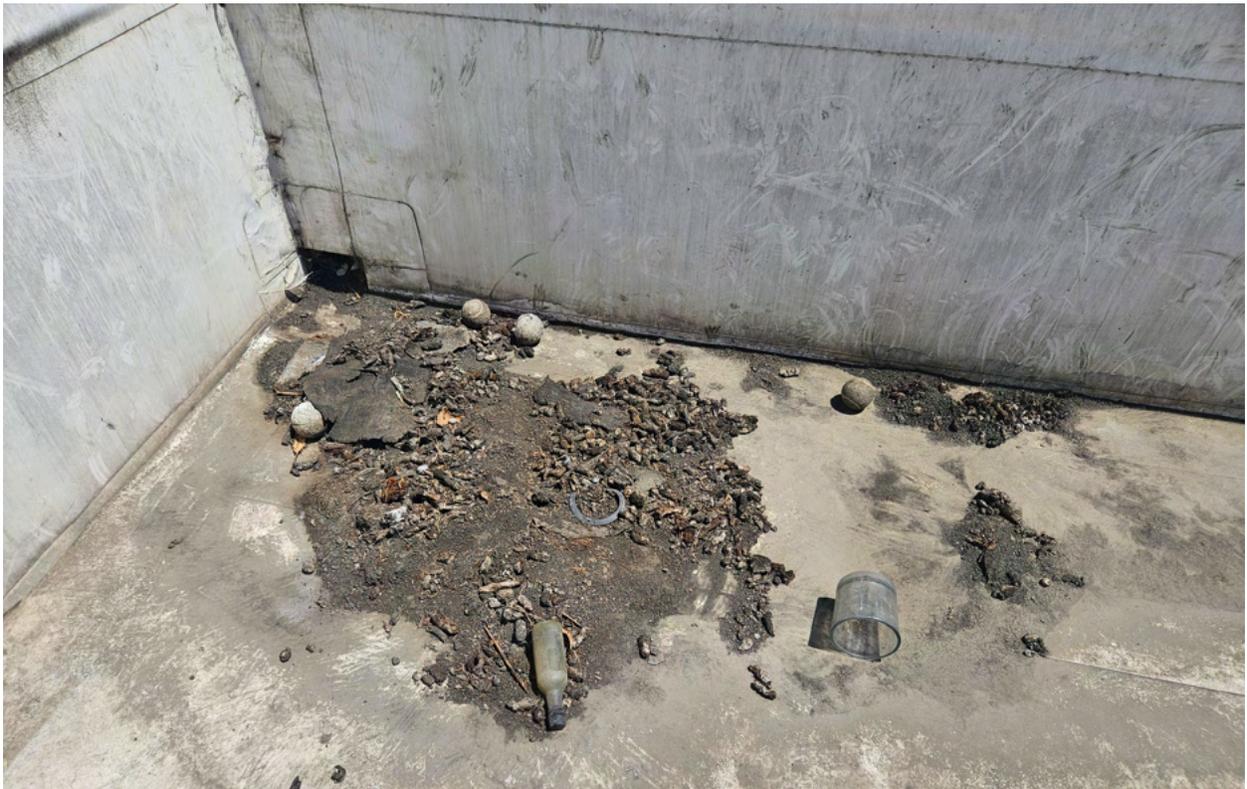
Figure 5.7 (Bottom) A through-wall scupper at the northeast corner of the rear low roof, TEF, 2025.

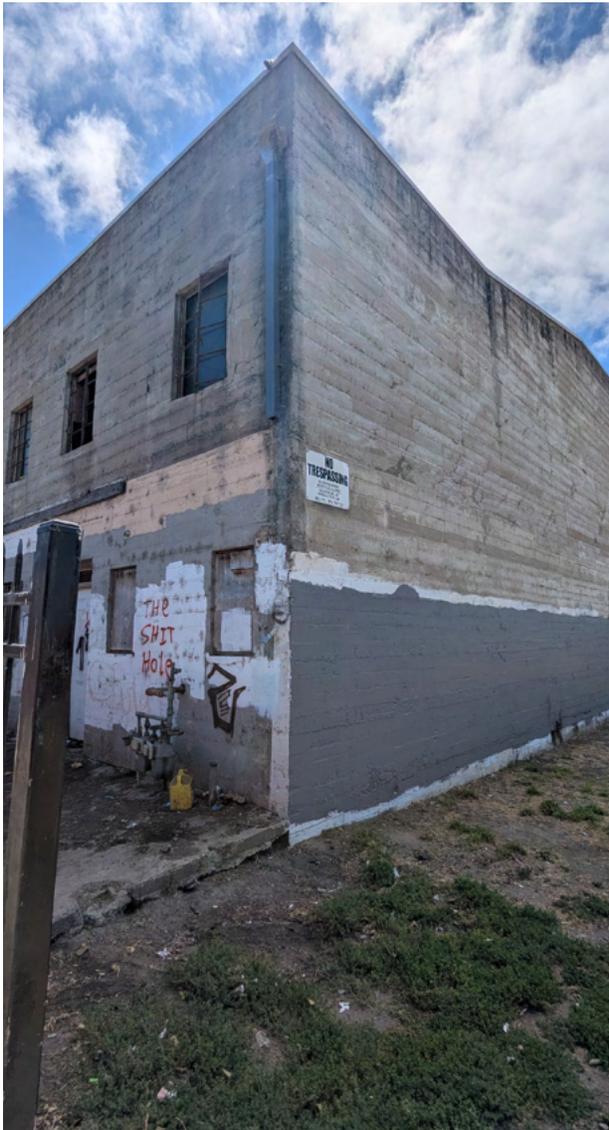
Figure 5.8 (Left) Sheet metal conductor head and downspout at rear (east) facade, TEF, 2025.

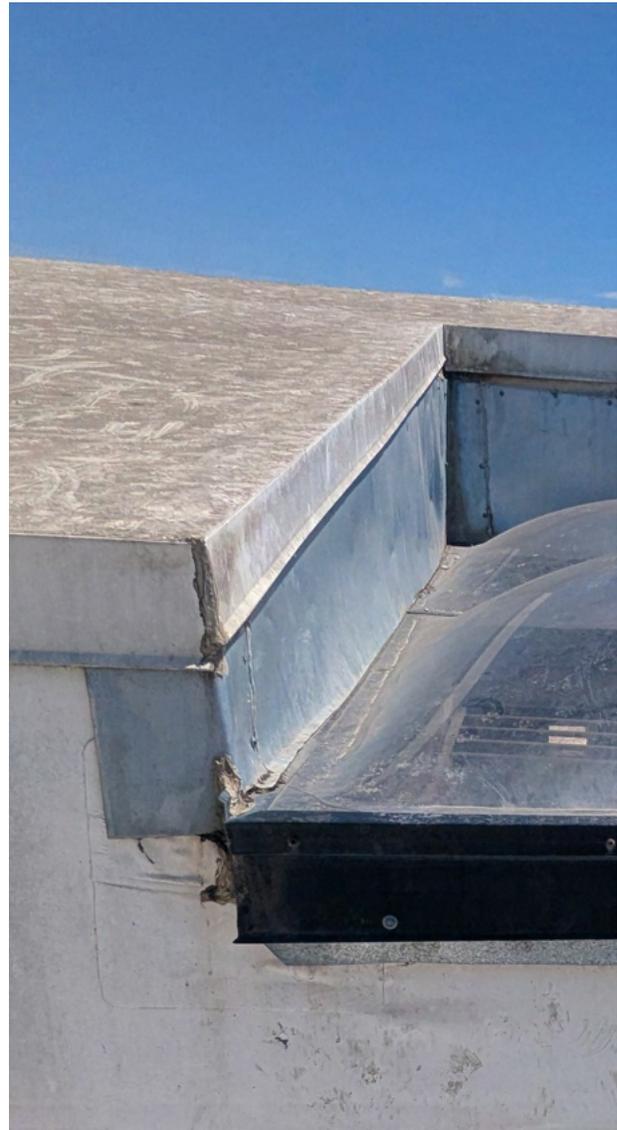
Figure 5.9 (Right) The typical edge condition at the gabled roof over the third floor, TEF, 2025.

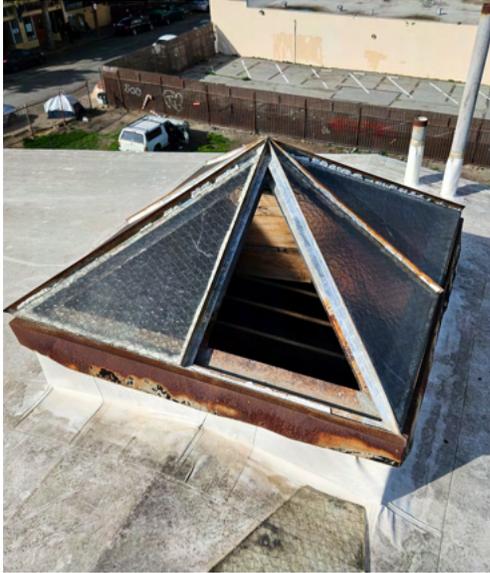
Figure 5.10

(Top Left) A steel pyramidal skylight over the third floor roof, TEF, 2026.

- A (presumably original) steel pyramidal skylight at the third-floor gabled roof is in poor condition with multiple broken and missing panes of chicken wire glazing and failing putty. The perimeter flashing is rusting and warping (Figure 5.10).
- The narrow strip of roofing between raised gable roof and the north edge of the primary roof is in good condition. The roofing turns up the cement plaster wall of the third-floor north wall, ending in a metal termination bar (Figure 5.11).
- Domed metal skylights were installed over the main roof lightwells in 2011. They are in good condition. Existing (presumably original) metal bar grilles over the lightwells remain in place below the skylights and appear in fair condition (Figures 5.12 and 5.13).

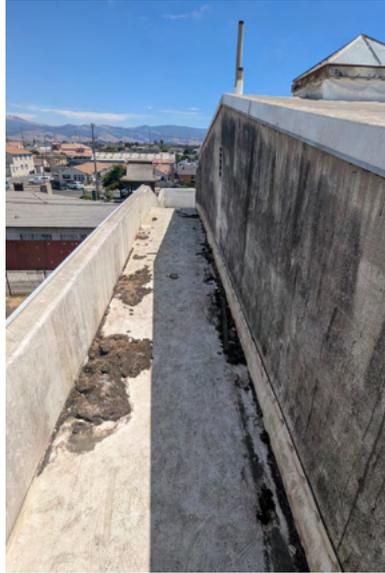
Figure 5.11

(Top Right) A narrow strip of roofing beyond the north wall of the third floor, TEF, 2025.

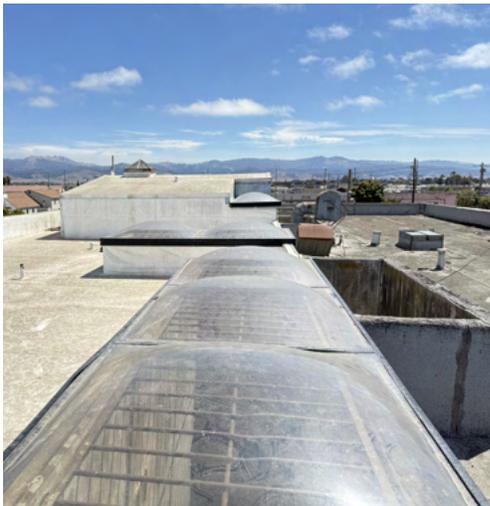
Figure 5.12

(Bottom Left) The domed skylights at the lightwells of 37 were installed over the existing metal bar grilles, Tipping Structural Engineers, 2025.

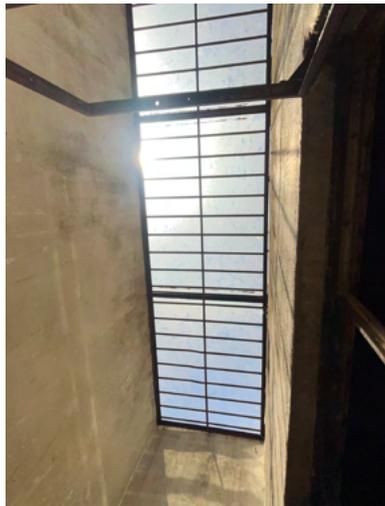
Figure 5.13

(Bottom Right) Each lightwell is capped with presumably original metal bar grilles, Groundwork Preservation, LLC, 2025.

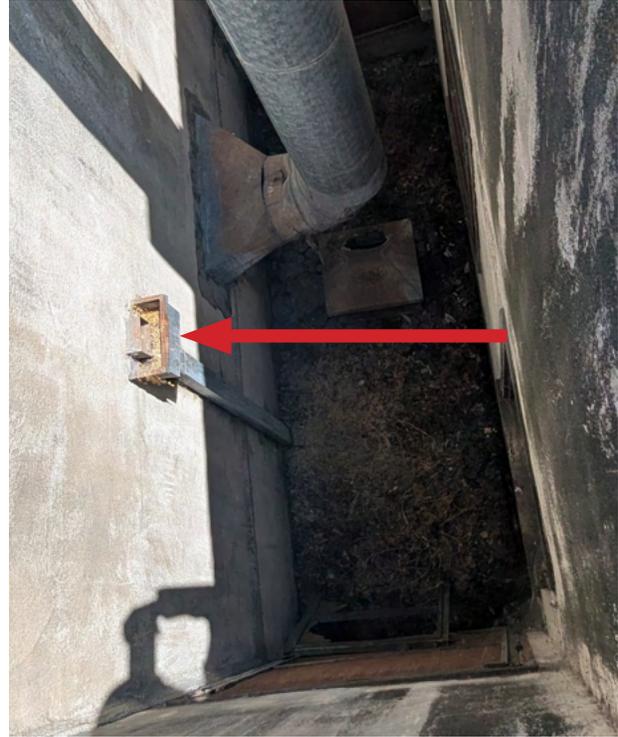
Figure 5.15 (Top Right) A sheet metal conductor head and downspout in Lightwell 6 may serve as drainage for Lightwell 3, TEF, 2025.

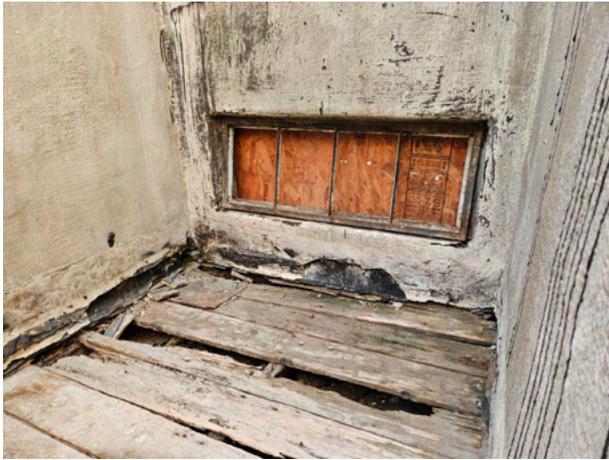
Figure 5.16 (Bottom Left) Detail view of floor to wall connection at north corner of Lightwell 2, TEF, 2026.

- Lightwell 2, the floor of which is visible from the third floor, has no roofing and no visible means of drainage. The 1x4 wood sheathing is weathered and damaged and the flashing at perimeter is inadequate and poorly executed (Figures 5.14 and 5.16). It is in poor condition. Although a floor/roof drain is not readily evident, a through-wall scupper with conductor head and downspout is evident at Lightwell 6, directly adjacent to Lightwell 2 in Building 39 (Figure 5.15) and may have originally served this lightwell (Additional investigation is recommended). The extant windows and through wall vents are in poor condition and areas of exposed wall are significantly degraded.

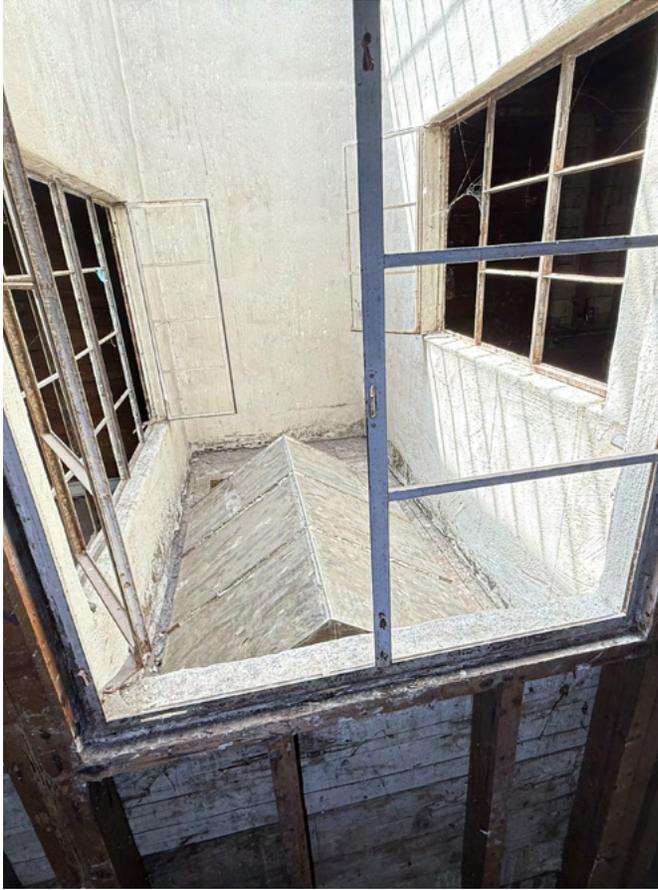
Figure 5.17 (Top Left) A double pitch steel skylight is extant at Lightwell 3, Tipping Structural Engineers, 2025.

- Lightwell 3 has no roofing installed at its floor and is in poor condition. There is a 1x4 wood sheathing extant on the floor and a recessed floor drain. The extant double steel skylight is in poor condition with failed putty and cracked chicken wire glazing. The steel casement windows are in poor condition with all glazing missing (Figures 5.17 and 5.19).
