Historic Structures Report

37-39 Soledad Street

City of Salinas, California | February 2026

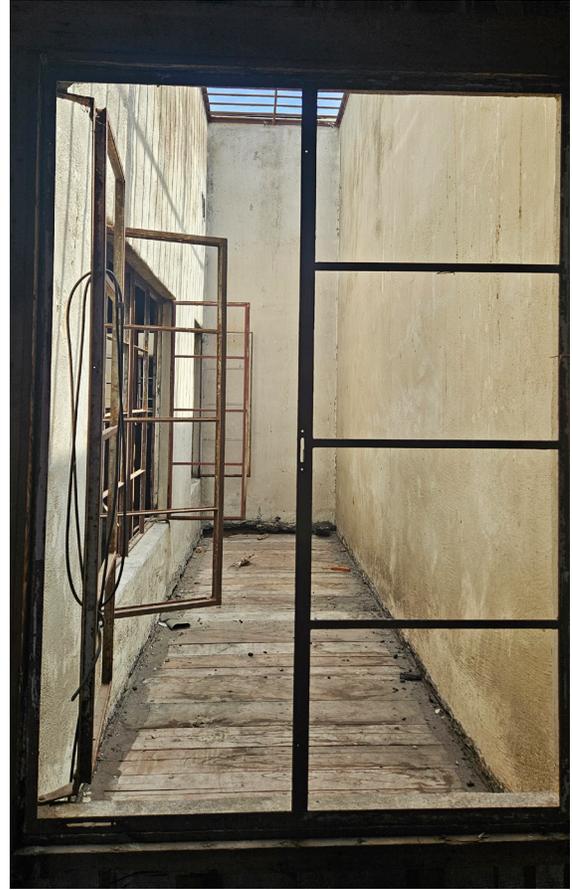
Figure 5.18 (Top Right) Lightwell 4, TEF, 2025.

- The floor of Lightwell 4 does not have any roofing installed, with 1x4 wood board sheathing extant (Figure 5.18). Although a floor/roof drain is not readily apparent, a through-wall scupper with projecting sheet metal tongue is evident at Lightwell 7 directly adjacent in building 39 (Figure 5.20) and may have originally served this lightwell (additional investigation is recommended). The steel casement windows are in poor condition with all glazing missing (Figure 5.21).

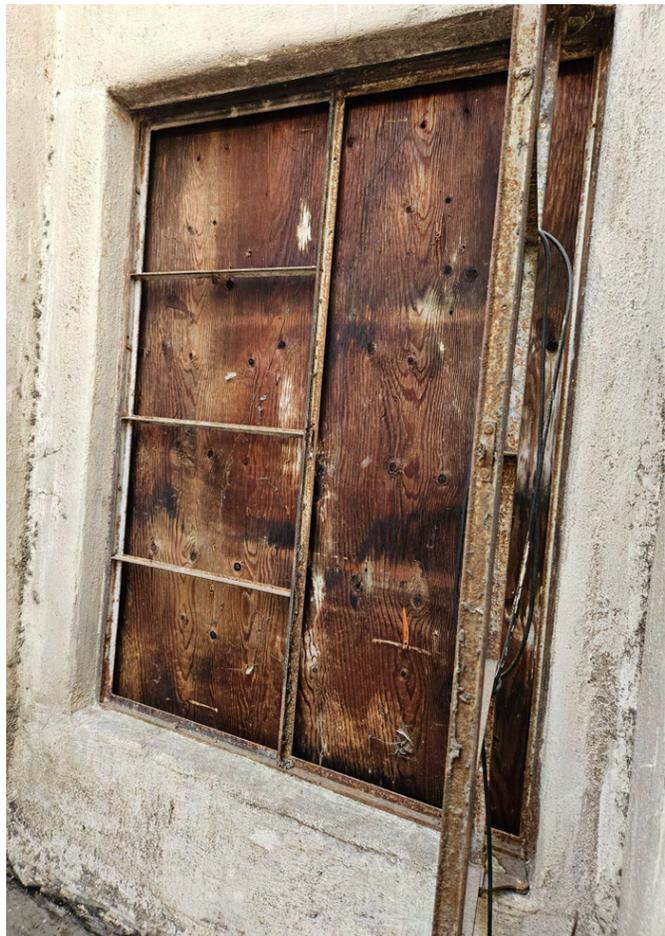
Figure 5.21 (Right) Window on the west wall of Lightwell 4, TEF, 2026.

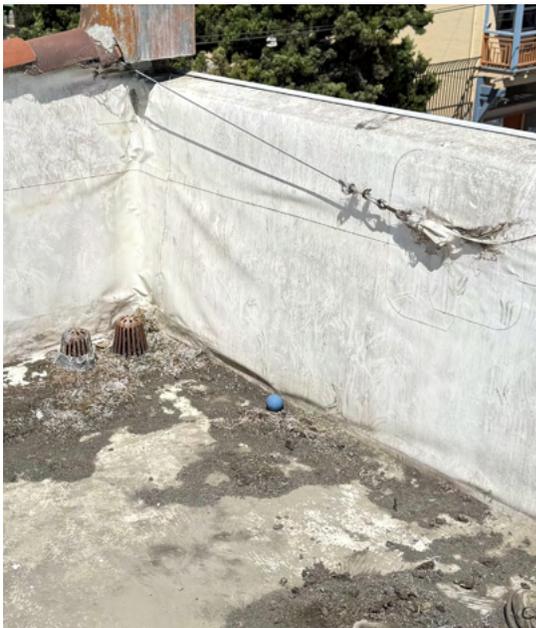
Figure 5.23
(Bottom Left) The roof drain and overflow drain at the southwest corner of the building, TEF, 2025.

- The roof drain and overflow drain at the southeast corner appear in poor condition and are clogged with buildup of organic matter and debris (Figure 5.23). The drains appear to lead to drain lines at the building interior (Figure 5.24).
- At the parapet in this corner, an anchor tie is flashed into the parapet wall and appears to support the neon sign at the building’s primary façade (Figure 5.23).
- The parapet walls and caps at the 37 Soledad roof generally appear in good condition. The TPO roofing is wrapped up the inside face of the walls and over the parapet caps. The caps appear to slope toward the roofing, and have been terminated with a coated metal flashing that wraps down the outside face of the building wall.
-

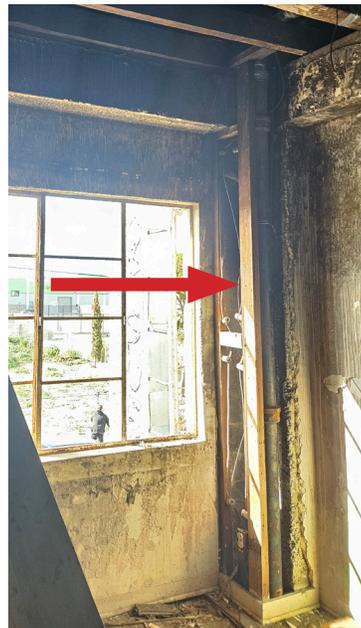
Figure 5.24
(Bottom Right) Interior drainage for the roof as seen at the second floor, TEF, 2025.

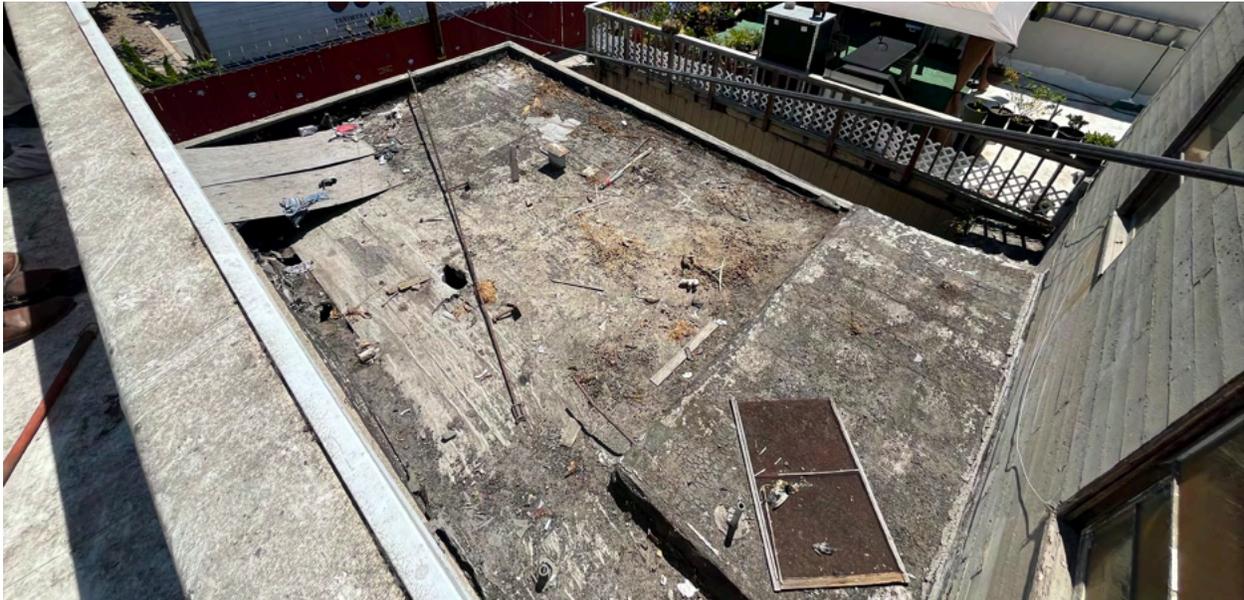
Figure 5.28 (Bottom) The roof of the rear building at 39 Soledad is collapsing, Groundwork Preservation, LLC, 2025.

Overall, the main roof of 39 Soledad is in extremely poor condition. The existing asphaltic roofing is beyond its useful life and has been patched in many locations (Figure 5.27). The west end of this roof was similarly damaged by fire and has collapsed. Only one roof drain was located for the entirety of this roof within the burned area of roofing – it is not extant. The roof at the rear one-story building similarly is in extremely poor condition. In multiple locations the roof appears to have failed with visible holes through the roof (Figure 5.28). It is a collapse hazard.

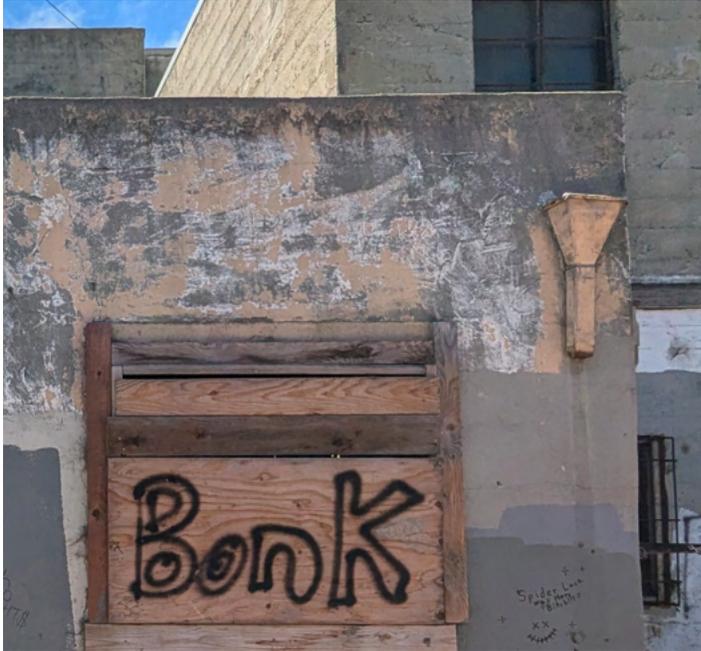
Figure 5.29 (Top Left) A painted sheet metal conductor head extant at the northeast corner of the rear addition building, TEF, 2025.

- A through wall scupper and painted sheet metal conductor head is extant at the northeast corner of the rear, lower roof, but are likely in poor condition overall. The downspout is incomplete (Figure 5.29).

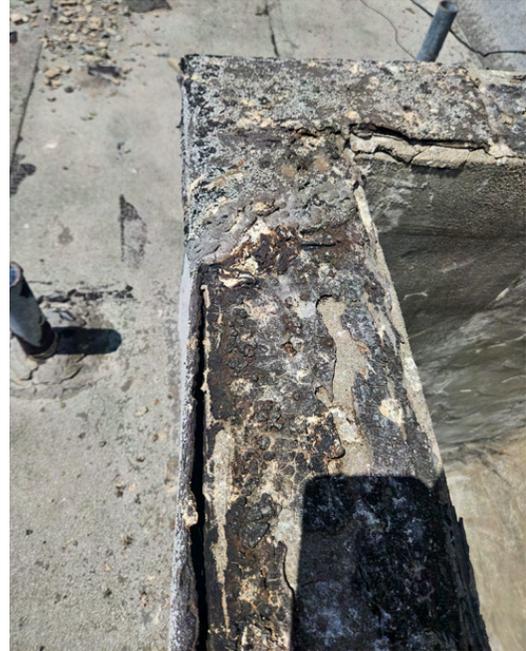
Figure 5.30 (Top Right) Parapet damage at rear concrete wall of Building 39, TEF, 2025.

- The parapet walls around the roof, at both building perimeter and around lightwells are in extremely poor condition. The asphaltic roofing was run up the parapet walls but is missing or failed in many locations. Various layers of asphaltic covering, cement plaster and other adhesives/waterproofing have worn away at the caps to reveal concrete (Figure 5.30), wood board wall paneling, and in some locations, chicken wire (Figure 5.31).

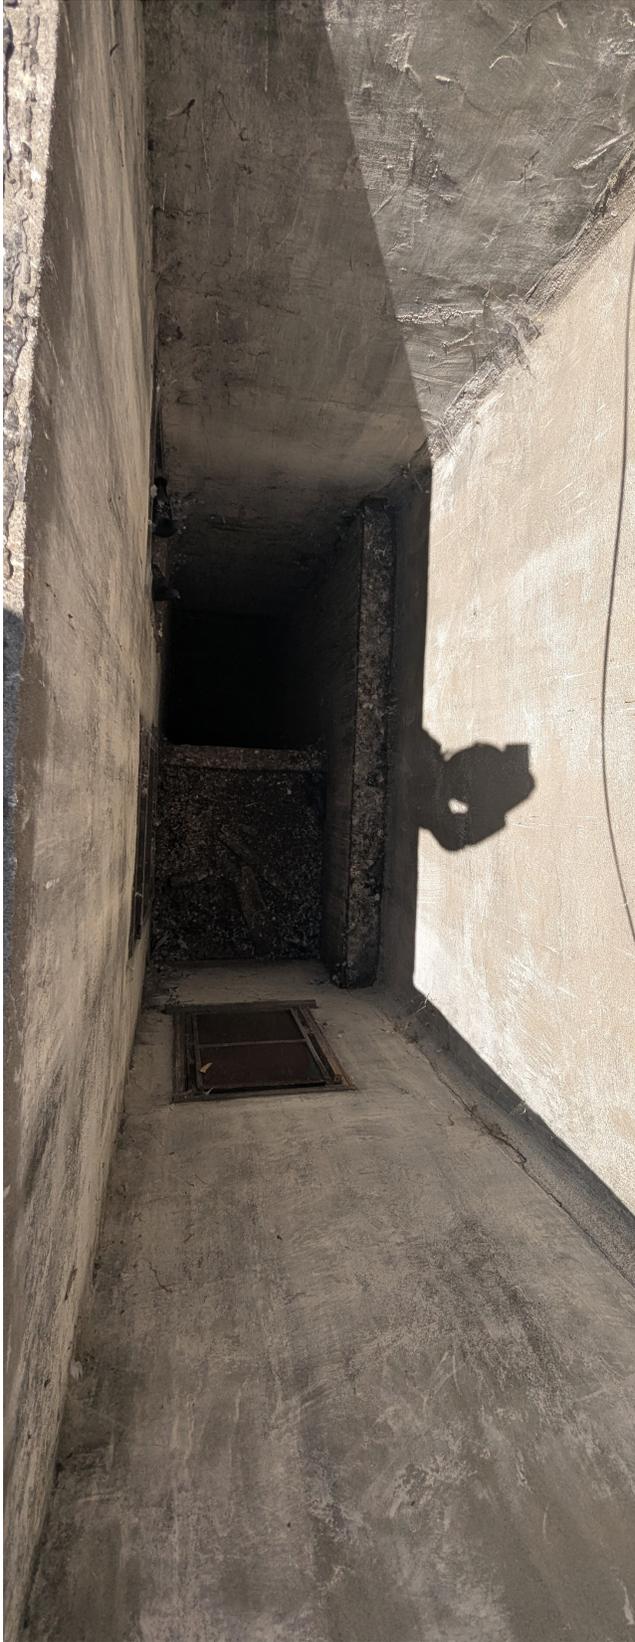
Figure 5.32 Lightwell 5, TEF, 2025.

- Lightwell 5, furthest east on the roof along the north building perimeter wall, is in poor condition (Figure 5.32). It appears to have two floor levels and is heavily impacted by nesting pigeons. No roofing is visible due to guano buildup and there does not appear to be any roof drainage. The windows were not accessible from the building interior but are presumably in fair to poor condition.

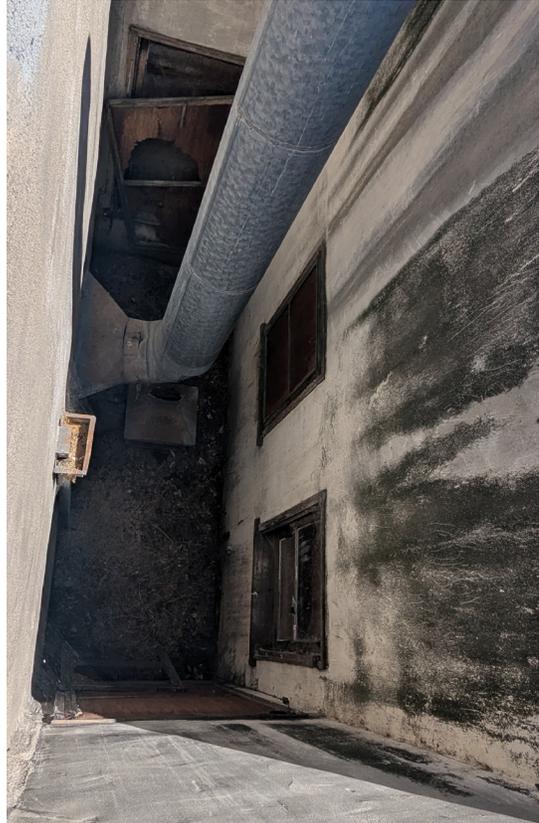
- Lightwell 6 is located just east of the building midline at the north building perimeter wall and is in poor condition (Figure 5.33). No roofing is visible at the floor due to a buildup of earth, detritus and plant growth. No roof or floor drain is visible. There is a buildup of bio growth on the cement plaster of the south wall. The windows are in fair condition with weathered components.

Figure 5.33 (Top) Lightwell 6, TEF, 2025.

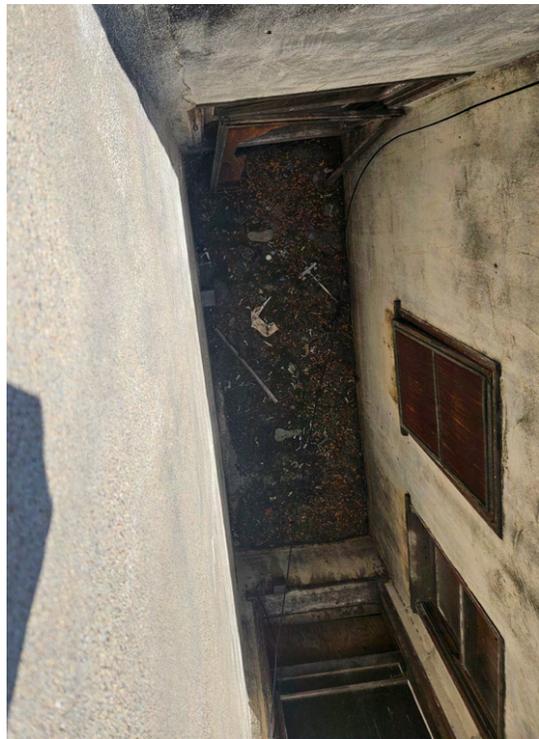
- Lightwell 7 is in poor condition (Figures 5.20 and 5.34). It is located west of the building midline on the north building perimeter wall and, similar to Lightwell 6, has a buildup of earth and debris at its floor level, making any remaining roofing indistinguishable. The windows are in fair condition with weathered components (Figure 5.35).

Figure 5.34 (Bottom) Lightwell 7, TEF, 2025.

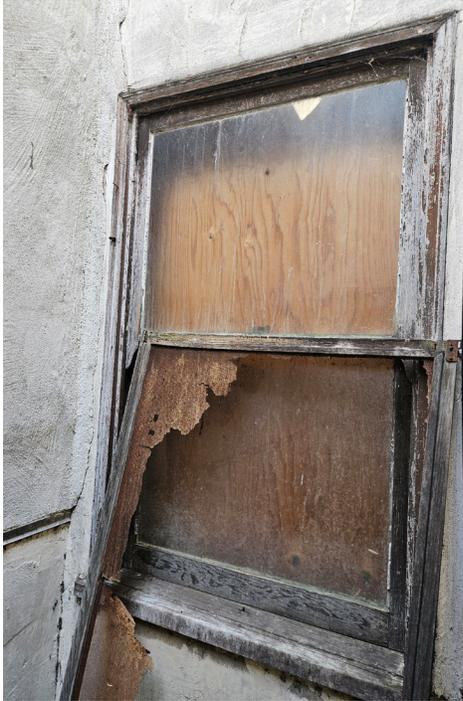
Figure 5.35 (Top Left) East window in Lightwell 7, TEF, 2026.

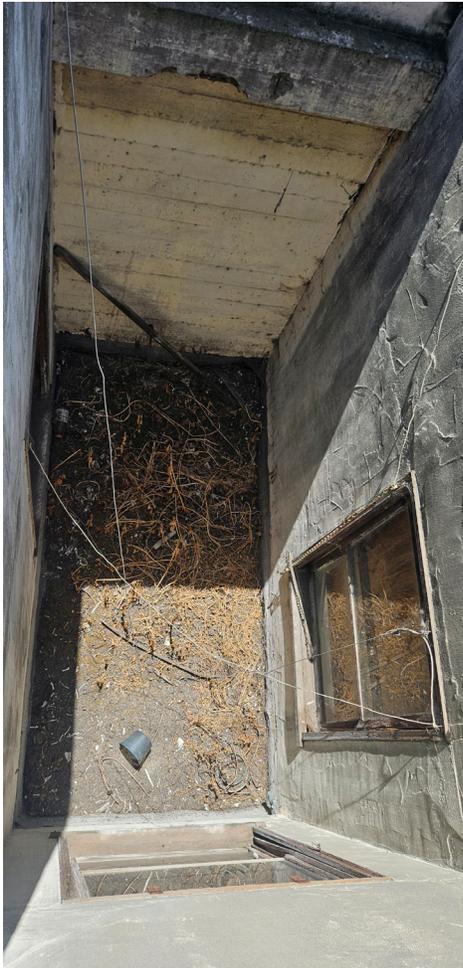
- Lightwell 8 is located west of the building midline along the south building perimeter wall and is in poor condition (Figure 5.36). This well appears to span all the way to grade. The well is actively inhabited by pigeons. The windows appear to be fair condition.

Figure 5.36 (Top Right) Lightwell 8, Tipping Structural Engineers, 2025.

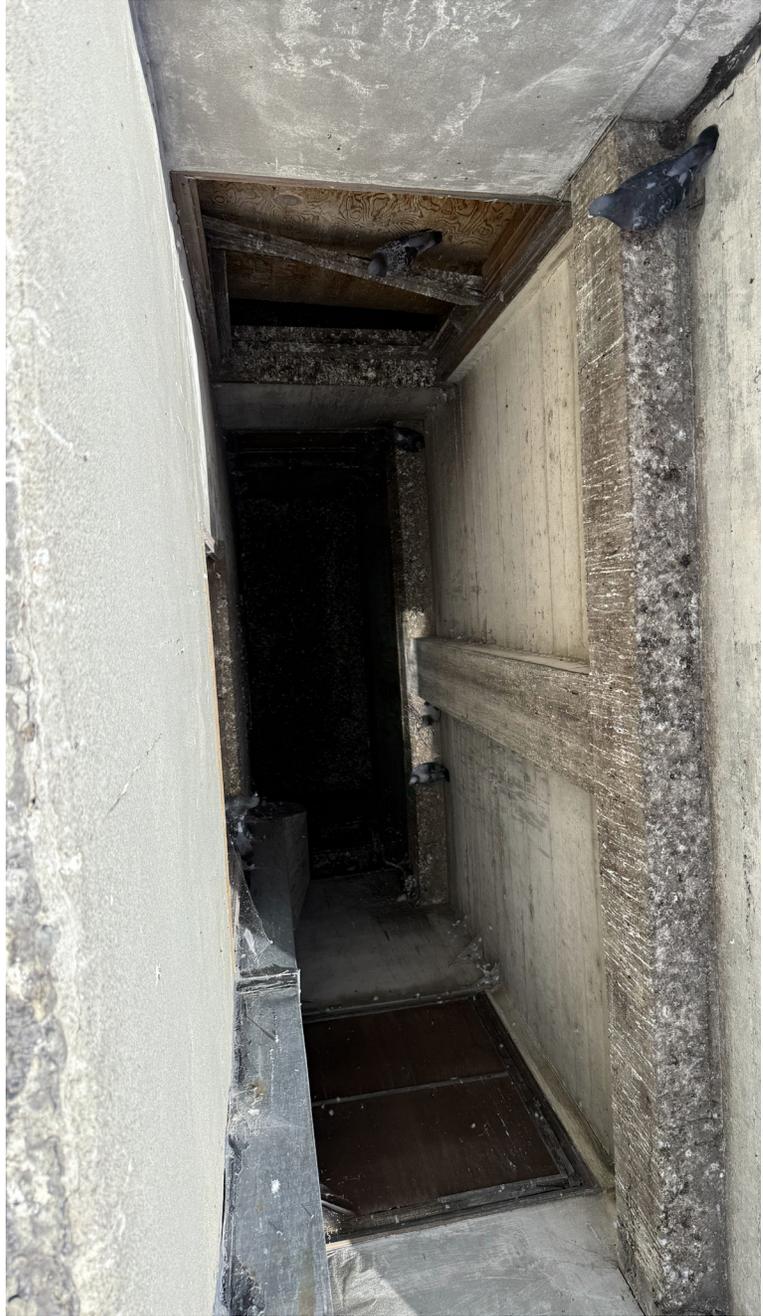
- Lightwell 9 is located west of the building midline perpendicular to the south perimeter wall and is in poor condition (Figure 5.37). No roofing or roof/ floor drain is visible below the dirt build up and plant growth. There is bio growth on the upper east parapet wall. The windows appear to be in fair condition.

Figure 5.37 (Bottom Left) Lightwell 9, TEF, 2025.

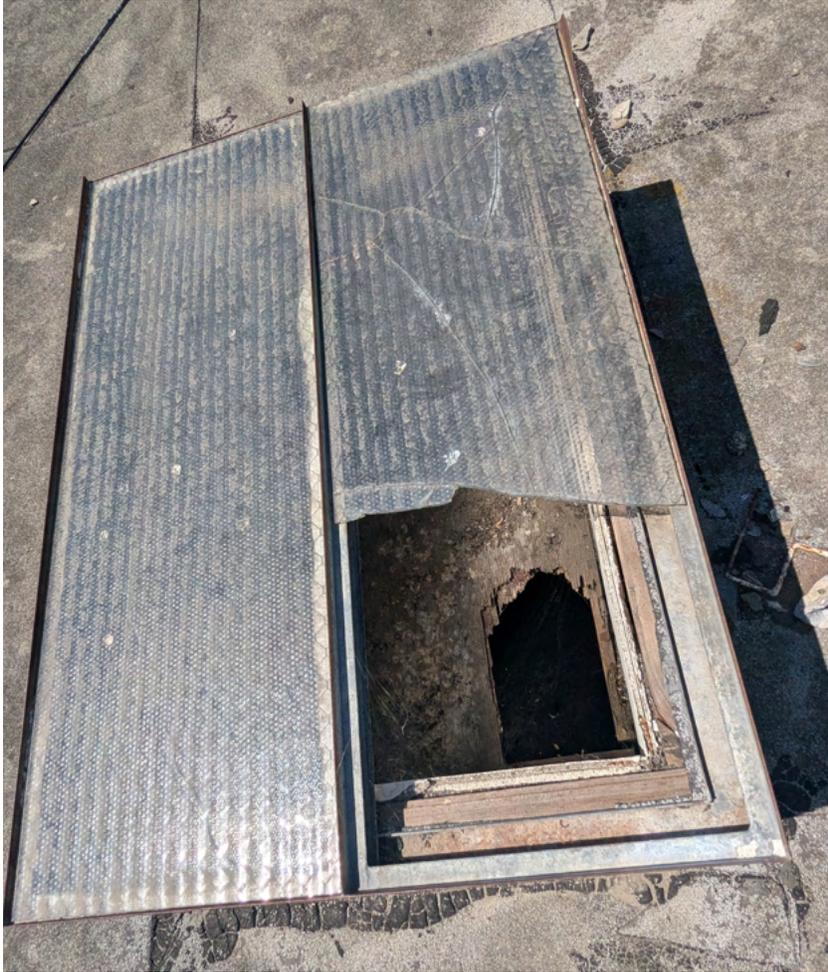
Figure 5.38
(Top) Skylight 1, TEF, 2025.

- Skylight 1 is a steel framed, double paned skylight with chicken wire glazing mounted over wood framing. It is located east of the building midline near Lightwell 6 and is in fair condition (Figure 5.38). The glazing of the north pane is broken. The frame has no coating and exhibits some rusting.

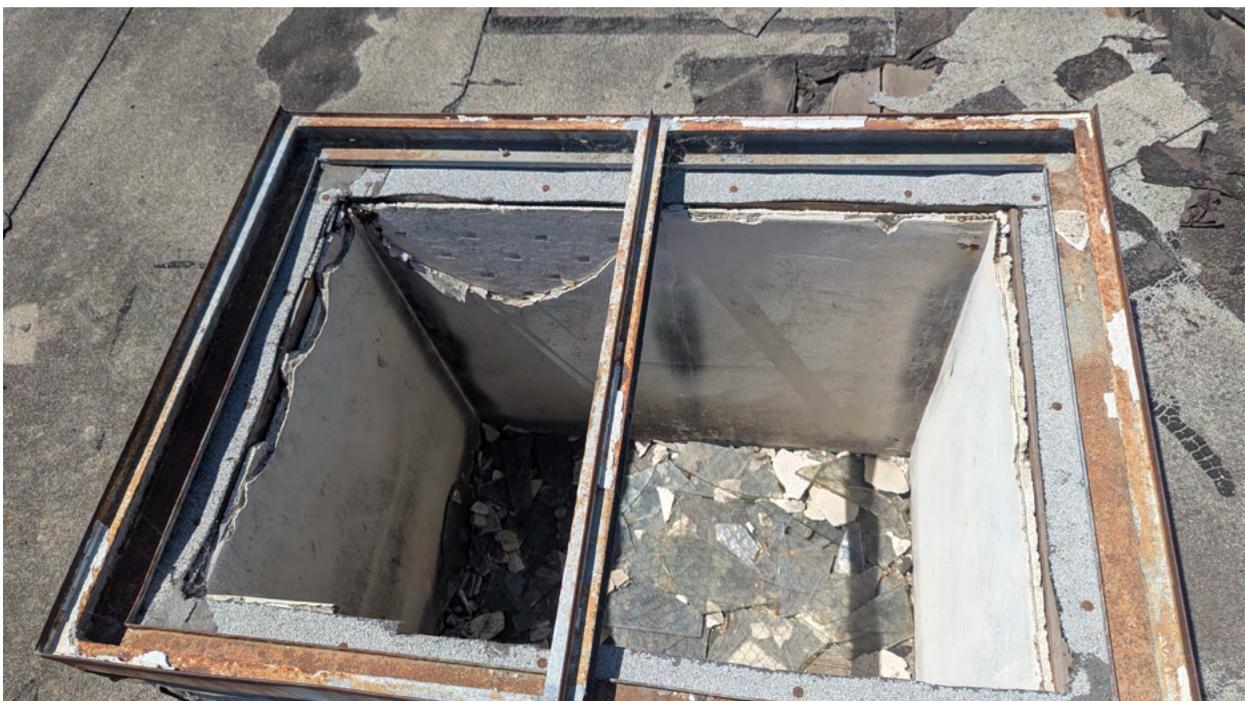
Figure 5.39
(Bottom) Skylight 2, TEF, 2025.

- Skylight 2 is located west of the building midline roughly in the middle of the roof field from north to south. It is a steel framed double paned skylight mounted over wood framing and is in poor condition (Figure 5.39). No glazing is extant and the frame has no coating and is rusting. Shards of chicken wire glazing is extant at the boarded-up skylight well below.

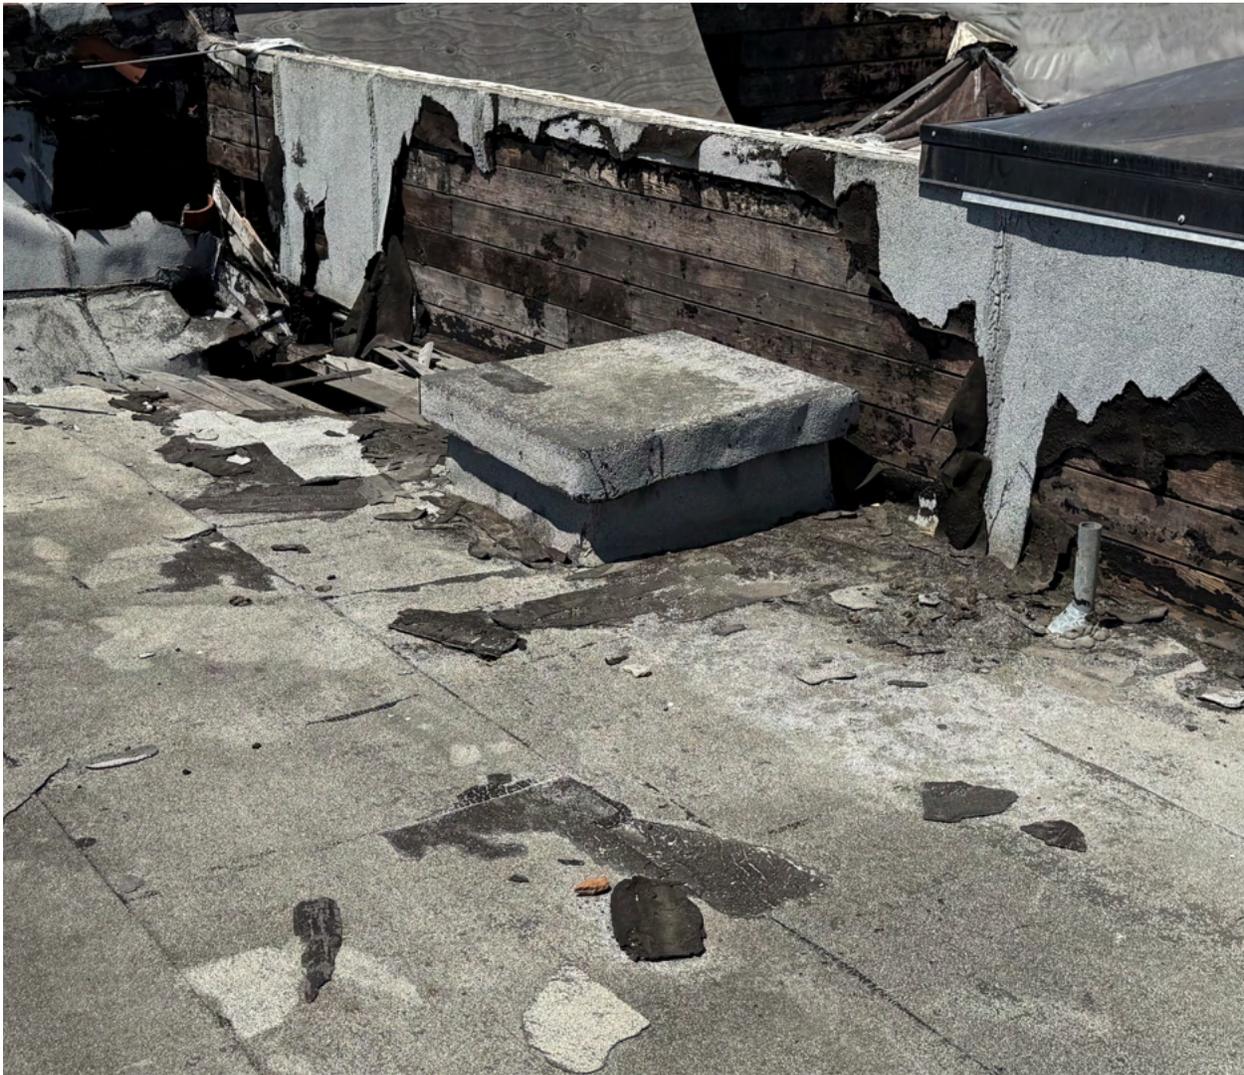
- A wood framed roof access hatch is located along the north perimeter wall at the far west end of the building. It has a wood framed cap with asphaltic roof covering and is in poor condition (Figure 5.40). The hatch appears to be within the area of fire damage but does not exhibit damage from the exterior.

Figure 5.40 Roof Access Hatch 1, TEF, 2025.

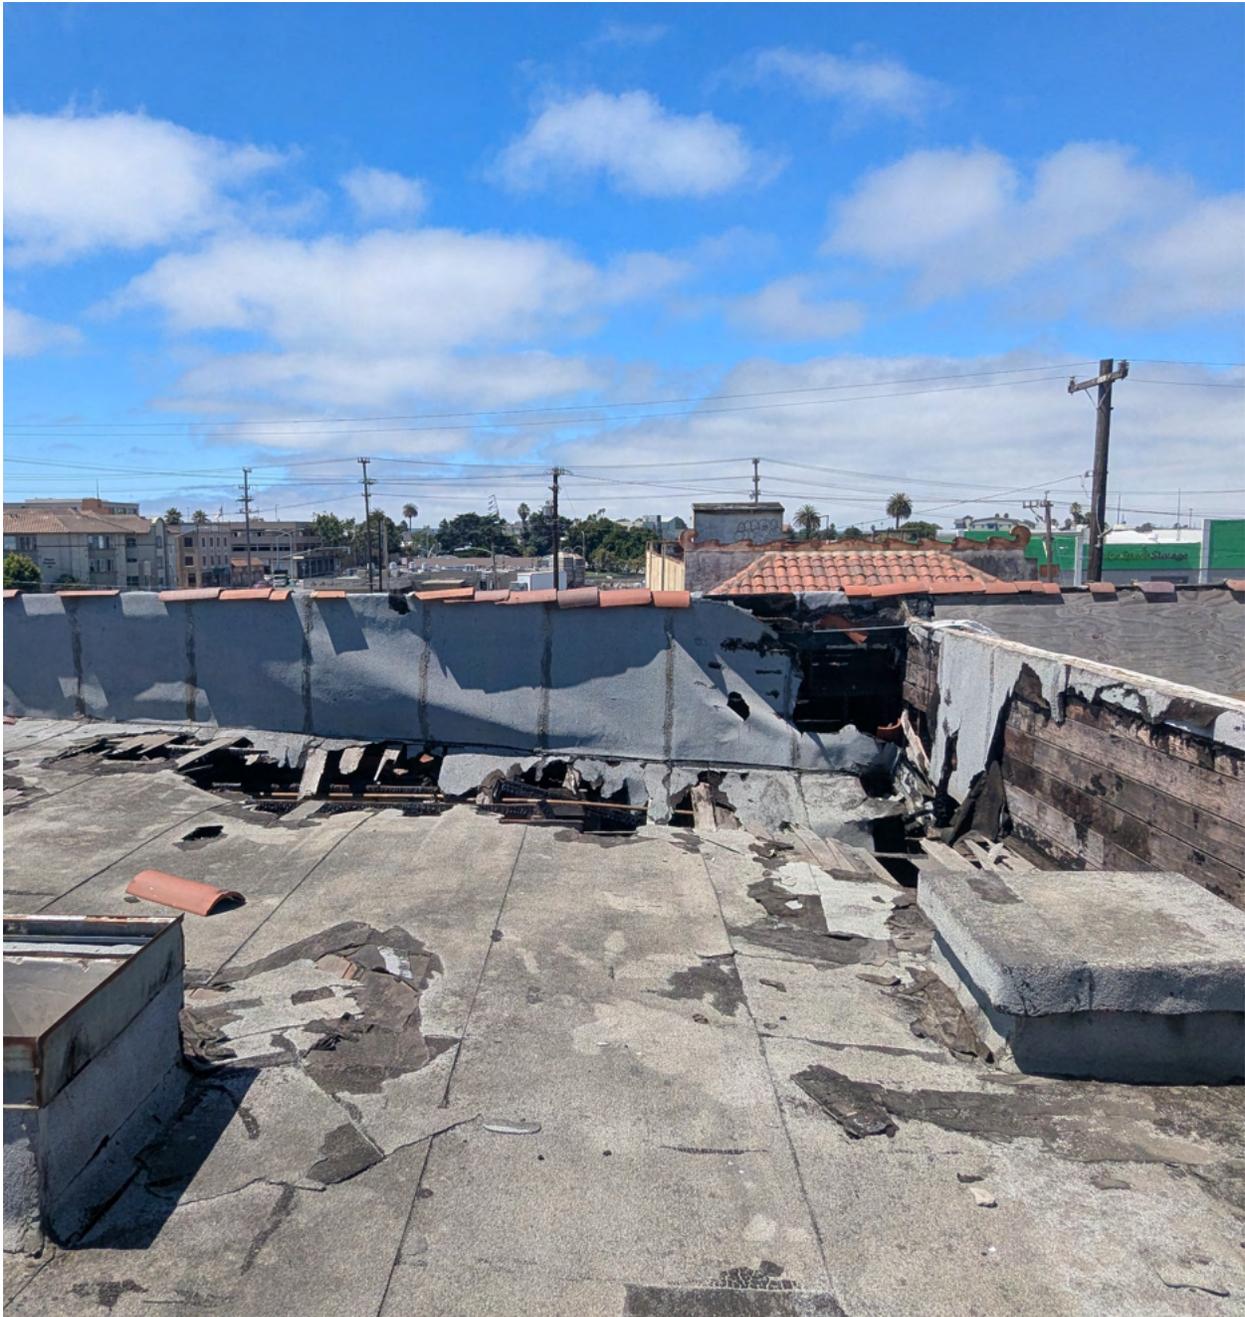
- The northwest corner of the 39 Soledad roof was burned in the fire and has collapsed (Figure 5.41). A majority of the asphaltic roofing along the parapet walls at the west and north walls has failed or is completely missing, exposing the wood board wall sheathing. The roof drain and overflow drain that existed in the northwest corner are missing, however drainage piping below belies its existence (Figure 5.42). Similar to the west parapet wall at the 37 roof, the barrel clay tiles mounted on top of the wall are broken, loose, or have fallen off the wall. They present a fall hazard.

Figure 5.41 West end of 39 Soledad roof, TEF, 2025.

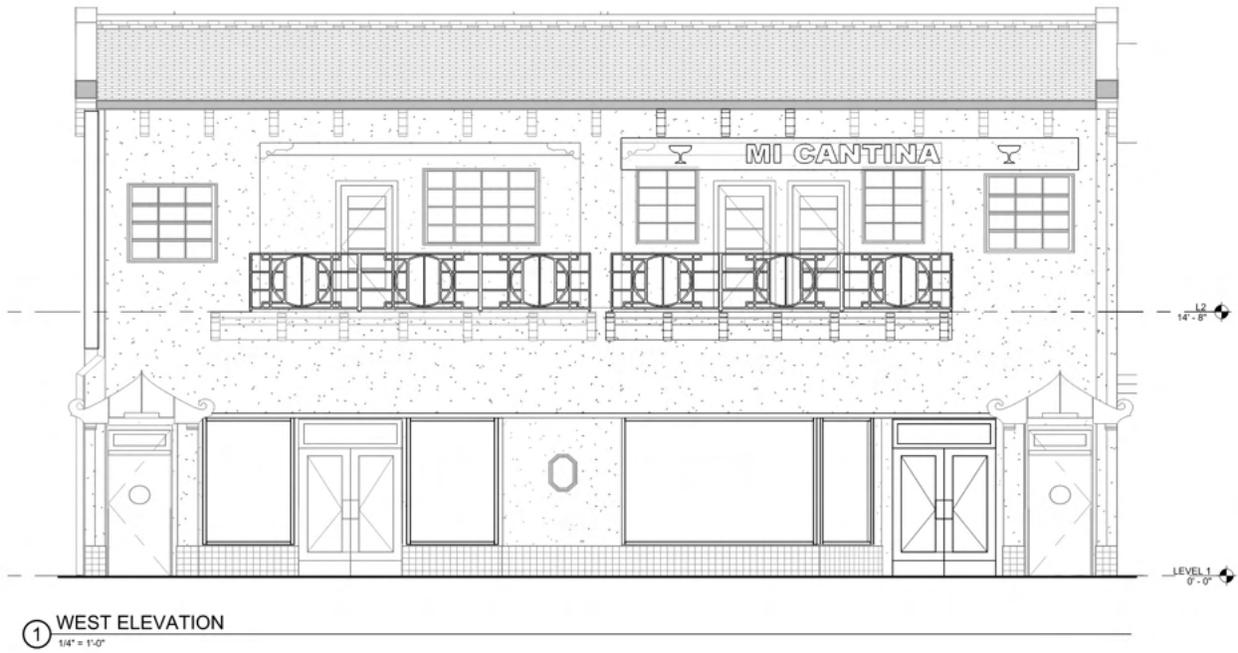
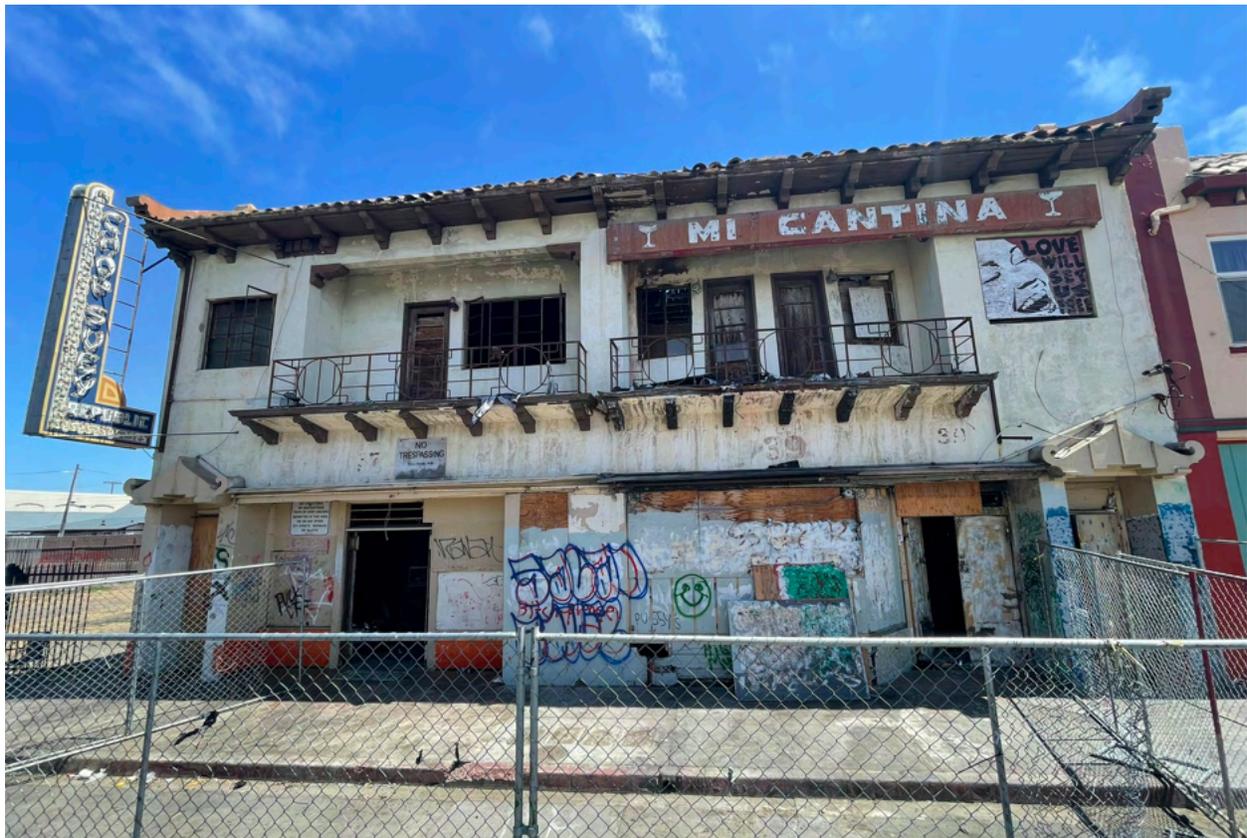
Figure 5.43 (Top) West Façade elevation, TEF, 2025.

Figure 5.44 (Bottom) West Façade, Groundwork Preservation, LLC, 2025.

Overall, the west façade of 37-39 Soledad is in very poor condition due to the extensive fire damage and resulting structural damage. Despite this, some of the individual components on the facade are in fair shape (Figures 5.43 and 5.44). Special attention is paid herein to each of the façade components as the west façade is a primary contributing feature to the historic significance of the building.

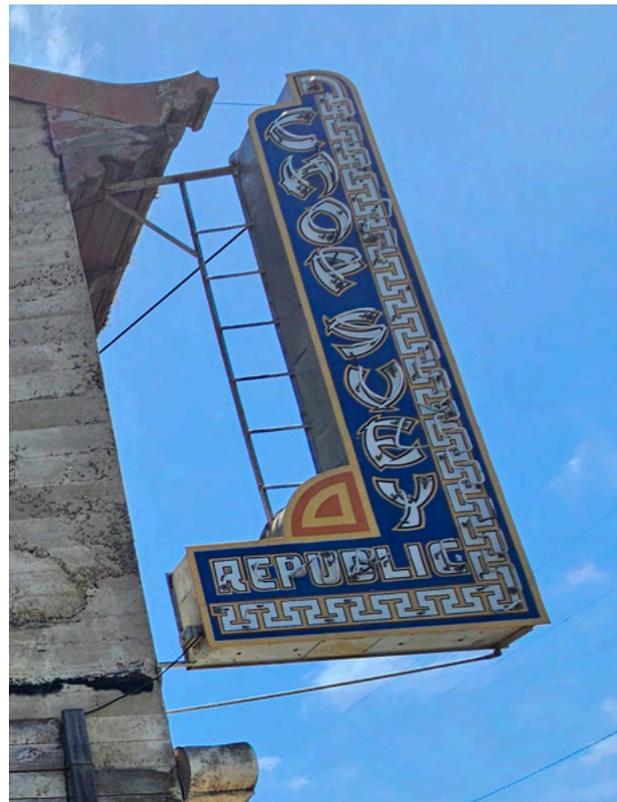
- For Pent Roof description, see Section 5.2.2.
- The painted sheet metal decorative scrolls, one above each end of the the pent roof, are in fair condition. Each has a hole at its protruding end due to corrosion (Figure 5.45).
- There are seventeen painted decorative wood brackets below the pent roof, the majority of which are in fair condition. At the burned portion of the pent roof, some brackets may require replacement in kind (additional investigation required).
- The projecting neon blade “CHOP SUEY REPUBLIC” sign (reconstructed in 2009 by the Asian Cultural Experience of Salinas) is in good condition (Figure 5.46).

Figure 5.46 (Right) “CHOP SUEY REPUBLIC” sign, TEF, 2025.

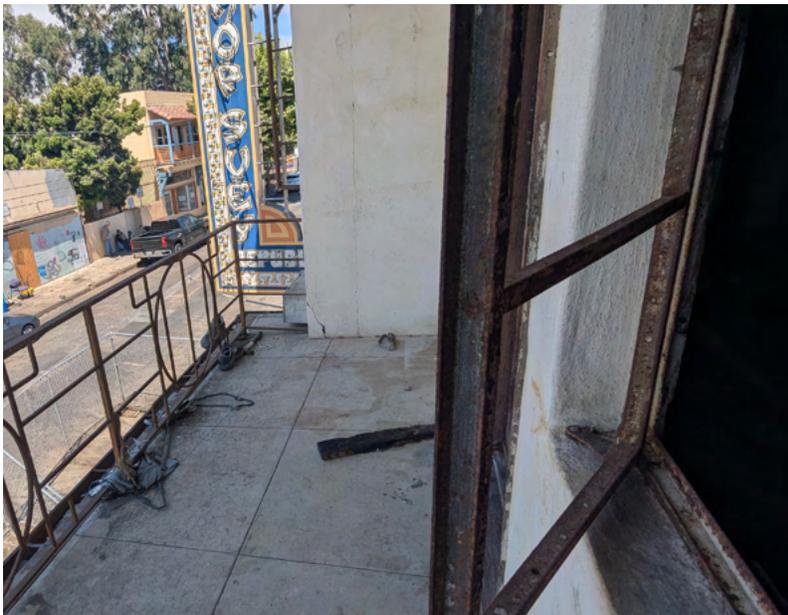
Figure 5.47

- The projecting sheet metal “MI CANTINA” sign above the 39 second story alcove is in fair condition. The white paint used for the characters is missing in varying locations, while the red paint is faded. The sheet metal shows signs of deterioration/mild corrosion in various locations. Historic photos show that the sign originally read “LOTUS INN” and had neon lighting mounted in front of each character. The holes for the neon light appear to still exist (Figure 5.26).
- The painted decorative wood brackets mounted at the corners of the second story alcoves are in fair condition.
- The steel sash fixed and casement windows on the façade are in poor condition. All glazing is missing; there is no coating on the steel, and there is extensive surface rusting (Figure 5.47).

(Top) The steel casement window at the balcony is rusting but still operable, TEF, 2025.

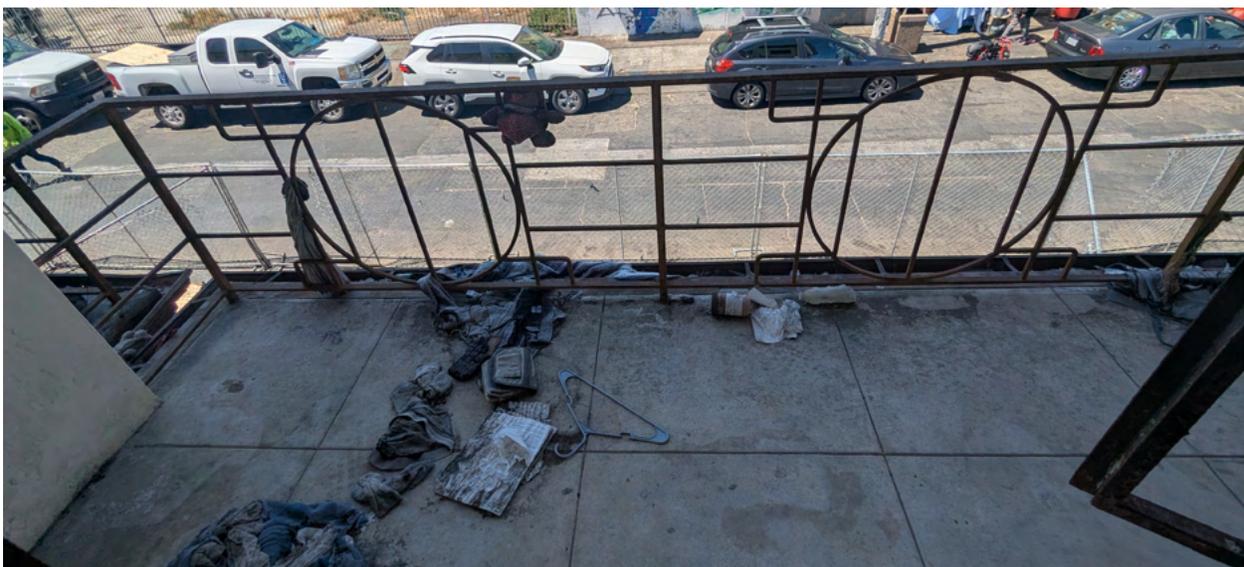
Figure 5.48

(Bottom) Scored concrete floor at second floor balcony of 37 Soledad, TEF, 2025.

- The projecting concrete balconies at the second floor are scored above at the balcony floor, with metal ogee gutters at the perimeter. The concrete is in fair condition with one large crack visible at the north side of the 37 balcony (Figures 5.48 & 5.49). The gutters are in fair to poor condition. A large section of the gutter is corroding and warping on the 39 Soledad balcony (Figure 5.50). The gutters appear to drain at the center of the façade through a drainage pipe internal to the building.

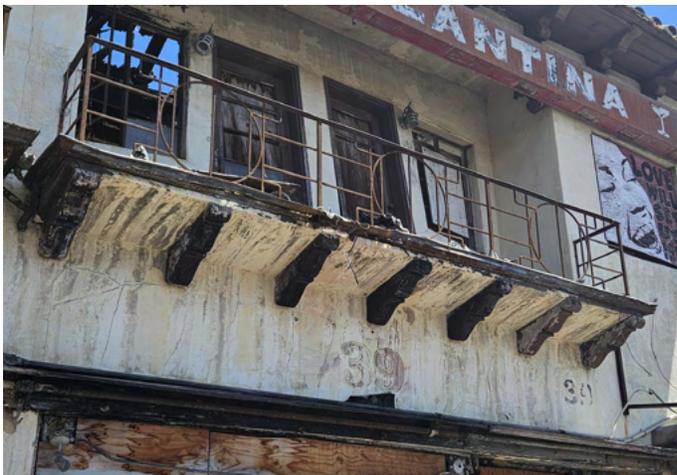
Figure 5.49 (Top) The concrete balcony at 37 Soledad has a large crack, TEF, 2025.

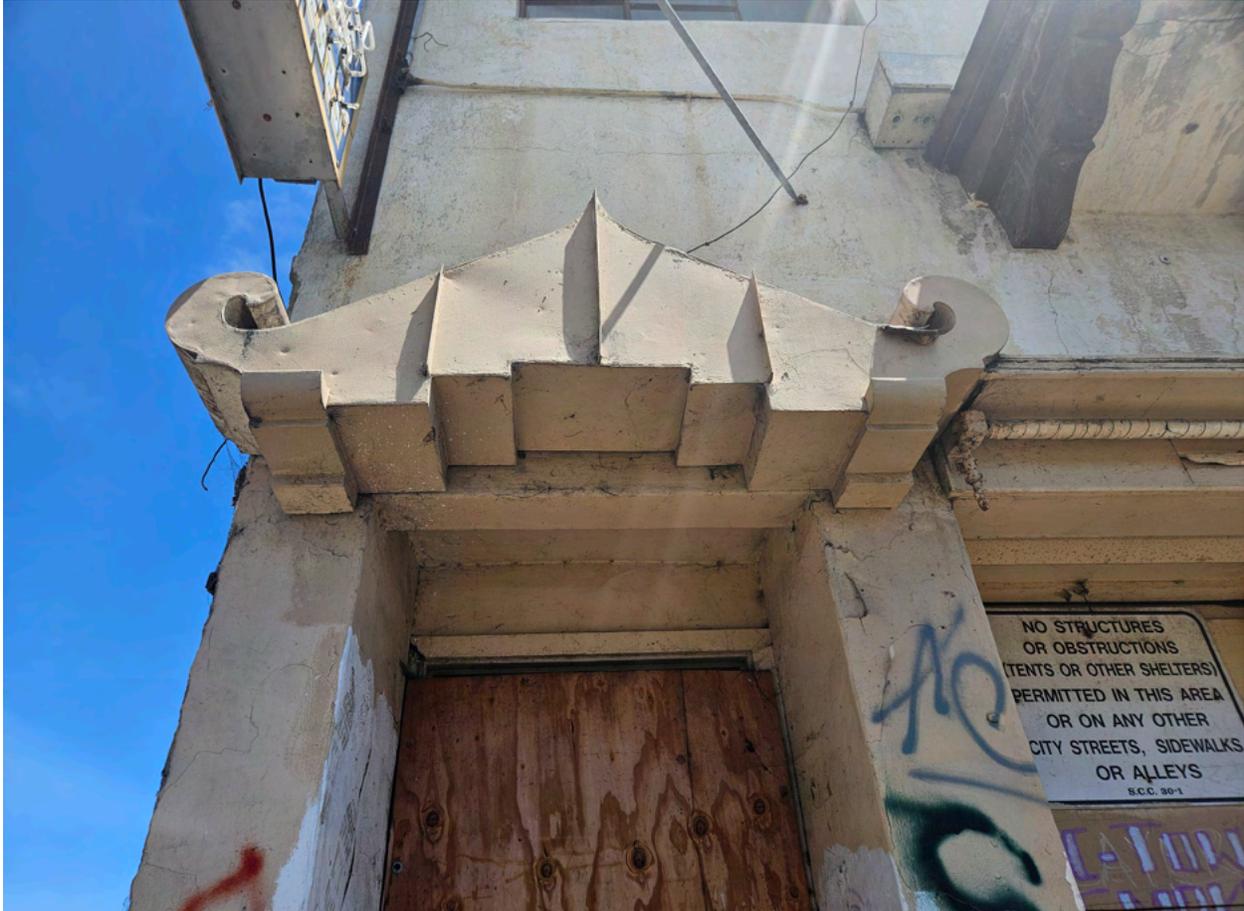
Figure 5.52 The triangular shaped and pedimented metal marquee at the north pedestrian entry, TEF, 2025.

- Install contemporary wall mounted pendant light fixtures at original alcove locations. Fixtures to be compatible with building aesthetic.
- Clean and repair the metal panel marquees over the residential entries to ensure water tightness. Component may be temporarily removed and reinstalled to repair if required. Paint to match (or approximate) original color.

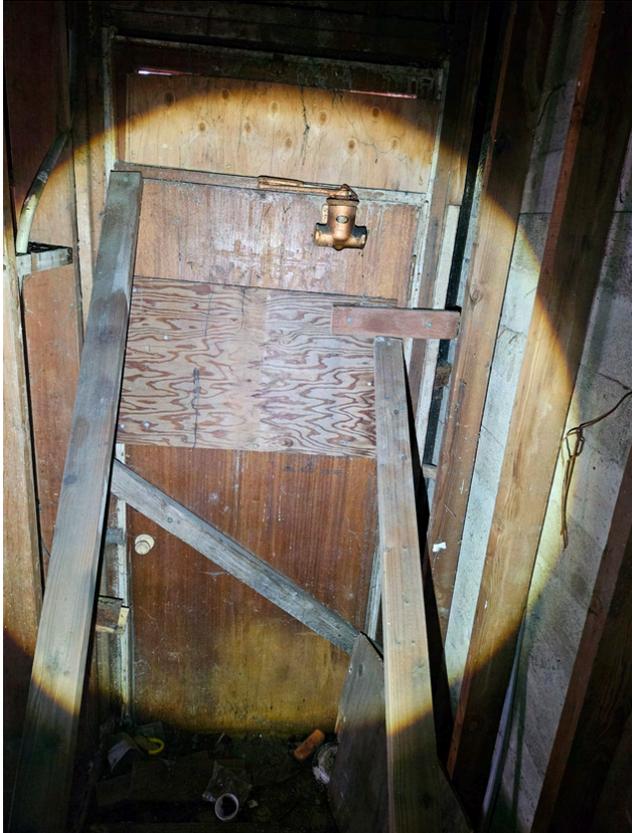
Figure 5.53 (Top Left) Pedestrian entry and transom from interior of 37 Soledad, TEF, 2026.

- Repair or replace in kind existing flush wood pedestrian doors with glazed porthole. Install code compliant hardware. Stain door to match (or approximate) original color. Repair or recreate glazed wood transom above door to approximate original, finish to match door. If code compliant hardware at transom is not feasible, transoms may be fixed in place.

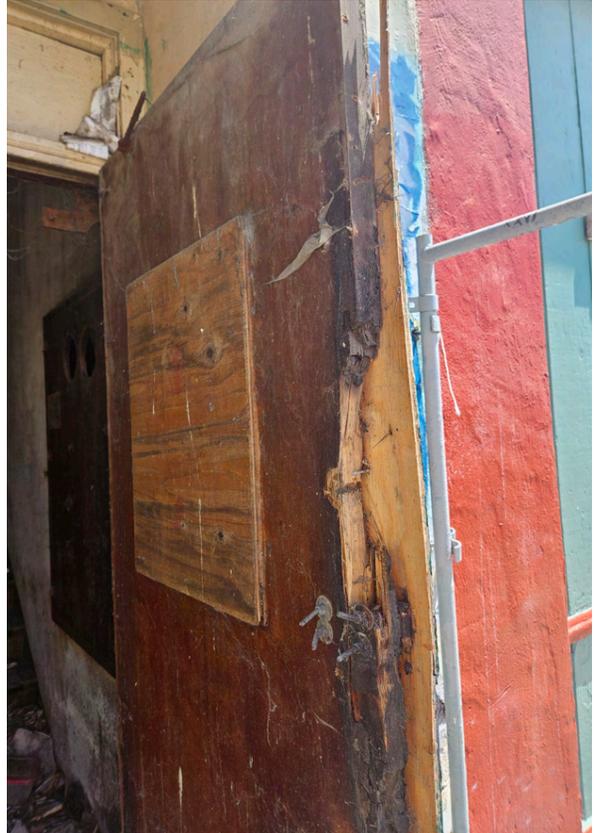
Figure 5.54 (Top Right) Pedestrian entry at 39 Soledad, TEF, 2025.

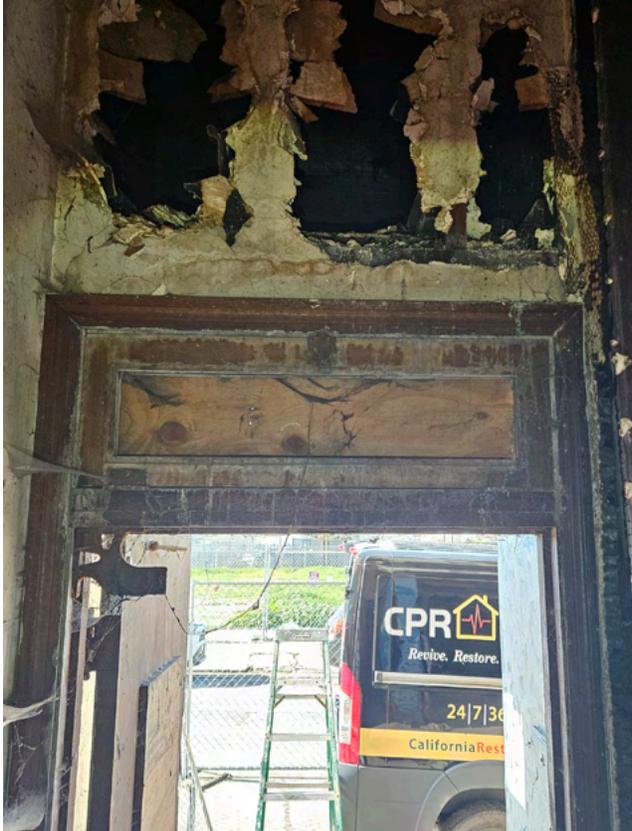
- Wall mounted pendant light fixtures at the balconies are industrial in nature. They are mounted adjacent to the doorways (one fixture at 37 Soledad, two at 39 Soledad). The fixture at 37 Soledad appears to be original. The fixtures are in poor condition.
- The decorative metal marquee with triangular pediment shape and decorative end scrolls above each pedestrian entry are in fair condition (Figure 5.52).
- The wood flush pedestrian door with porthole opening at 37 Soledad is in fair condition; it is unclear if glazing remains in the porthole. The transom above appears intact (covered with plywood), is in fair condition, and may retain glazing (Figure 5.53). The door at 39 is in poor condition; the strike side stile is badly damaged and partially missing from a previous (attempted) break in (Figure 5.54). The transom is in fair condition with missing glazing (Figure 5.55).

Figure 5.55 (Bottom) Transom at 39 Soledad pedestrian entry, TEF, 2026.

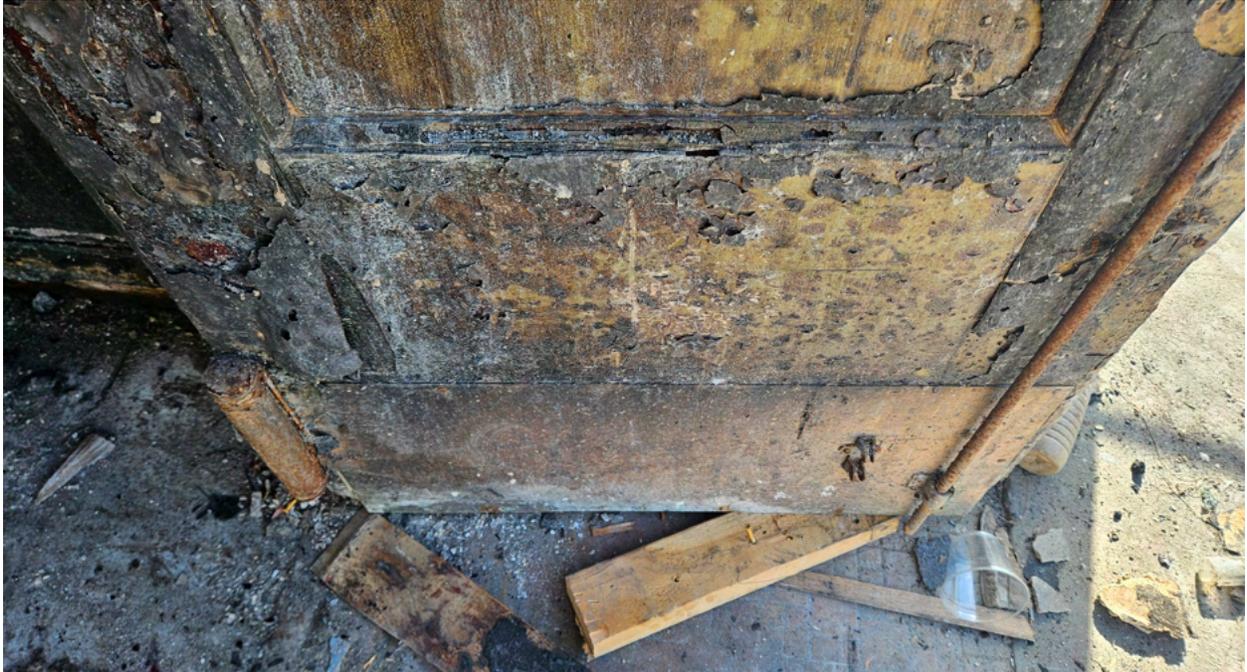
- There are a pair of wood frame, glazed storefront doors with transom above at each storefront entry (currently covered with plywood). The doors and transom at 39 are in poor condition, are missing glazing and have been damaged by fire at the interior. The doors at 37 are similarly in poor condition, with missing glazing and damage at wood components from various attachments. The original transom appears to have been removed and replaced with an inappropriate metal vent in its place, in fair condition. The transom appears to have been in-swinging hopper windows (Figure 1.20).

Figure 5.56 (Top) Fire-damaged storefront at 39 Soledad, TEF, 2026.

- First floor storefronts:
 - Verify condition of wood storefront framing and bulkhead wall framing at 37 Soledad. 39 Soledad storefront is primarily fire damaged and should be replaced in kind, in original location and configuration. Reconstruct 37 storefront where components are beyond repair to approximate original and as required to accept new storefront glazing system (see next recommendation).
