Historic Structures Report

37-39 Soledad Street

City of Salinas, California | February 2026

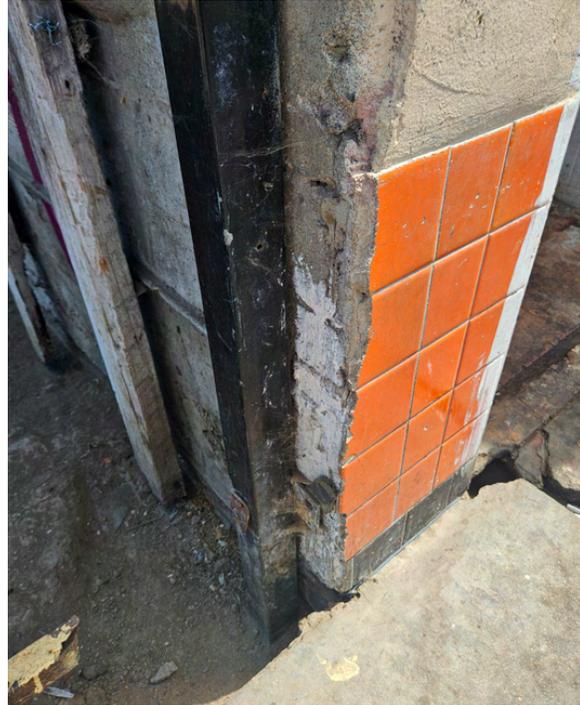
- The original storefront framing was wood framed with wood-framed bulkheads covered with 4x4 ceramic tiles (Figures 5.58 and 5.59). The brightly colored orange tile with a first course of black tile is still largely intact at 37 Soledad, although the tiles are damaged and chipped at the far north edge of the building. The tiles have largely been removed, painted, or covered with plywood at 39 Soledad. Multiple locations are cracked but extant tiles are in fair condition.

Figure 5.58 (Top) The orange and black ceramic tile bulkhead at the far north edge of the building has been chipped, TEF, 2025.

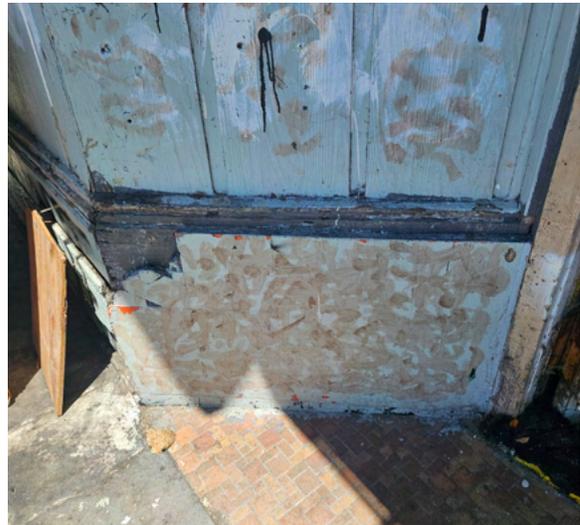
Figure 5.59 (Center) The majority of extant ceramic tile bulkhead at 39 Soledad has been painted over, TEF, 2025.

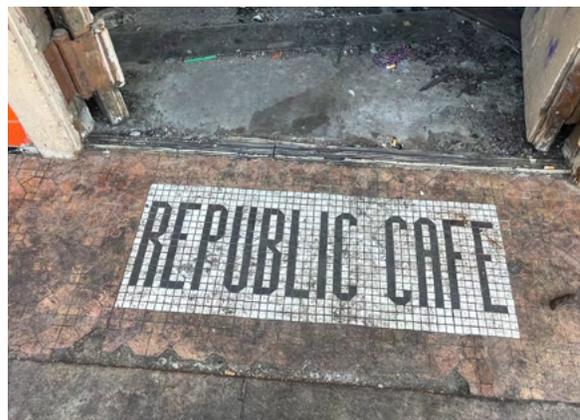
- The original mosaic tile sidewalk at the building entries, including the “REPUBLIC CAFE” mosaic of black and white ceramic at building entry 37, is very dirty and damaged in multiple locations. It is in poor condition. (Figure 5.60)

Figure 5.60 (Bottom) The original “REPUBLIC CAFE” mosaic, Groundwork Preservation, LLC, 2025.

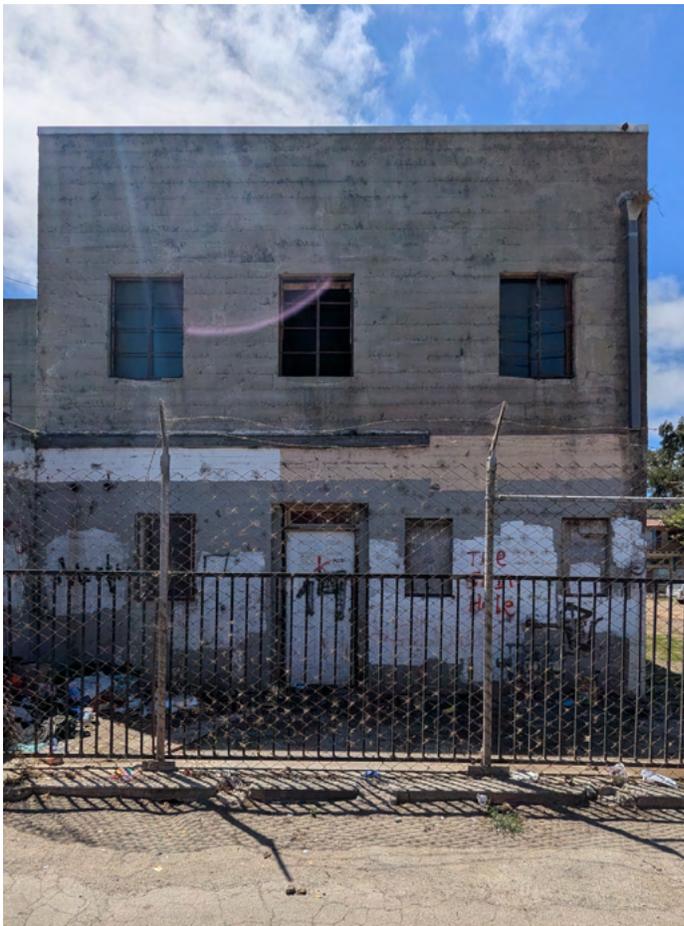
- Three fixed steel windows at the second floor are in poor condition. All the glazing is missing and they are visibly corroding. The north window has been damaged with the sash bent out of the frame/ wall (Figure 5.63). The concrete sills of all windows are various stages of spalling.
- Three smaller windows at the first floor are also steel sash and are boarded up. They are all in poor condition, with missing glazing and corroding components (Figure 5.64). The wood framed opening and extant wood transom of the rear entry are in poor condition. The original door was removed and replaced with a contemporary paneled fiberglass door, in fair condition.

Figure 5.63 (Left) The rear (east) façade of 37 Soledad, TEF, 2025.

Hire a qualified architect or licensed general contractor to further assess the conditions of steel sash and wood windows, with attention to component condition, concrete window opening condition, window sash and hardware operability. If replacement in kind is required, additional focus should be paid to original installation of the window to determine a recommended method for removal of windows.

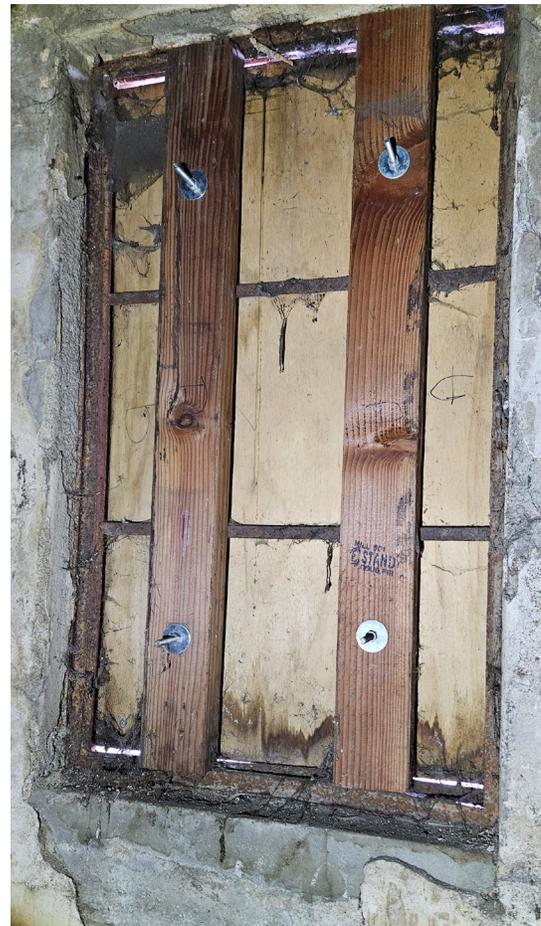
Figure 5.64 (Right) A boarded-up first-floor steel sash window at the rear (east) façade of 37 Soledad, TEF, 2026.

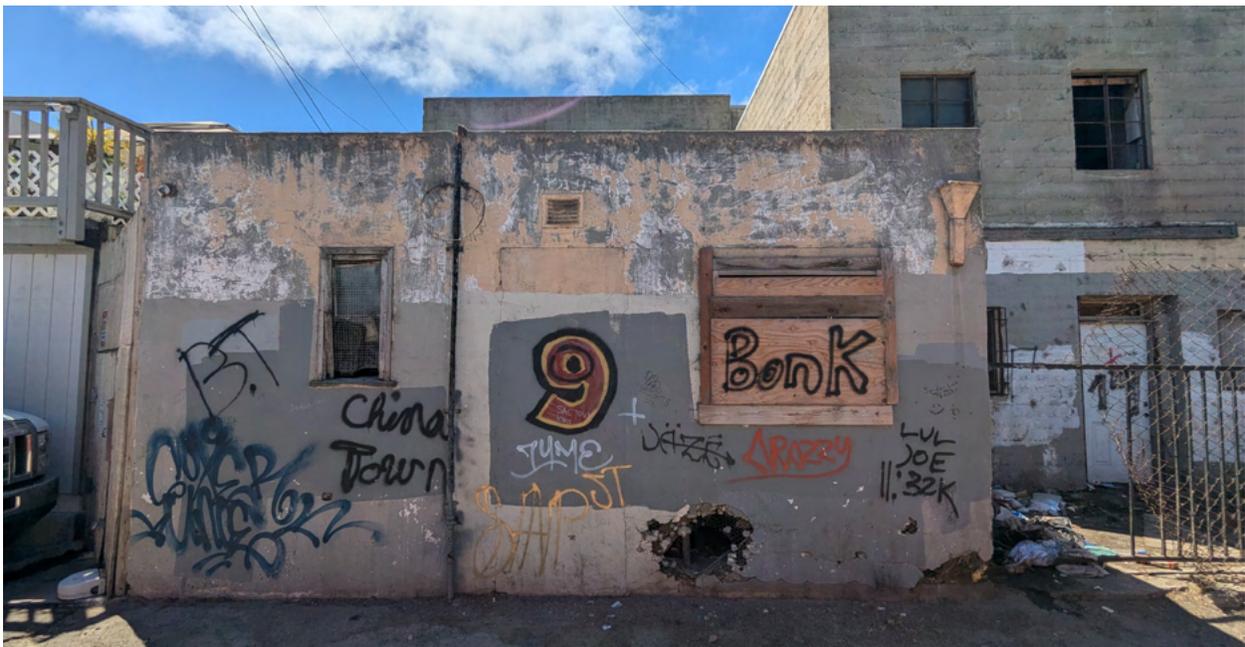
- A wire mesh window covering is rusted (Figure 2.13). Presumably there are wood framed windows behind. They were inaccessible but are likely in poor condition.
- Both doors appear to be wood flush doors with glazed wood transoms above and are in fair condition (Figures 5.65).

Figure 5.65 (Top) The primary rear door of 39 Soledad, as seen from the interior, TEF, 2026.

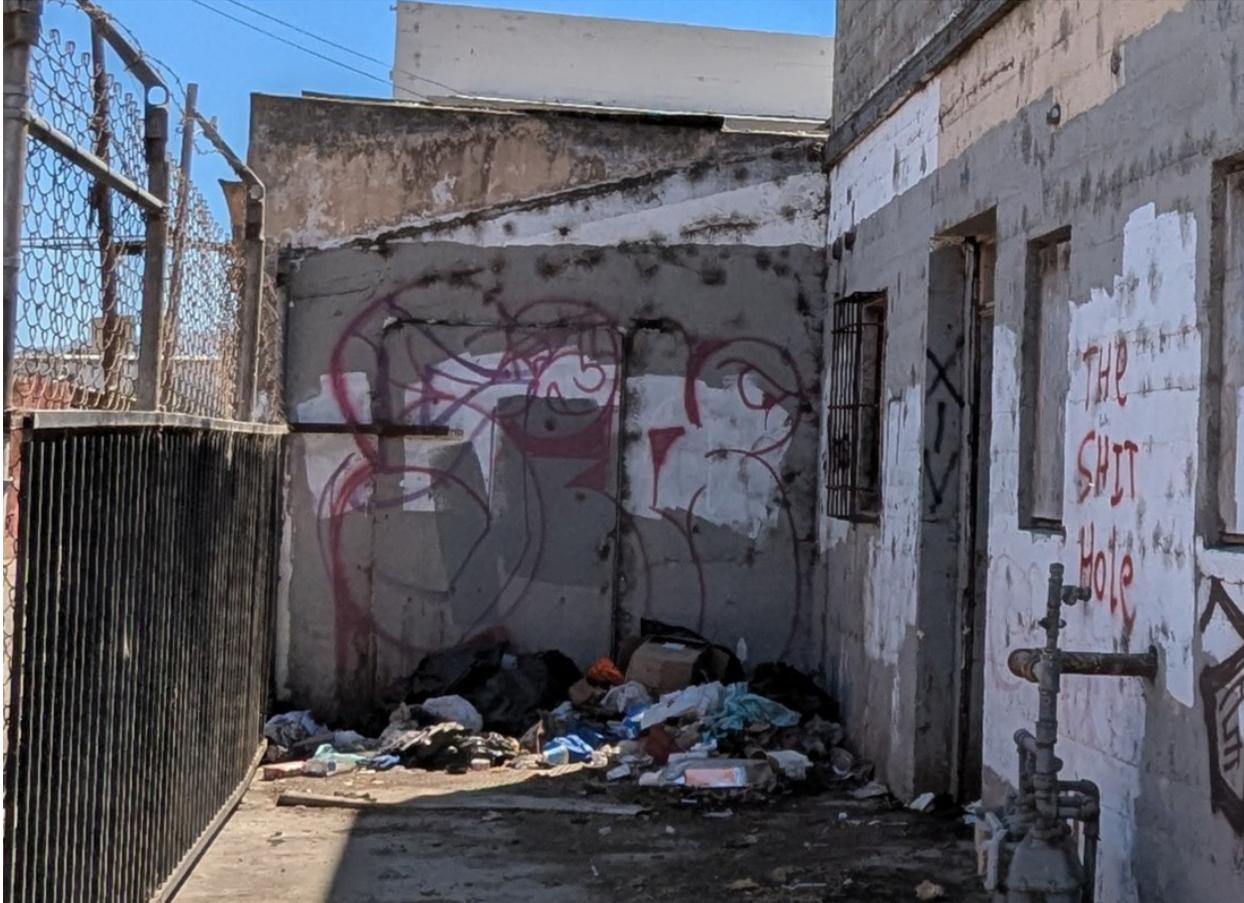
Figure 5.67 North façade of the rear building behind 39 Soledad, TEF, 2025.

- A portion of the north wall has been boarded up at what may have been a door opening. There is heavy water staining and mold growth along the wall, indicative of excessive water infiltration in the wall, and very likely due to the failed roof (Figure 5.67).
- The doors and transoms on the south and east facade are covered and difficult to assess. As they are less accessible and exposed to elements, they are presumably in fair to poor condition, (Figures 2.14 and 2.15).

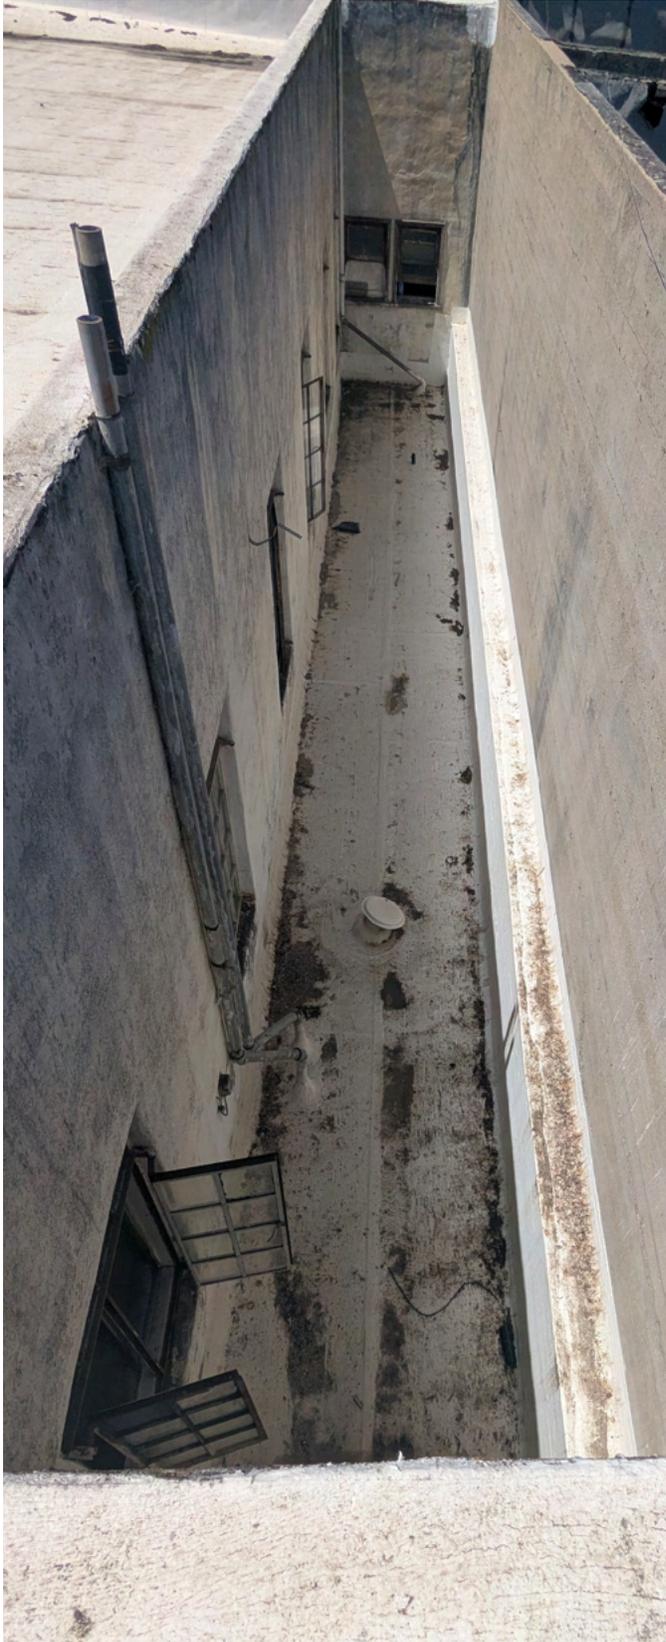
Very little of the south façade is visible due to the building constructed adjacent to 39 Soledad to south. The portion of visible façade is in good condition. Due to its location in a lightwell of the adjacent building, it is somewhat weather protected and has no openings (Figure 5.68).

Figure 5.68 The exposed south wall of 37 Soledad, TEF, 2025.

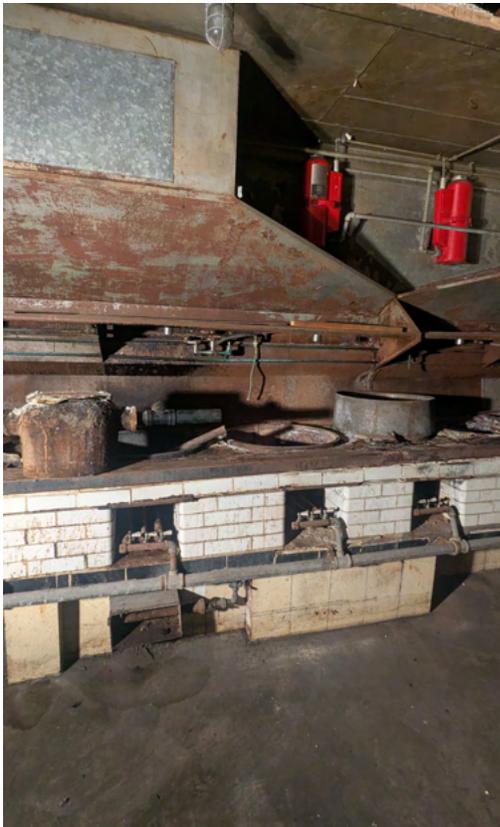
- Throughout the building, many of the finishes have been removed to reveal knob and tube wiring, remnant plumbing, and utility lines in the ceilings and walls. (Figure 5.69). This is not a life safety threat as the building has no services, but points to the inadequacy of the utility systems for this building.
- At the first-floor rear kitchen, remaining kitchen equipment is in poor condition. A tiled counter exists beneath a series of stainless steel woks and exhaust hoods. The components are in disrepair, are dirty and rusting (Figure 5.70).

Figure 5.69 (Top) Typical exposed knob and tube wiring, seen here at the first-floor restaurant north wall of 37 Soledad, TEF, 2025.

Figure 5.70 (Bottom) Remnant woks in the 37 Soledad kitchen, TEF, 2025.

Component	Recommendation	Urgency
Electrical systems	Remove all remnant knob and tube wiring.	Recommended
Plumbing systems	Remove all existing plumbing fixtures and associated piping/ roof vents.	Recommended
Second floor (37 Soledad)	If the second floor will be re-inhabited, determine a second means of egress.	Recommended

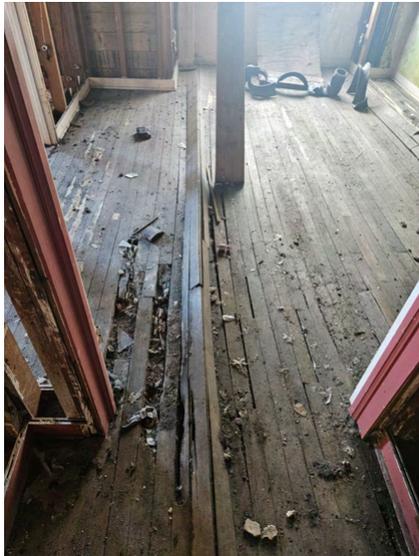
Figure 5.71 (Top Left) Buckling floor in the front bedroom of 37 Soledad apartment, TEF, 2025.

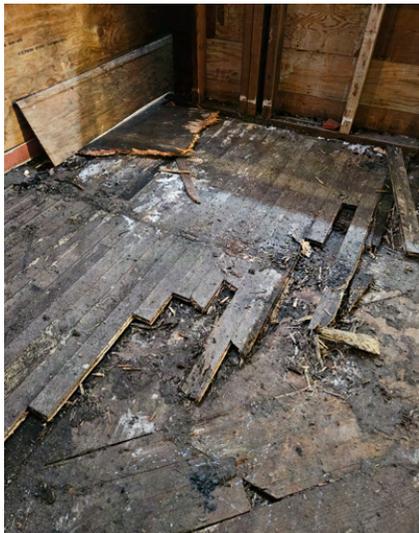
Figure 5.72 (Bottom Left) Partially demolished flooring in the 37 Soledad apartment living room, TEF, 2026.

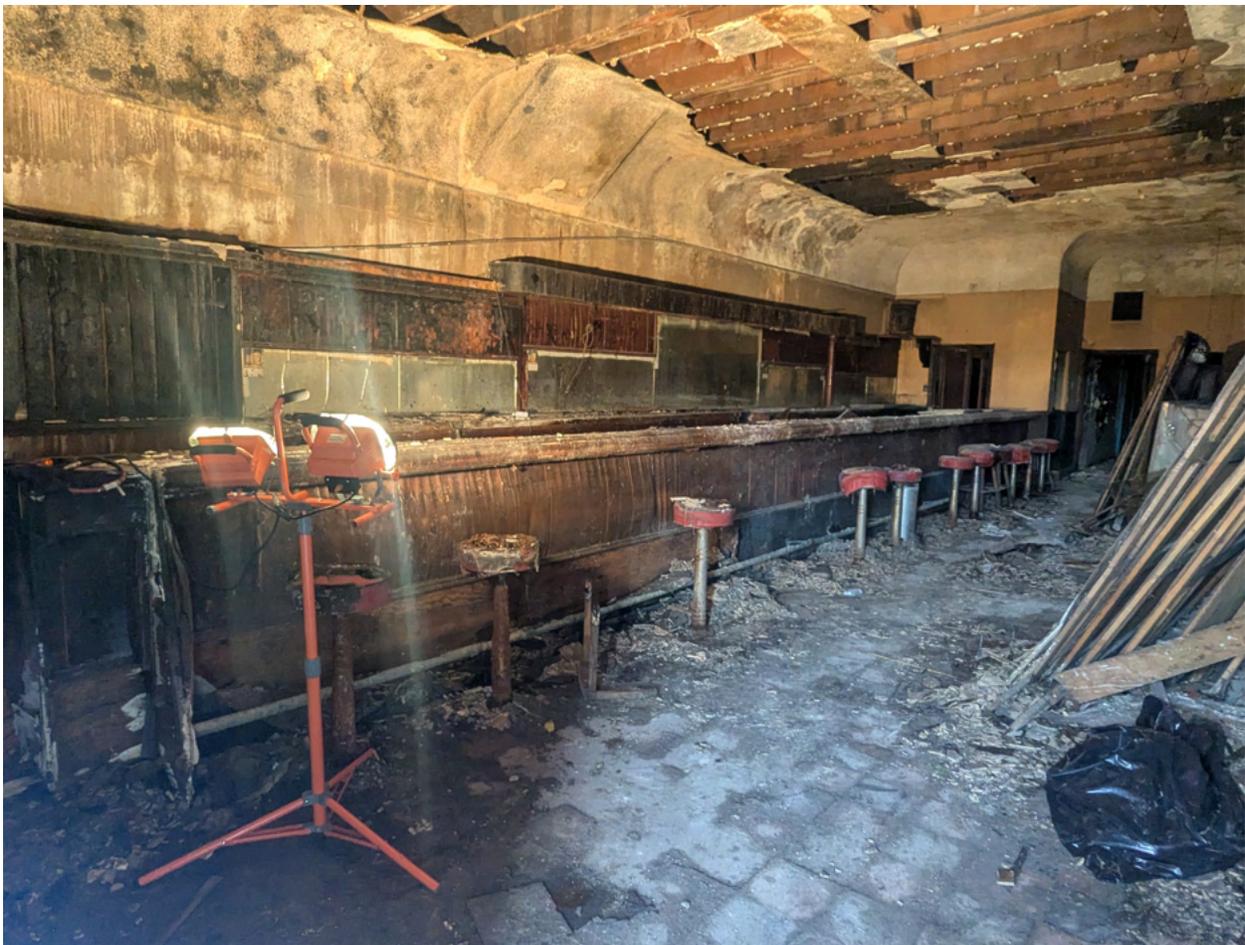
- The original bar room on the first floor is in poor condition. The front half was heavily damaged by fire in 2022, with the floor and roof framing entirely collapsed and the front façade. The plaster of the walls and ceiling is intact in some locations but has largely fallen from the ceiling and walls, littering the space. The framing of the original coved ceiling remains intact (Figure 5.74). The original display area at the front storefront is entirely burned (Figure 5.75).
- The freestanding service bar and associated built in bar stools are in poor condition. A portion of the bar has been damaged by fire; the front veneer of the bar is in particularly poor condition. The bar is littered heavily with large pieces of fallen ceiling plaster making full condition assessment difficult.

Figure 5.74 The first-floor bar in 39 Soledad, TEF, 2026.

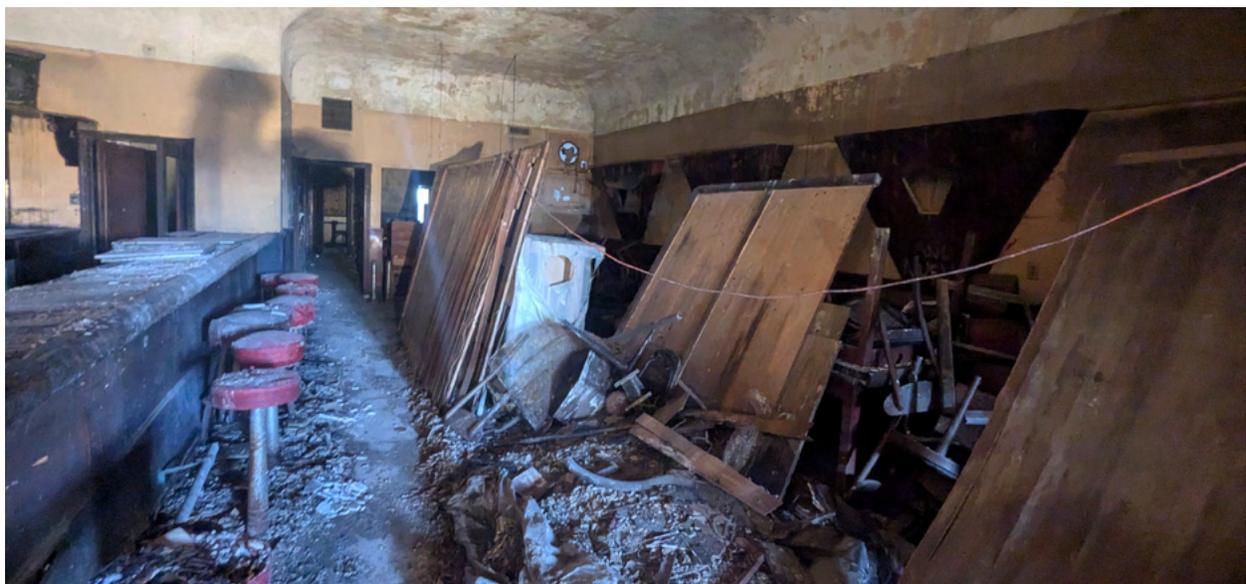
- The wood back bar with mirror backsplash is in poor condition. A portion of the bar was damaged by fire and the mirror backsplash is missing or has detached from the wall in multiple locations. Buildup of detritus in the space and fallen plaster make full assessment of these components difficult.
- The wood light sconces installed on the south wall are in poor condition (Figure 5.76). At least one has been damaged heavily by fire. The veneer and wood components of many have failed/ peeled away.

Figure 5.76 (Bottom) 39 Soledad bar, TEF, 2026.

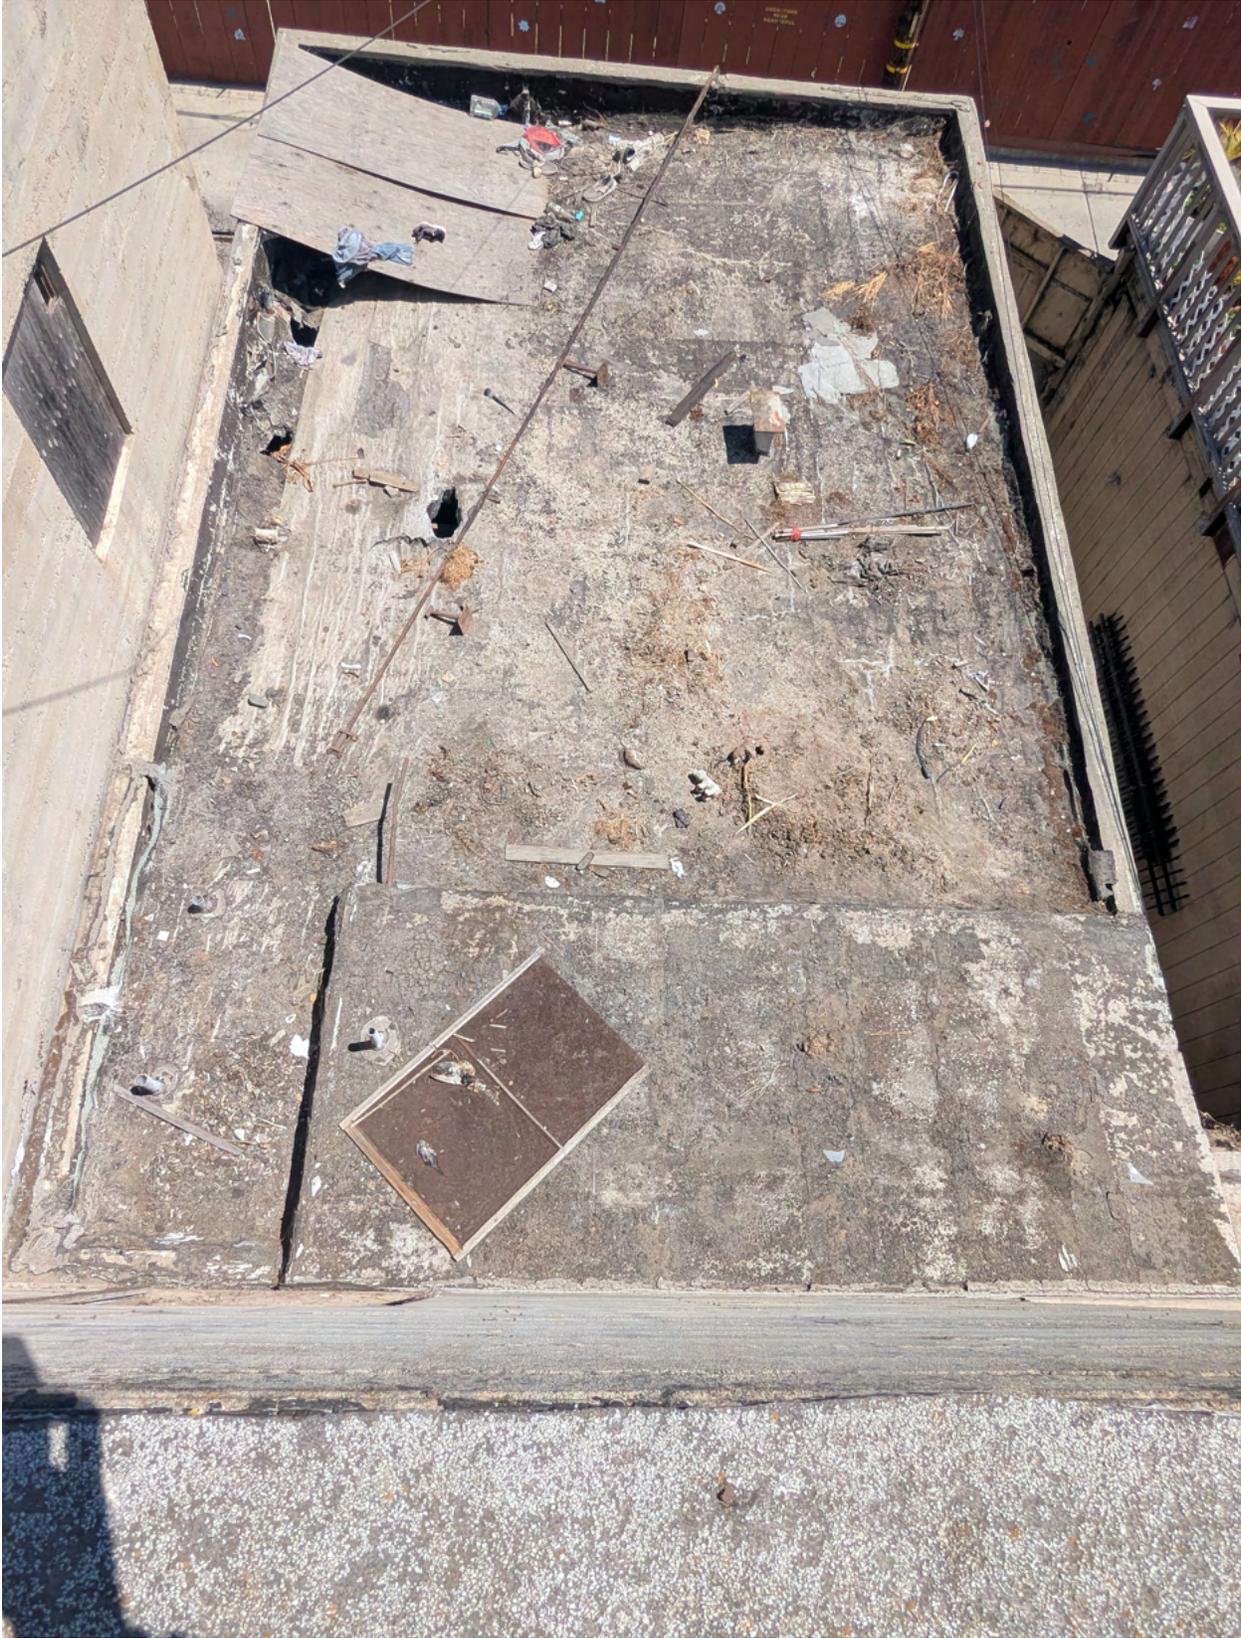
The building at the rear of 39 Soledad is a collapse hazard, with the majority of the roofing and framing failed and large holes in the base of the exterior walls (Figure 5.66).

Figure 8.1 Roof of rear building at 39 Soledad, TEF, 2025.

- The one-story building at the rear of 39 Soledad is a collapse hazard and should remain actively boarded up to keep out intruders and vagrants.
- There is extensive evidence of building occupation by local unhoused individuals and animals. This building is a hazard and should not be occupied. It should remain boarded up and be monitored to ensure inhabitation is not undertaken.

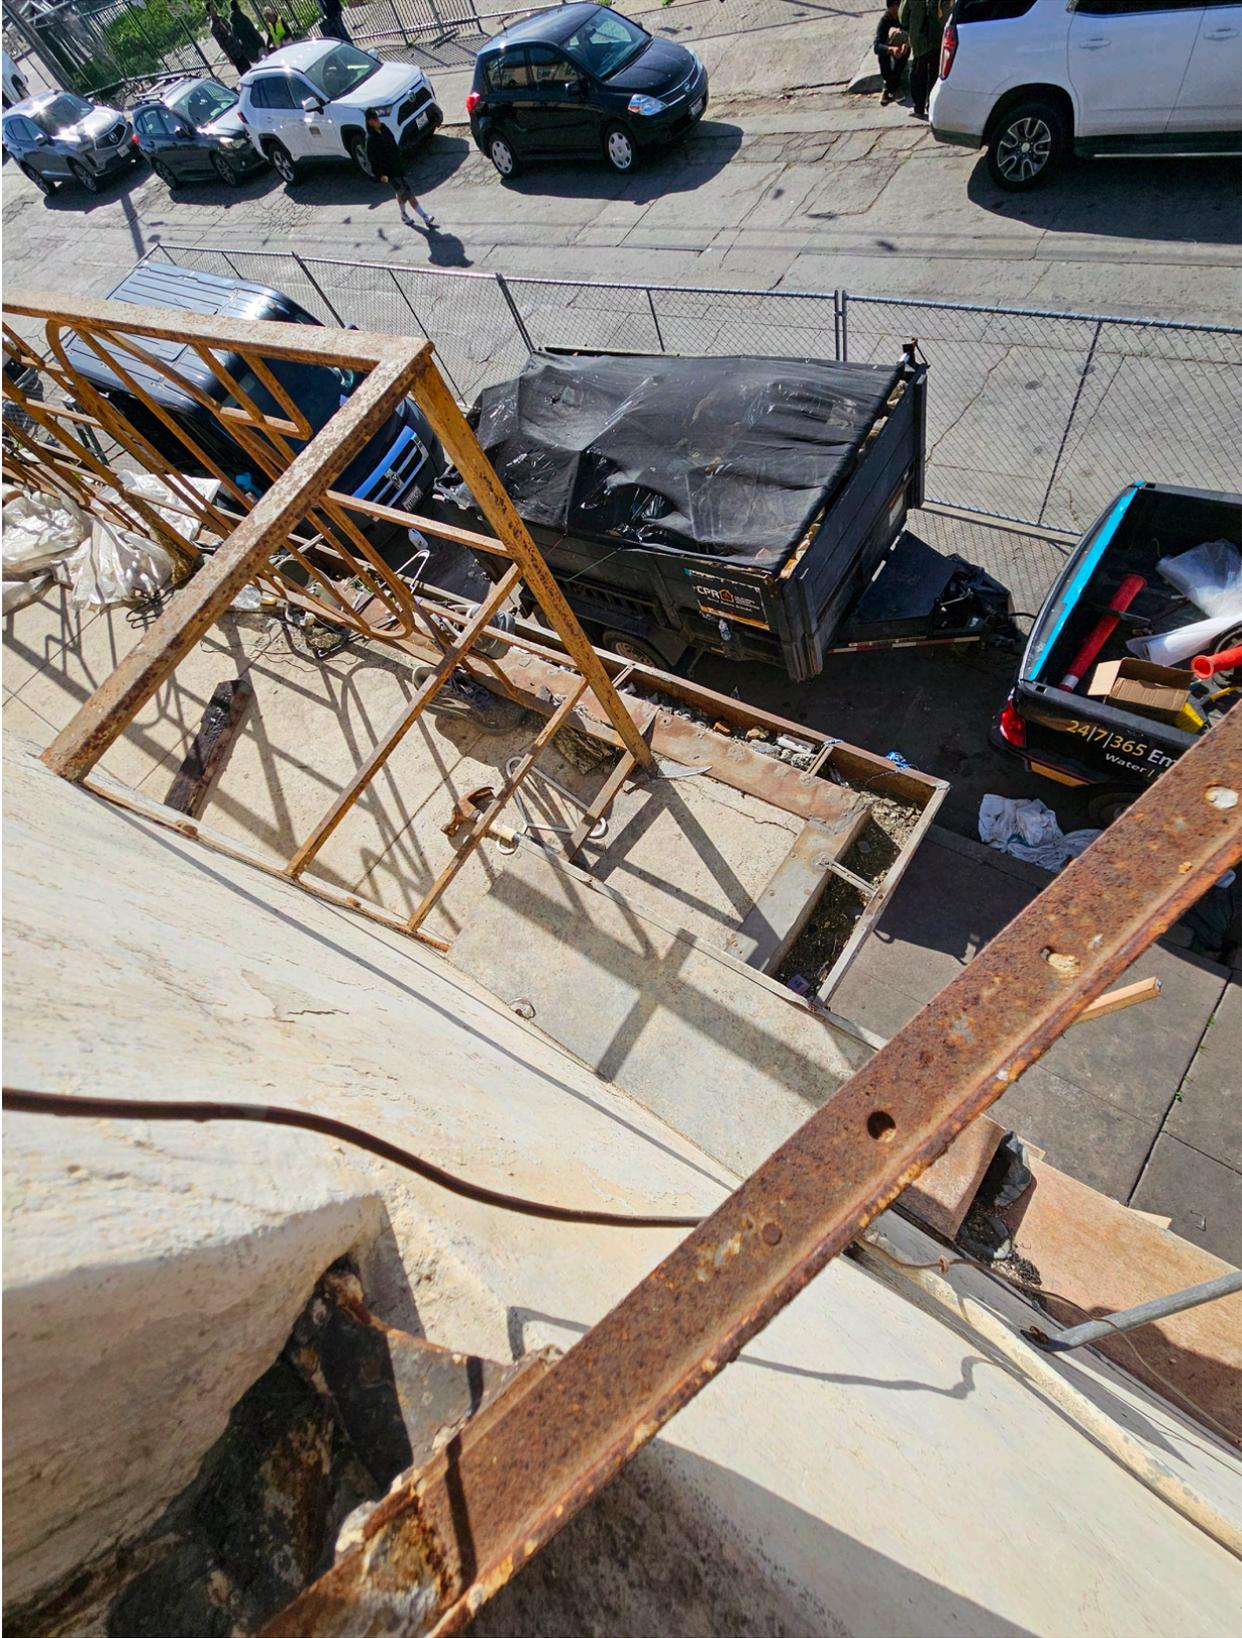
Figure 8.3 Edge condition of concrete balcony as seen from above, TEF, 2026.
