# **HISTORIC STRUCTURE REPORT**

# **38 Soledad Street**

**March 2025**

TEF Design  
Groundwork Preservation, LLC  
Howard Carter Associates, Inc.

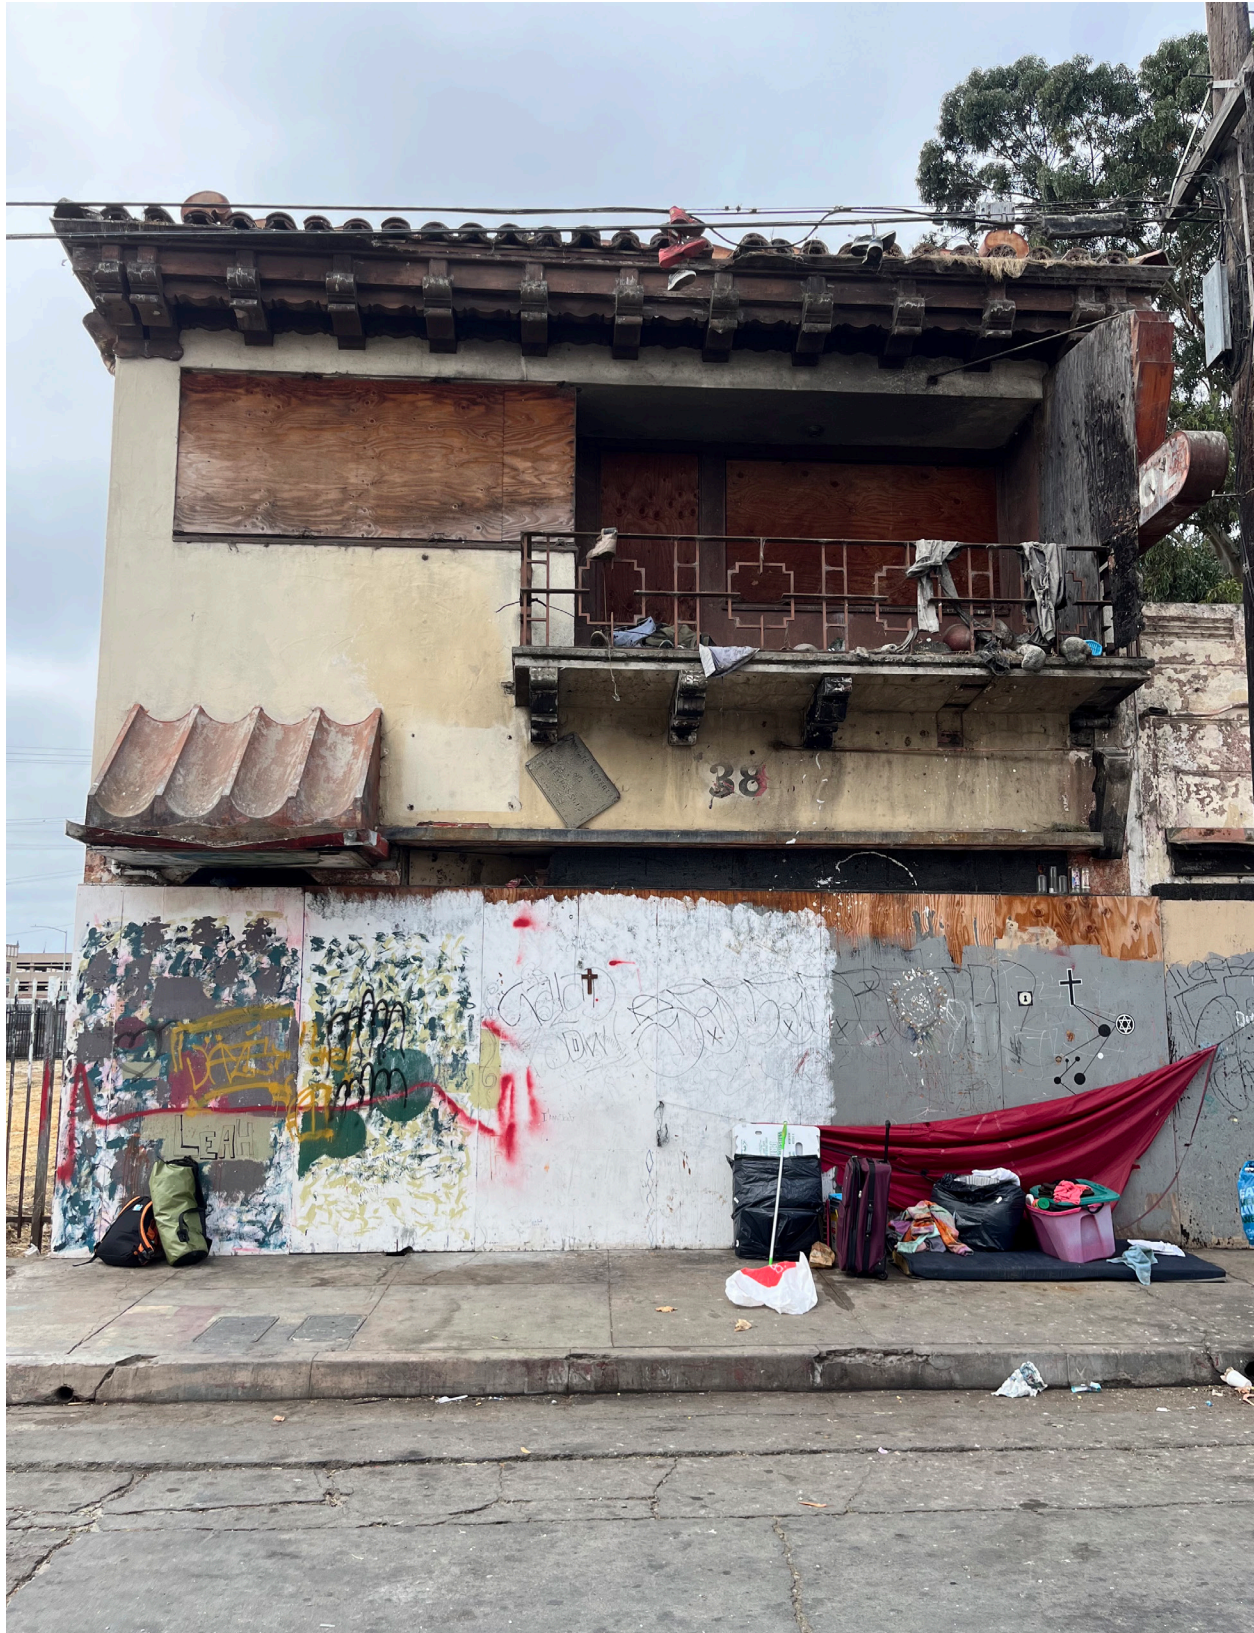
The primary (east) facade (Figure 2.2) faces Soledad Street and is arranged asymmetrically. The ground story is completely obscured by plywood boards; however, a historic photograph (Figure 1.12) indicates that there is a tile bulkhead across the base of the facade. There are two architectural bays on the ground floor. The left bay contains one original flush wood door with a circular window that is recessed into the facade at a slight diagonal. The door had a metal kick plate according to a historic photograph, although it is unknown if it is extant. A metal panel marquee with concave grooves and ridges mimics the clay tile roof and is affixed to the facade above the entryway, which served as the primary entry to the apartment on the second floor. Historically, it had a metal trim with horizontal grooves and decorative wood scrolls. These were removed in 2018. The north bay features a storefront with one central pair of wood glazed storefront doors and a wood hopper transom above, most of the glazing missing. The doors are flanked by two large, presumably wood framed, storefront windows above a low concrete stem wall. The doors appear to be original. The entryway is recessed, with the window walls angled inward towards the doors. Angled storefronts were a common feature of commercial buildings in Salinas after the 1930s.<sup>55</sup> A horizontal metal reveal is affixed to the soffit above, distinguishing the projecting second story above from the recessed storefront below.

The second story projects slightly over the ground story and is also arranged asymmetrically, with two distinct architectural bays. The south bay contains a multi-paned steel sash industrial window, broken into six sash across the front and one sash facing north towards the recessed balcony in the north bay. Although currently obscured by plywood, hardware projects beyond the covering at each sash, indicated that each is likely an operable casement window. Pictures from 2011 show that the glazed window panes are broken. The adjacent north bay is recessed from the primary facade with a projecting concrete balcony and an associated painted (red) metal railing. The design of the metal railing is Chinese inspired with repeating and symmetrical geometric motif. The underside of the balcony contains five scrolled wood brackets, one of which is currently missing and another that is fully detached and hanging off of the building. A door and window provide access to the balcony and are set within the deep recess. These openings are currently obscured by plywood. Historic photographs indicate that the door is a five lite, glazed wood door adjacent to a steel sash window with five sash (presumably all operable similar to the adjacent). A light fixture is set flush mounted in the ceiling of the recessed bay. A roughly Z-shaped red metal sign with the words "Arre's Pool," in white, is affixed to the upper north side of the facade.

Figure 2.2 East facade of 38 Soledad Street looking west, Groundwork Preservation, LLC, 2024.

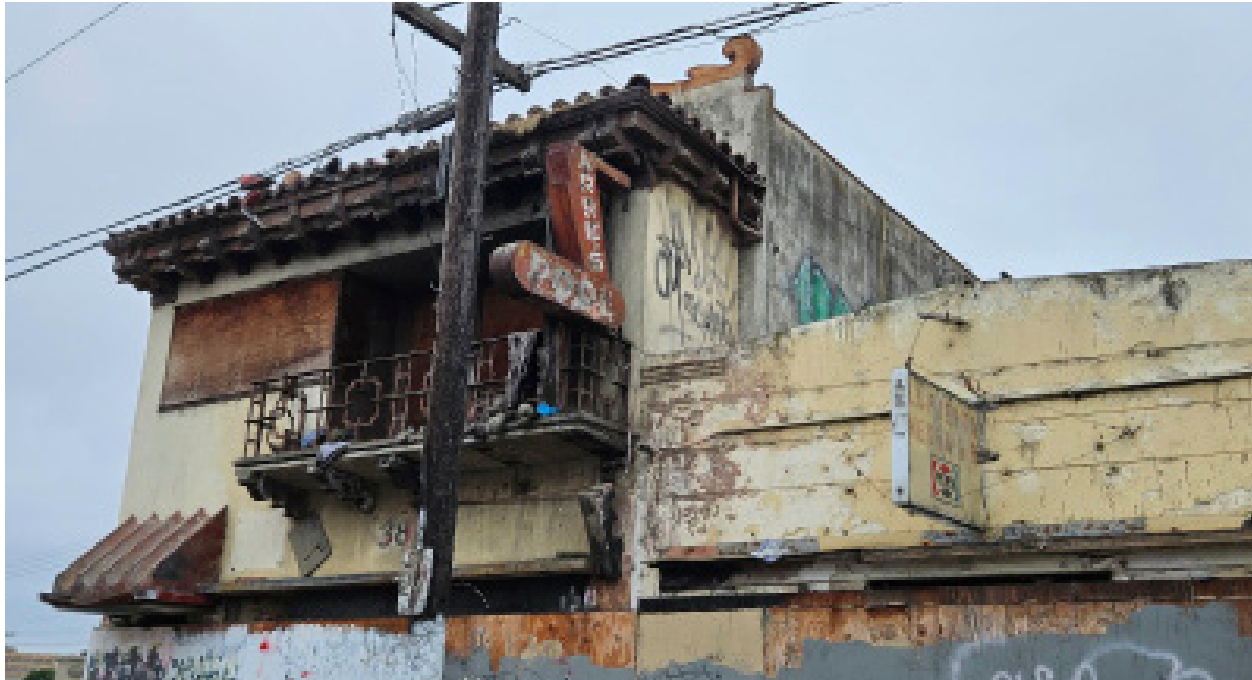
The north facade abuts the adjacent building at 36 Soledad Street, which obscures most of the north facade at the ground story of the subject building (Figure 2.3). The visible upper portion of the facade is clad in stucco and covered in graffiti. At the east elevation, the hipped portion of the clay tile roof is visible from the north, and the detailed wood cornice continues below the roof line to abut the taller wall behind. Here the roof steps up to the flat roof beyond. Above 36 Soledad Street and towards the rear of the facade, is a partially visible opening which may serve as a door to the adjacent roof.

Figure 2.3 Front of north facade as seen from Soledad Street, 38 Soledad Street looking southwest, TEF Design, 2024.

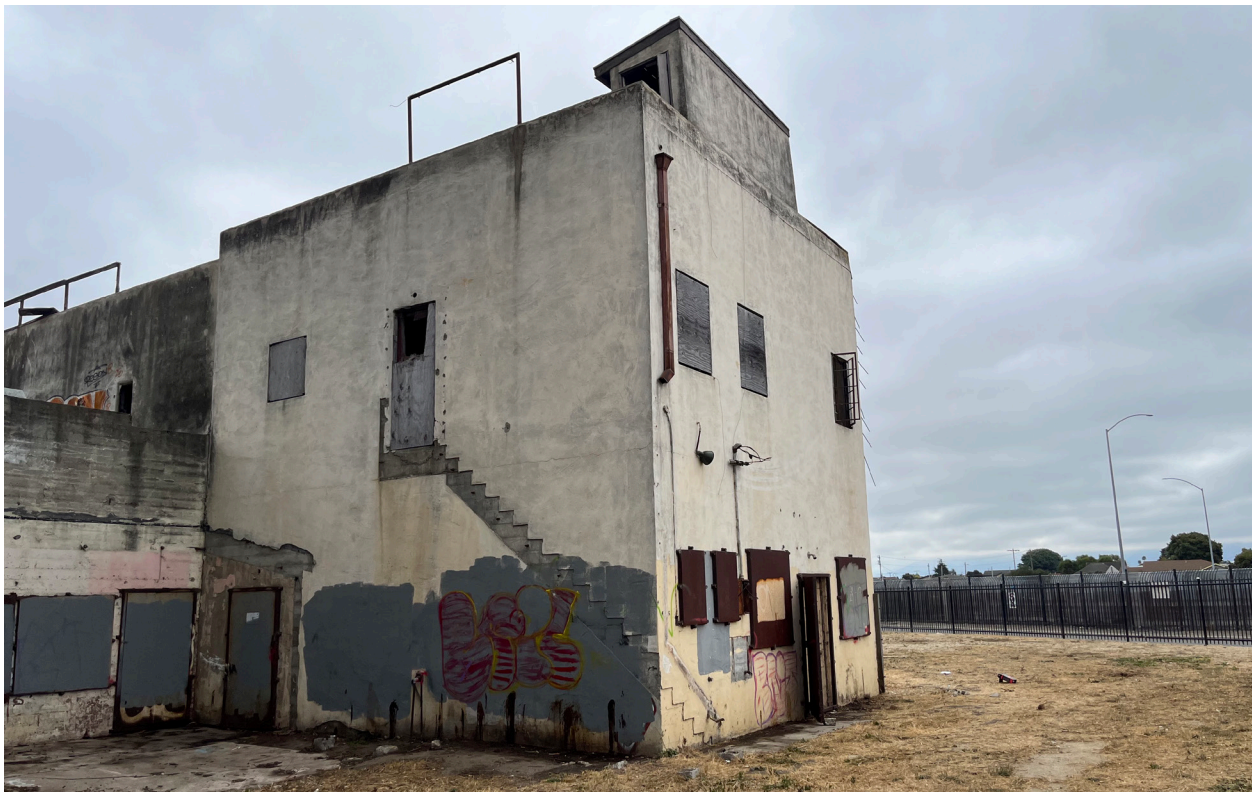
The back portion of the facade steps up at the roof line where it aligns with the rear of 36 Soledad Street and appears to be finished in a different stucco application, possibly indicating an alteration or addition. There is a doorway and square window opening at the second floor that are covered by plywood. This doorway served as a second means of egress from the apartment as evidenced by the ghost outline of an exterior staircase that once led from this door to the rear yard. The staircase descended towards the rear and wrapped around the corner of the building towards the west facade (Figure 2.4). A steel shutter door is located on the first floor and is bolted shut. The stucco around this door is stripped away, revealing concrete behind. Multiple rectangular frames constructed of flat stock steel are mounted to the inside face of the roof parapet wall and project above the roof line. They were used as laundry drying racks for tenants in the second story apartment.<sup>56</sup>

Figure 2.4 Rear of north facade, 38 Soledad Street looking southeast, Groundwork Preservation, LLC, 2024.

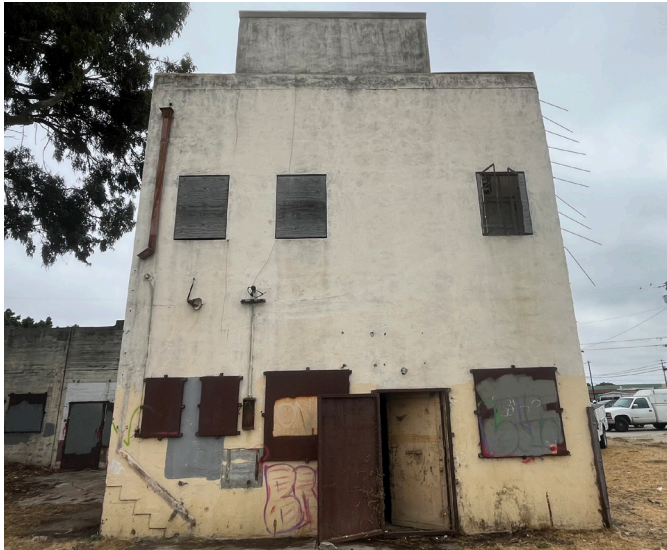
The rear (west) facade (Figure 2.5) faces a small yard and a contemporary metal fence, with a paved alley and industrial yard beyond the fence to the west. The facade is clad in stucco. The ground floor contains one door opening, located in the approximate center of the facade. The door is flanked by two large window openings, with two smaller window openings located to the left side of the facade. All of the openings are obscured by industrial steel shutters bolted directly to the building. From the interior, the two larger rectangular windows are visible and are steel sash like those on the primary facade. The second story contains three rectangular windows: two multi-paned wood-frame double hung windows located on the left side, and a steel sash casement window on the south side that is missing its glazing. Above, at the east end of the parapet wall, a metal conductor head and associated discontinuous downspout sit below a metal through wall scupper. Centered in the facade, a small rooftop penthouse with a shed roof projects beyond the parapet wall. It is clad in stucco with wood fascia boards at the roof line. The penthouse contains a north-facing exterior doorway that is visible from the ground (visible in Figure 2.4).

Figure 2.5 West facade of 38 Soledad Street looking east, Groundwork Preservation, LLC, 2024.

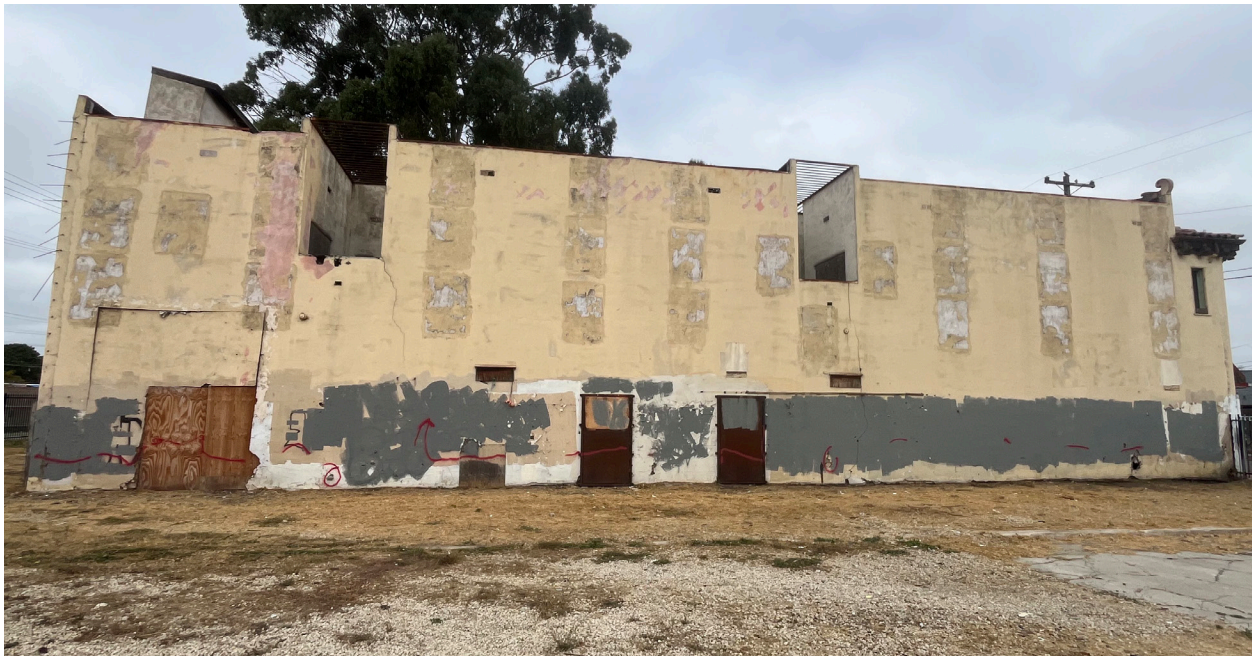
The south facade (Figure 2.6) faces an empty lot that extends to Market Way. The facade is clad in stucco. Photos from 2007 indicate that the facade originally did not have any openings on the ground floor; only one window at the second floor and the two large lightwell openings previously described. Today, two non-historic industrial steel shutter doors are located in the center of the facade on the ground floor and are bolted shut. Two small, narrow, horizontal openings are located above and to either side of these doors, both covered in plywood and with a minimal sheet metal awning above. One, apparently original, narrow wood-framed, vertical window frame remains on the second story below the hipped roof and decorative cornice at Soledad Street. The window sash is missing.

One lightwell is located in the approximate center of the facade and one towards the rear of the facade. Both are covered by rusted steel grates overhead. The lightwells appear to be accessible to the second story apartment via multiple door or window openings which are covered by plywood. The central lightwell has one metal multi-pane window on the east wall. Google Maps photographs from Market Way in May 2011 show that the majority of the openings were metal, multi-pane, possibly casement, windows. However, this is difficult to confirm due to the quality of the photographs and the distance at which they were taken from the subject property.<sup>57</sup> It is unknown if any of this fenestration is still present beneath the plywood. The two lightwells have a portion of flat roof that are likely occupiable. These roofs appear to drain via through-wall metal scuppers in the parapet wall of the lightwell on the east facade.

Observation of the exterior facades indicates that the flat roof at least partially drains via oversized holes cut through the parapet wall on the south facade and at walls facing the lightwells. Some of these appear to have a metal louver installed over them; the majority do not. It is possible these holes were added later in the life of the building to serve as ad-hoc overflow scuppers or may serve as the primary method for drainage. There is no sign of drainage lines or outlets at the interior of the building or the base of exterior walls to indicate the use of interior drain lines.

Figure 2.6 South facade of 38 Soledad Street looking north, note lightwells at roofline, Groundwork Preservation, LLC, 2024.

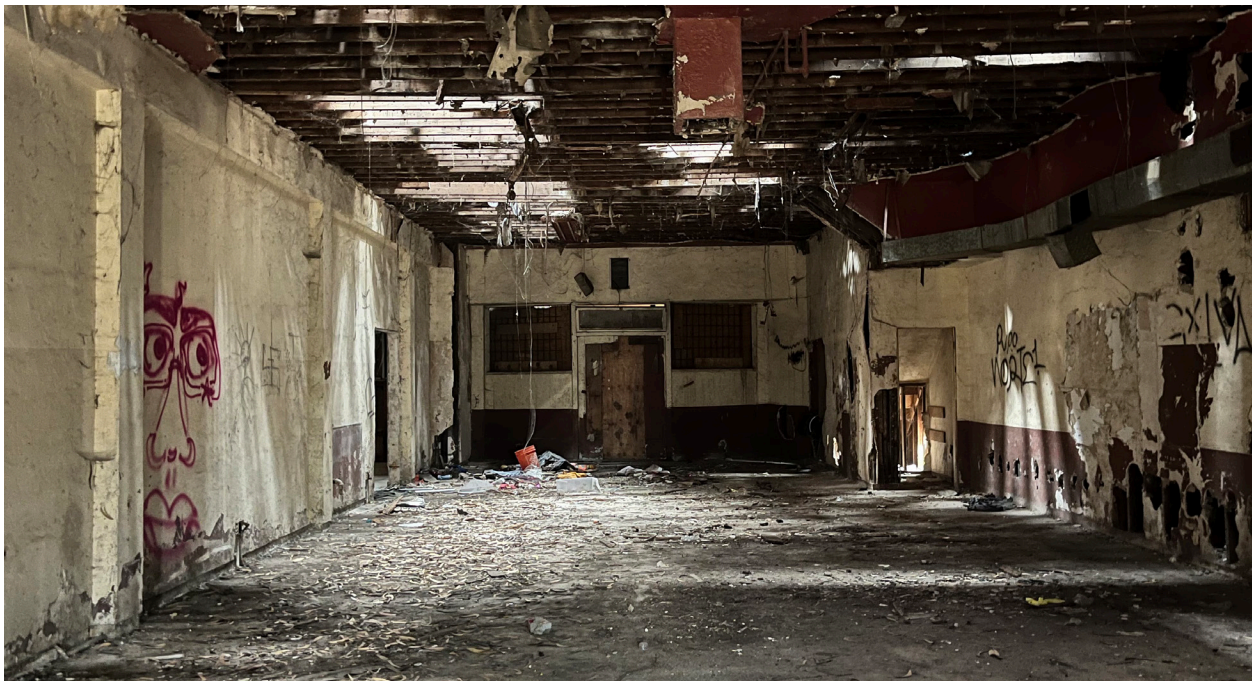
The interior of the subject property is in poor condition and has been vacant for over forty years. The ground floor (Figure 2.7) is primarily a large rectangular room that contains a storefront at the east end (Figure 2.8), a small bathroom at the northwest corner, and an interior stairway to the second floor located at the southeast corner. Underneath the stairwell is a storage closet. The rear entrance is located at the west side of the building (Figure 2.9). The floor is composed of concrete and the interior walls are clad with plaster and gypsum board on the ground floor. Portions of the second-floor framing are fully visible from the ground floor where the ceiling has deteriorated and fallen. An opening on the north interior wall provides access between the subject building and 36 Soledad Street to the north. A series of concrete pilasters with a continuous beam above articulate bays along the north interior wall. A metal HVAC vent runs along the top of the south interior wall and a large HVAC unit and portion of ducting has fallen to the ground on the west side of the south wall.

Figure 2.7 38 Soledad Street, ground floor interior looking east towards storefront, Groundwork Preservation, LLC, 2024.

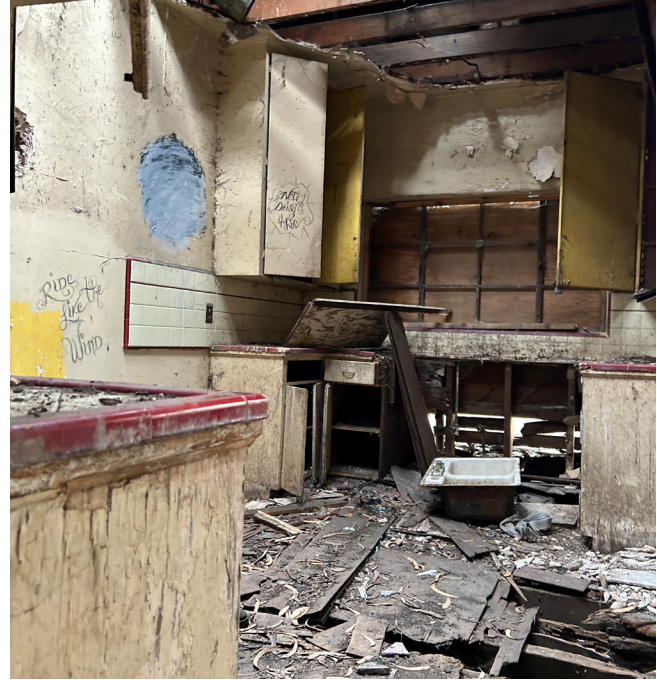
Figure 2.11 38 Soledad Street, second floor interior, view from stair landing looking towards kitchen, City of Salinas, 2024.

The majority of the second floor is inaccessible due to a lack of structural integrity; however, limited visibility from the stairway landing provides some insight into the condition (Figure 2.10). Several rooms are visible, including a kitchen with many of the wood cabinets and tile backsplash extant but in extremely poor condition (Figure 2.11), a winding hallway, and at least two rooms. The floor and ceiling finish appears to have been plaster and some floors may have been wood. Historic accounts state that the second floor contained a kitchen, living room, den, five bedrooms, and two full bathrooms. Additionally, there was access to the roof from the second floor where tenants dried their laundry on the metal drying racks visible at the north façade. It is also possible that doorways in the lightwells provided exterior access between different rooms on the second floor, although this can't be confirmed. Much of the plaster finish has deteriorated from water damage, revealing the wood wall framing behind. Portions of the roof are severely damaged and/or have failed. The building also experienced a fire in the second-floor apartment in 2018 that caused an unknown amount of damage.<sup>58</sup>

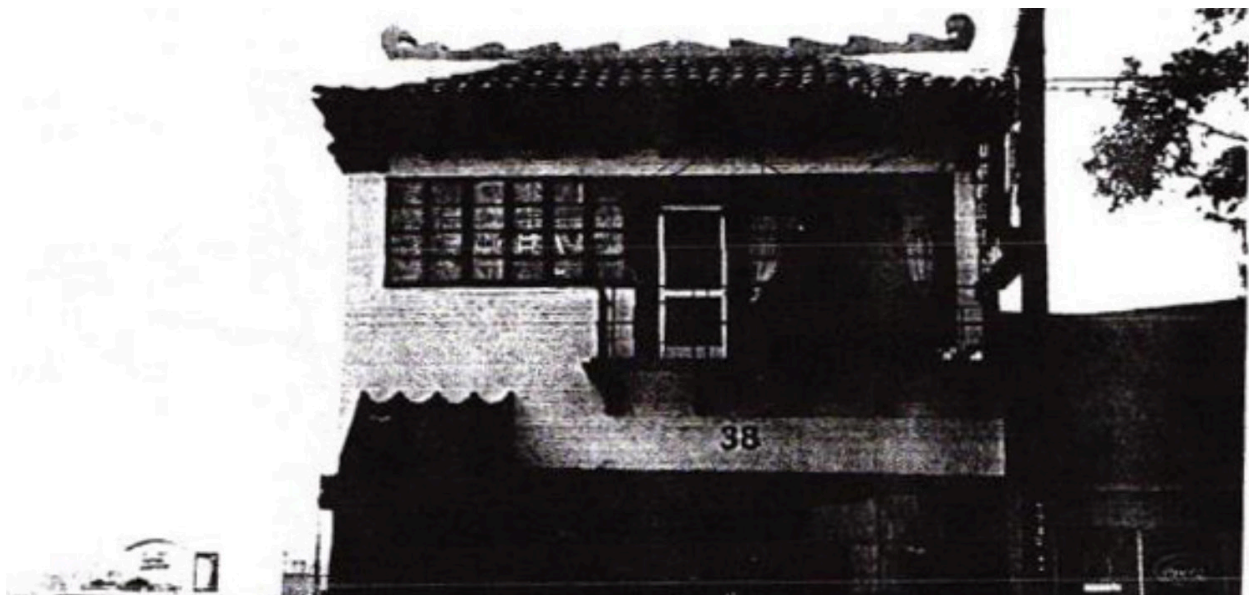
Figure 2.12 38 Soledad Street, 1985, Monterey County Historical Society, "Department of Parks and Recreation 523 Form for Arre's Pool Hall," 1.

38 Soledad Street featured prominent Chinese architectural detailing, characterized by the hipped tile roof, extended and upturned projecting eaves, decorative wave motif parapet cap, projecting balcony, and railing on the second story balcony with Chinese design motifs (Figure 2.12). The design also incorporates elements from Art Moderne, including the flat roof, stucco exterior finish, window bands that create horizontal emphasis, and entryway walls angled inwards toward the door.

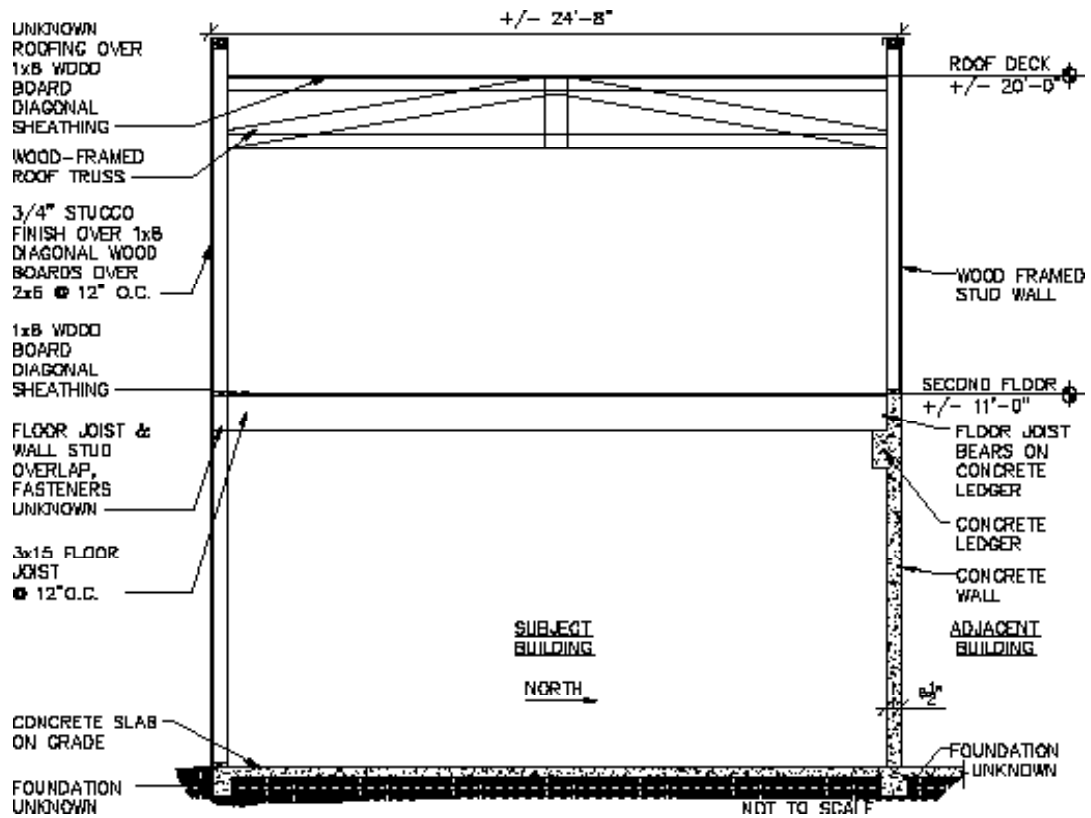
Figure 4.1 Sketch of typical building section looking westward, Howard Carter Associates, Inc, 2024.

The building at 38 Soledad Street is a two-story wood and concrete structure, (approximately 25ft x 100ft), thought to have been built around 1948 (Figure 4.1). The ground floor is a large, open space built on a concrete slab on grade. There is a staircase at the east and a bathroom at the west. The east, west, and north walls of the building are constructed of concrete. The south wall of the building is wood framed. The second floor and the roof are framed with wood members that span across the short dimension of the building, the north/south direction. The upper floor has a smaller enclosed plan area than the first floor because it has two small lightwells that may provide patios for the upstairs apartment. The front of the building has a balcony that projects out from the building and appears to be built out of concrete with large wood corbels underneath. The balcony has a decorative steel railing and is protected by a projecting hipped clay tile roof with decorative wood cornice below. Behind the balcony's projecting roof is a parapet wall that is topped with a wave shaped metal cap. The other three sides of the building also have parapet walls with scuppers for roof drainage. The exterior of the building has a stucco finish on all sides.

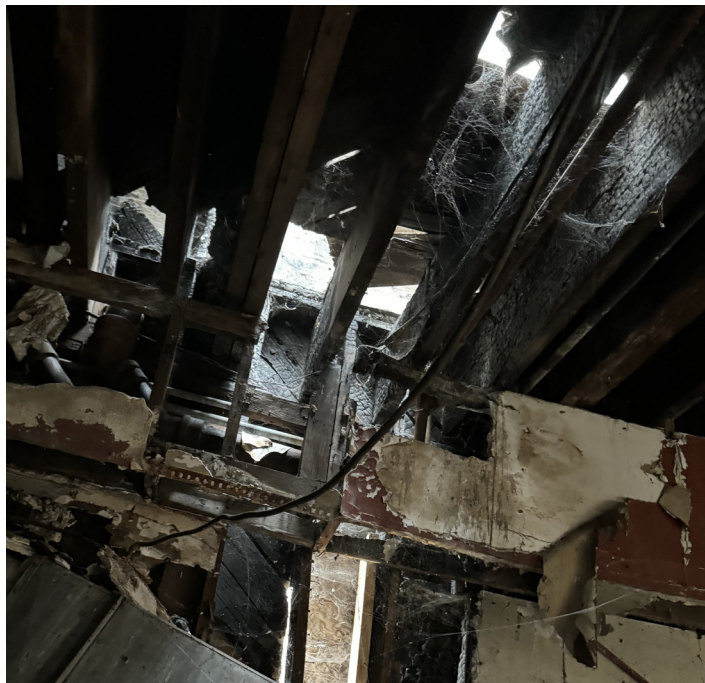
Figure 4.3 Photo of wood floor joist connection to wood wall framing at the south wall, Howard Carter Associates, Inc, 2024.

The exterior wall on the south side of the building consists of 2x6 wall studs @ 12" on center on both the upper and lower levels. The wall studs are approximately 11' tall on the lower level and 9' tall on the upper level. The connection of the lower-level wall base to the slab was not visible. The connection at the second floor consisted of the wall studs being directly fastened to the floor joists (Figure 4.3). The upper-level walls were built on top of the second-floor framing. The connection at the roof consists of the

upper-level wall studs fastened directly to the roof framing. The wood species of the wall studs is unknown. The exterior wall sheathing consists of 1x8 boards installed diagonally. None of the fasteners in the connections were visible. There is extensive damage to the wall studs at the west side of the south wall due to an earlier fire. There are multiple studs that do not have drywall on the inside. There are locations where the wall studs are no longer fully braced in the weak axis (parallel to the wall plane) direction due to damaged exterior sheathing and stucco. This could cause the studs to buckle.

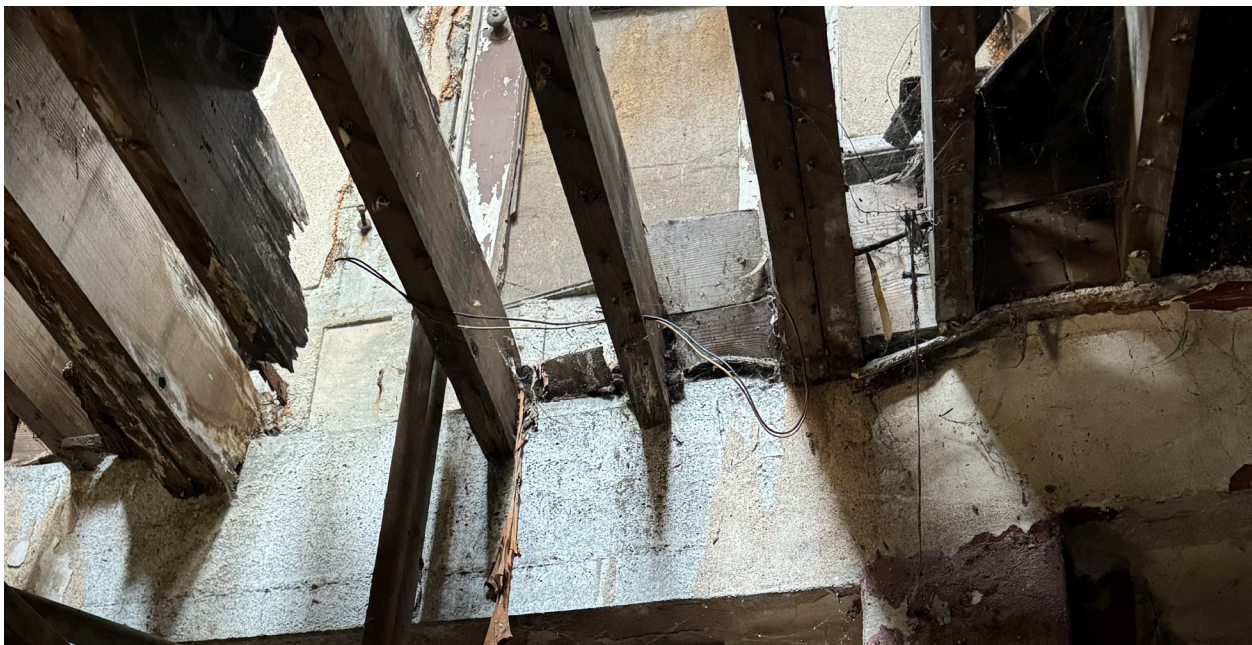
The north wall is constructed of concrete; a portion of it is shared with the adjacent building. The concrete wall is 6 1/2" thick and has multiple piers (columns that are integral but project out from the wall and appear as pilasters). The wall and pier reinforcement are unknown, as well as the compressive strength of the concrete. There is a wide doorway in the concrete wall to access the adjacent building. The foundation under this wall is unknown. The concrete wall has an integral ledger directly below the floor level to support the floor joists (Figure 4.4).

Figure 4.4 Photo of wood floor joist connection to concrete ledger at the north wall, Howard Carter Associates, Inc, 2024.

The floor joists show extensive fire damage at some locations. Several of the joists are no longer bearing on the concrete ledger and are hanging unsupported. There are large regions of the floor with missing sheathing. There is also evidence of water exposure due to fire damage at the exterior walls and large portions of missing roofing.

Structural calculations show that the vertical load capacity of the second-floor joists and wall studs would be adequate for the loads specified by current code if the wood members were undamaged by fire and weather. However, the actual strength of the floor framing is unknown. Visual observation from a distance is inadequate to determine the reduced structural capacity of the wood. It is estimated that approximately 50% of the floor joists will require replacement due to fire or weather damage.

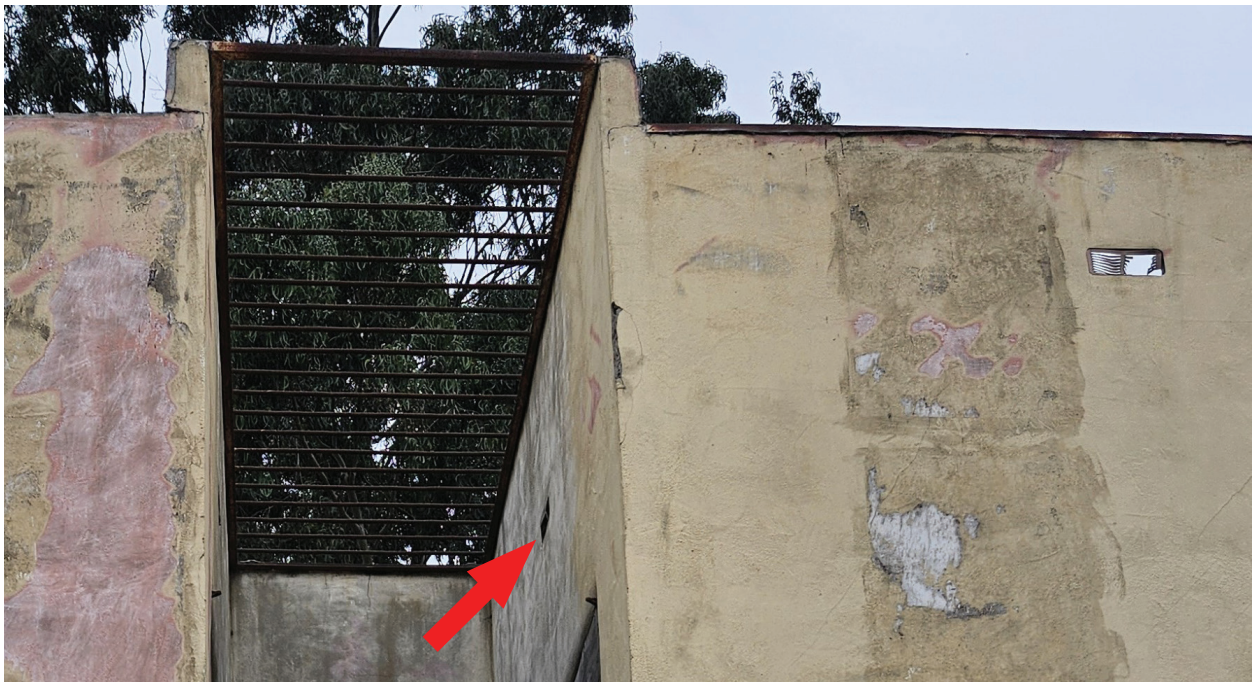
Figure 5.4 The metal through wall scupper seen here serves as drainage to the deck of the lightwell, typical of both lightwells, TEF Design, 2024.

- The condition of the scupper above the clay tile roof on the east facade is unknown (Figure 5.6).
- The parapet caps applied at the north, south and west parapet walls of the roof and at the lightwell east parapet walls are rusted and missing or detached in many locations. It is unclear if the cap is sloped to drain towards the roof (Figure 5.4).

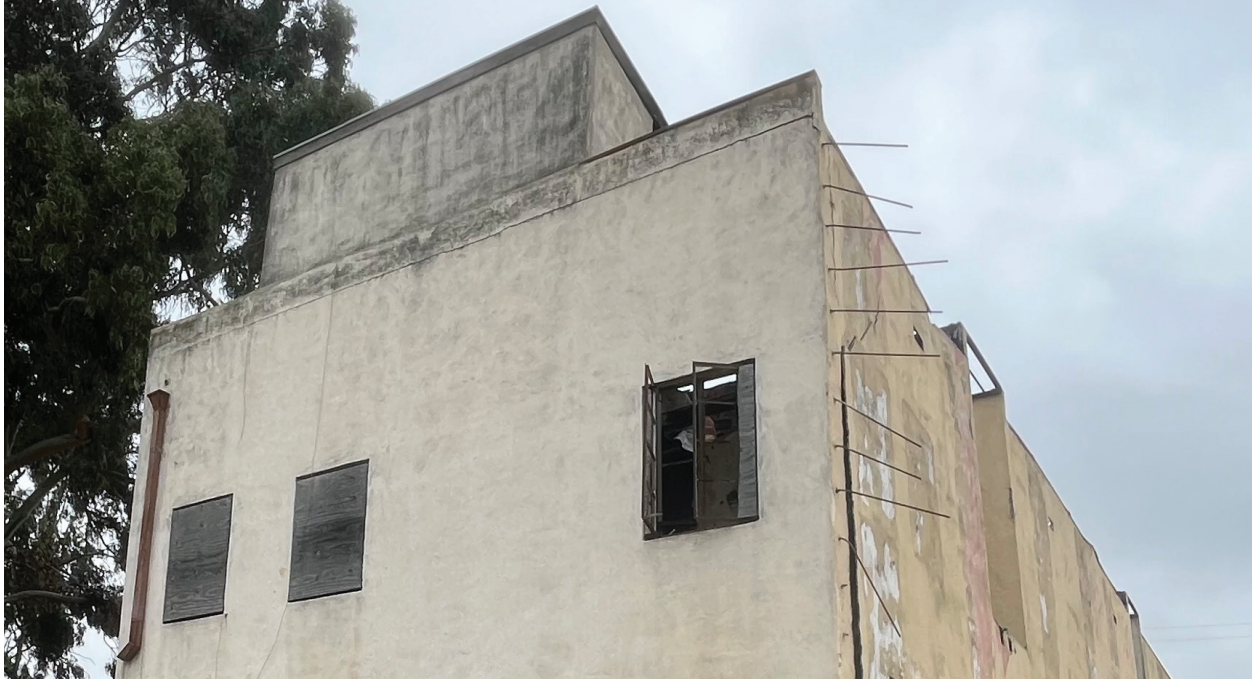
Figure 5.5 Oblique view of the upper portion of the west facade, Groundwork Preservation, LLC, 2024.

- The conductor head and downspout at the west façade are rusted and the downspout is incomplete. With no evidence of water staining below the downspout, it is likely that the scupper is clogged (Figure 5.5).

- The roof at the south penthouse structure is likely a simple rolled asphalt roof with metal edge trim. Although inaccessible, it is very likely in extremely poor condition (Figure 5.5).

- Various defunct light fixtures and wall mounted wiring remain.
- The wall is graffitied and there are numerous holes at locations of previous attachments (Figure 5.14).
- At the parapet wall above and at the wall of the penthouse above, the stucco is particularly dirty (Figure 5.5).
- The steel shutters installed over windows and doors on this facade are attached directly to the concrete walls and will leave additional holes when removed.
- At the north side of the west facade, holes at consistent intervals run vertically along the façade height. They appear to be reinforcement rebar of the north wall that have been cut or ground off.

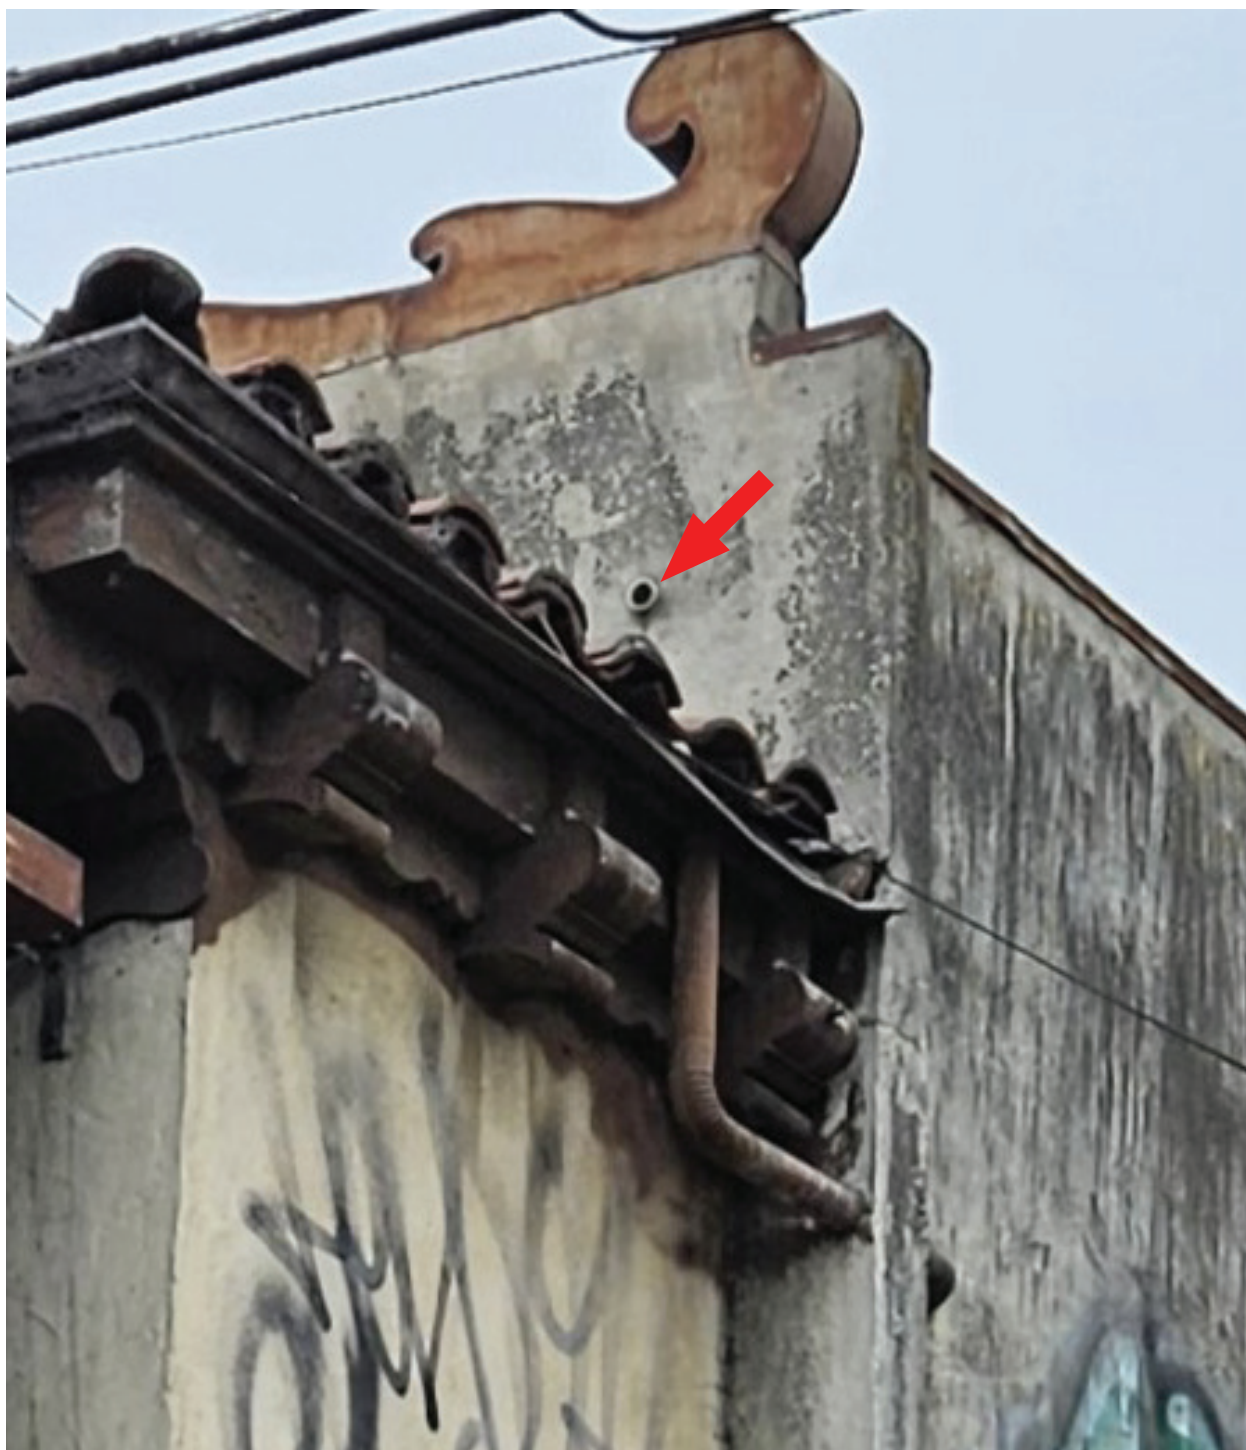
Figure 5.6 A small, round through wall metal scupper presumably drains water from the main roof to the hipped clay tile roof at the east facade, TEF Design, 2024.

- The hipped, barrel, clay tile roof at the east facade appears to be in poor condition (Figure 5.7). A number of tiles are missing from the east facing eave and the tiles are generally excessively dirty. At the southern hipped portion, tiles appear to have shifted. Many tiles may be loose or broken and require further inspection.
- A large portion of the k-style custom profile copper gutter serving the clay tile roof is missing at the east eave. The edge of the gutter is bent down in several locations and the entirety of the gutters are blocked, with many plants growing (Figure 5.7). Round metal downspouts at the north and south hipped eaves are rusted, (the south pipe having a large hole) and both return into the building (Figures 5.6 and 5.8).

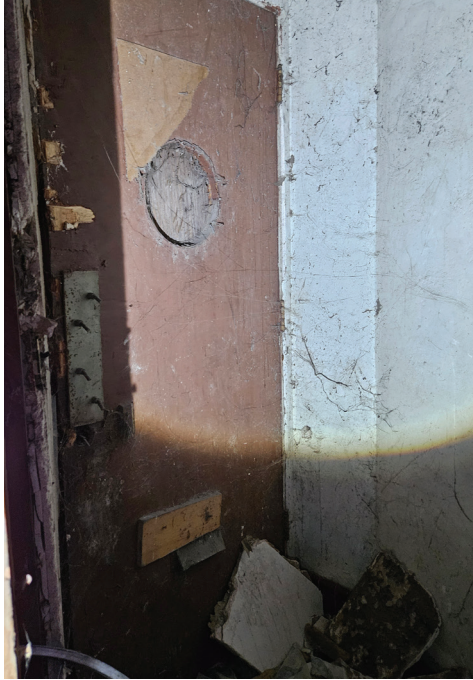
Figure 5.9 View of primary residential entry door at the east facade, TEF Design, 2024.

- The single flush wood door is in fair condition. The circular window is missing (Figure 5.9).
- The metal panel marquee is in fair condition.
- The wood storefront is generally in poor condition. The primary wood frame components may be salvageable, and the hopper window is still intact. Both leaves of the doors appear to have been cut through, with the abutting stiles and portions of the rails at each leaf missing. The storefront windows appear to be entirely removed (Figure 5.10).
- Paint has failed on the majority of wood components on the building and the wood appears weathered. The brackets below the balcony, in particular, are in poor shape. One bracket hangs off the building haphazardly and presents a fall risk to the public (Figure 5.11).
- The decorative metal railing at the balcony is weathered but in fair shape. It is approximately 32 inches high (Figure 5.12).

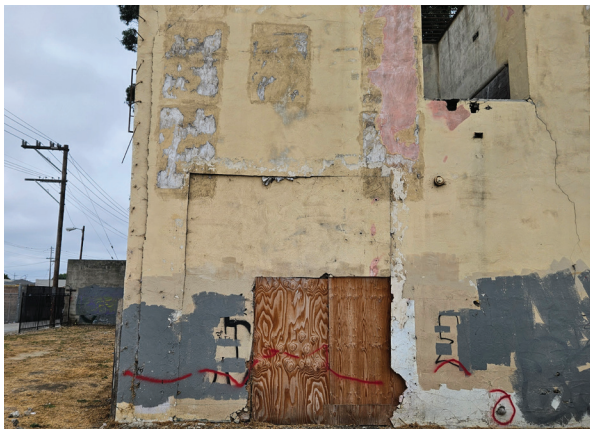
Figure 5.17 Close up view of boarded opening at the west end of the south facade, TEF Design, 2024.

- An area of wall roughly 10 feet wide by 10 feet tall has been cut through, patched, and is not in plane with the rest of the wall (Figure 5.17). In a six foot by six foot area of this cut portion, the stucco and wall sheathing is missing all together and the hole is covered by plywood. The wall framing behind this opening has also been removed (Figure 5.18). Given that a fire occurred in this area of the building in 2018, this opening was possibly made by the Fire Department in gaining access to the building.

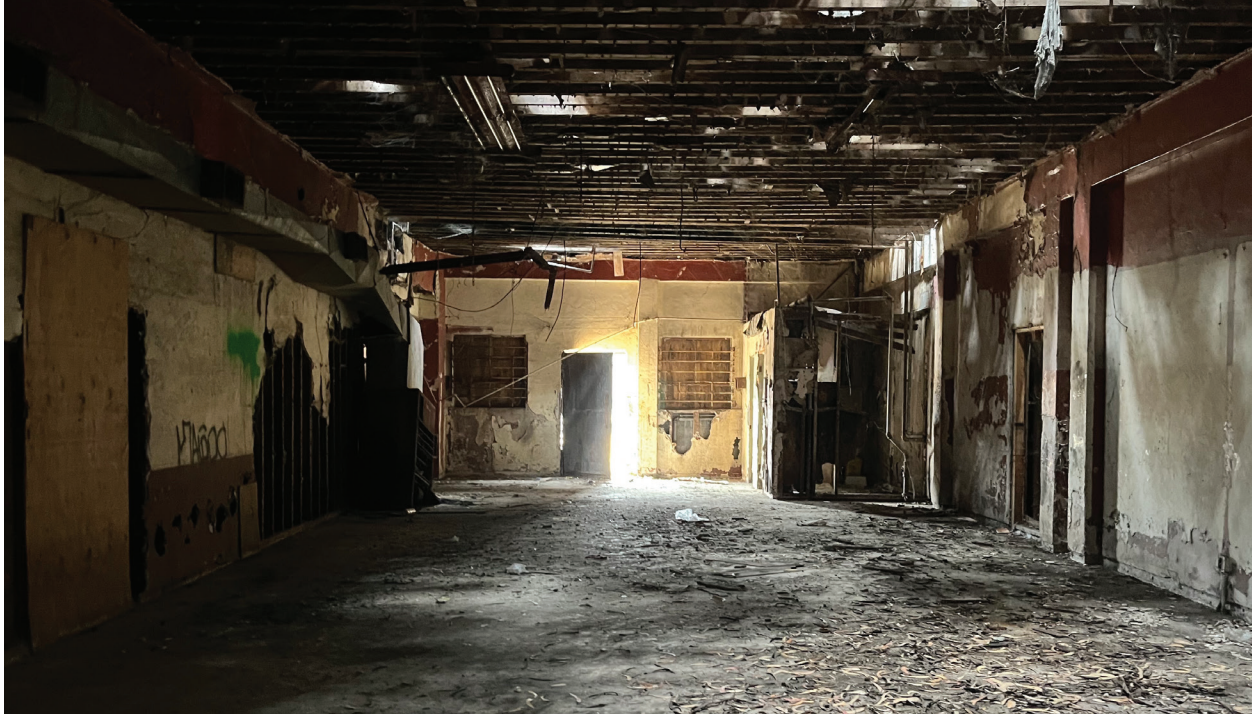
Figure 5.22 View of ground floor interior looking west, Groundwork Preservation, LLC, 2024.

- The floor is strewn with dirt, leaves, ceiling finish that has failed and fallen, and trash (Figure 5.21).
- The ceiling finish has deteriorated almost entirely and fallen from the ceiling. Some light fixtures and appurtenances remain attached to the underside of the wood floor framing (Figure 5.22).
- A remaining HVAC duct and unit along the south wall is not secure and hanging unsupported (Figure 5.18).
- Gypsum board along the south wall has been damaged (Figure 5.23).
- The stair to the second floor is in poor shape and inaccessible due to decay and a lack of structural integrity (Figure 5.24). There are multiple floor joists at the stair landing that are damaged and/or are no longer bearing on a ledger, and there is a significant quantity of missing floor sheathing.
