This report presents the results of our Closed-Circuit Television (CCTV) inspections performed to address the conditions of sanitary sewer mains and manholes in various locations throughout the City of Salinas. The CCTV inspections were conducted on large diameter sewer mains ranging from 12" to 30" diameter pipes and were completed using Pipeline Assessment Certification Program (PACP) standards.

The City of Salinas retained Mark Thomas to inspect and analyze the condition of approximately 5,300 linear feet of sanitary sewer mains and 23 manhole structures.

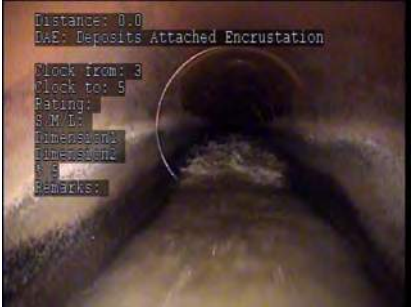
| Distance | Length | Code | Reversed | Clock Pos. | Severity | Rating | Category | Comment |
|---|---|---|---|---|---|---|---|---|
| 0.0 | | DAE | No | 3 / 5 | | | O&M | |

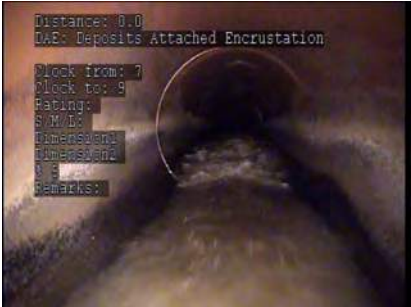
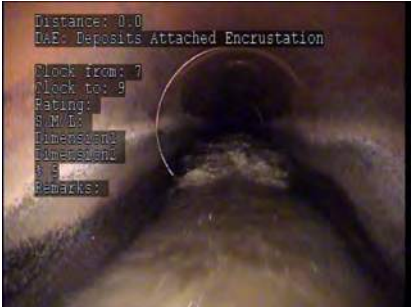
| Distance | Length | Code | Reversed | Clock Pos. | Severity | Rating | Category | Comment |
|---|---|---|---|---|---|---|---|---|
| 0.0 | | DAE | No | 7 / 9 | | | O&M | |

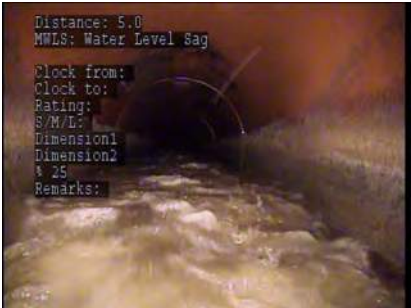
| Distance | Length | Code | Reversed | Clock Pos. | Severity | Rating | Category | Comment |
|---|---|---|---|---|---|---|---|---|
| 5.0 | | MWLS | No | / | | | Structural | |

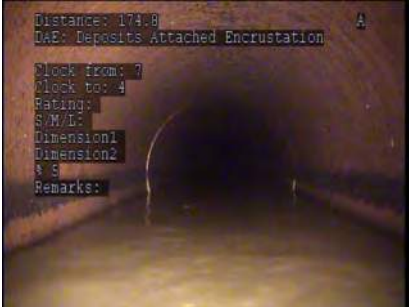
| Distance | Length | Code | Reversed | Clock Pos. | Severity | Rating | Category | Comment |
|---|---|---|---|---|---|---|---|---|
| 174.8 | | DAE | No | 7 / 4 | | | O&M | |

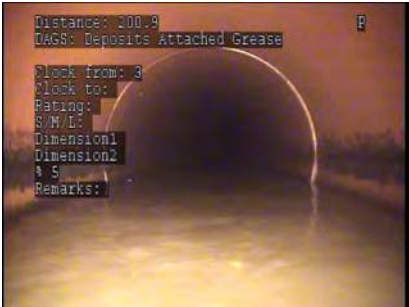
| Distance | Length | Code | Reversed | Clock Pos. | Severity | Rating | Category | Comment |
|---|---|---|---|---|---|---|---|---|
| 200.9 | | DAGS | No | 3 / | | | O&M | |

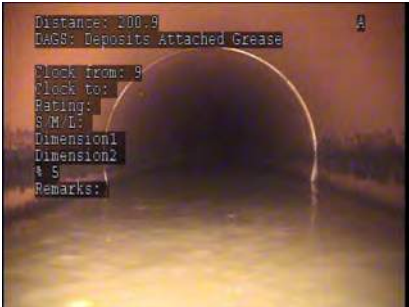
| Distance | Length | Code | Reversed | Clock Pos. | Severity | Rating | Category | Comment |
|---|---|---|---|---|---|---|---|---|
| 200.9 | | DAGS | No | 9 / | | | O&M | |

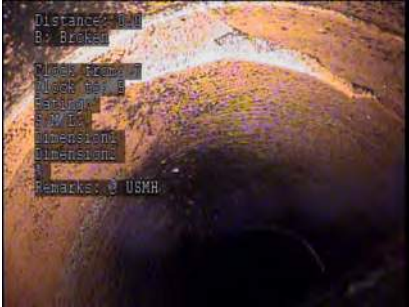
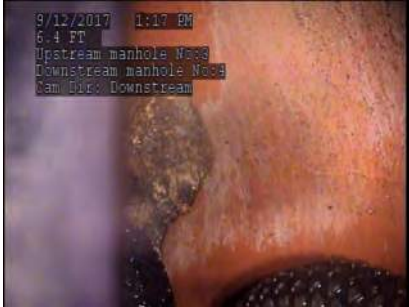
| Distance | Length | Code | Reversed | Clock Pos. | Severity | Rating | Category | Comment |
|---|---|---|---|---|---|---|---|---|
| 0.0 | B | | No | 7 / 5 | | | Structural | @ USMH |

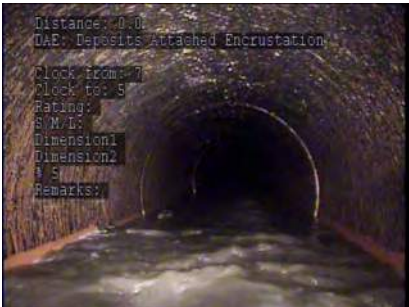
| Distance | Length | Code | Reversed | Clock Pos. | Severity | Rating | Category | Comment |
|---|---|---|---|---|---|---|---|---|
| 0.0 | DAE | | No | 7 / 5 | | | O&M | |

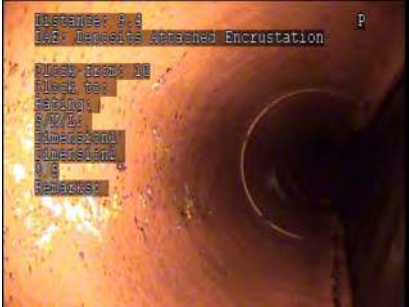
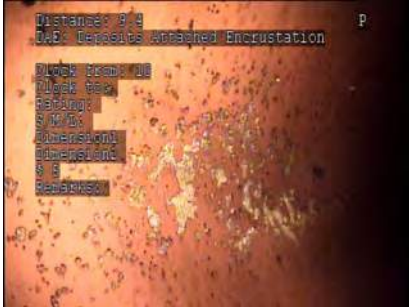
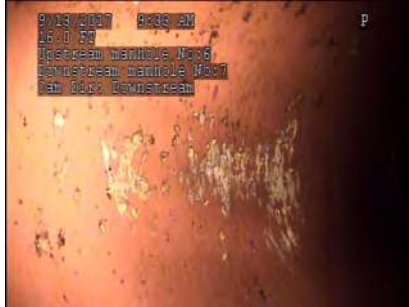
| Distance | Length | Code | Reversed | Clock Pos. | Severity | Rating | Category | Comment |
|---|---|---|---|---|---|---|---|---|
| 9.4 | | DAE | No | 10 / | | | O&M | |

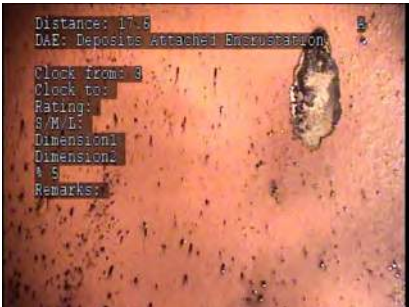
| Distance | Length | Code | Reversed | Clock Pos. | Severity | Rating | Category | Comment |
|---|---|---|---|---|---|---|---|---|
| 17.6 | | DAE | No | 3 / | | | O&M | |

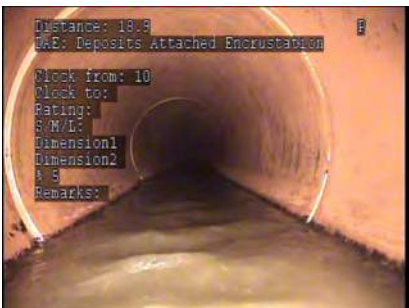
| Distance | Length | Code | Reversed | Clock Pos. | Severity | Rating | Category | Comment |
|---|---|---|---|---|---|---|---|---|
| 18.9 | | DAE | No | 10 / | | | O&M | |

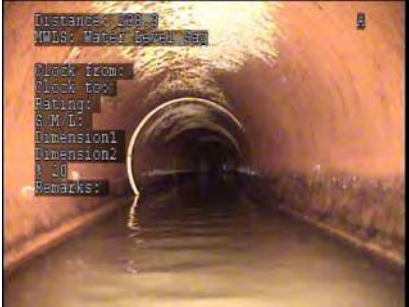
| Distance | Length | Code | Reversed | Clock Pos. | Severity | Rating | Category | Comment |
|---|---|---|---|---|---|---|---|---|
| 238.3 | | MWLS | No | / | | | Structural | |

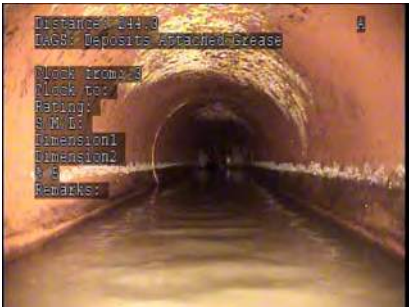
| Distance | Length | Code | Reversed | Clock Pos. | Severity | Rating | Category | Comment |
|---|---|---|---|---|---|---|---|---|
| 244.3 | | DAGS | No | 3 / | | | O&M | |

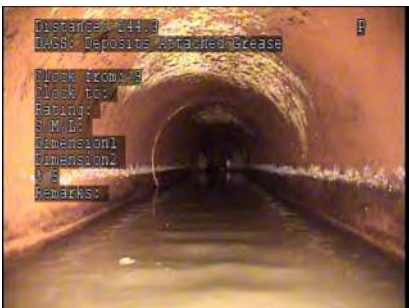
| Distance | Length | Code | Reversed | Clock Pos. | Severity | Rating | Category | Comment |
|---|---|---|---|---|---|---|---|---|
| 244.3 | | DAGS | No | 9 / | | | O&M | |

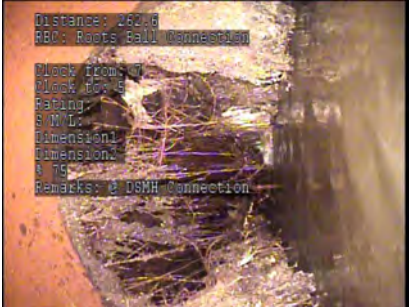
| Distance | Length | Code | Reversed | Clock Pos. | Severity | Rating | Category | Comment |
|---|---|---|---|---|---|---|---|---|
| 261.0 | | RBC | No | 7 / 5 | | | O&M | @ DSMH Connection |

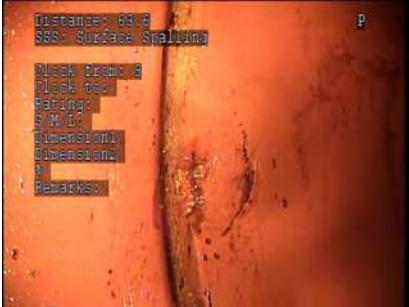
| Distance | Length | Code | Reversed | Clock Pos. | Severity | Rating | Category | Comment |
|---|---|---|---|---|---|---|---|---|
| 63.6 | | SSS | No | 9 / | | | Structural | |

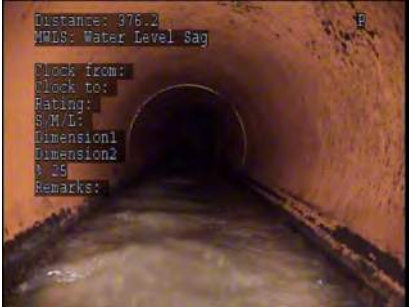
| Distance | Length | Code | Reversed | Clock Pos. | Severity | Rating | Category | Comment |
|---|---|---|---|---|---|---|---|---|
| 376.2 | | MWLS | No | / | | | Structural | |

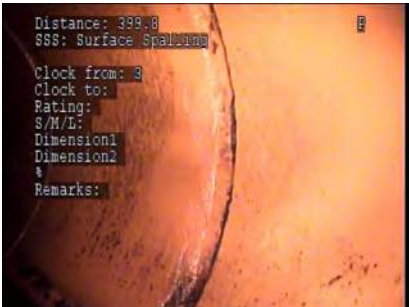
| Distance | Length | Code | Reversed | Clock Pos. | Severity | Rating | Category | Comment |
|---|---|---|---|---|---|---|---|---|
| 399.8 | | SSS | No | 3 / | | | Structural | |

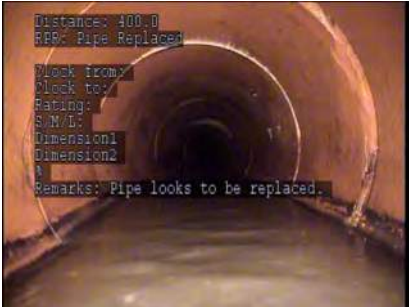
| Distance | Length | Code | Reversed | Clock Pos. | Severity | Rating | Category | Comment |
|---|---|---|---|---|---|---|---|---|
| 400.0 | | RPR | No | / | | | | Pipe looks to be replaced. |

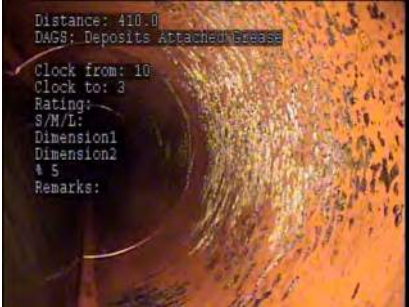
| Distance | Length | Code | Reversed | Clock Pos. | Severity | Rating | Category | Comment |
|---|---|---|---|---|---|---|---|---|
| 410.0 | | DAGS | No | 10 / 3 | | | O&M | |

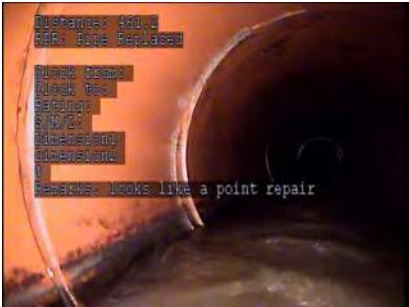
| Distance | Length | Code | Reversed | Clock Pos. | Severity | Rating | Category | Comment |
|---|---|---|---|---|---|---|---|---|
| 461.2 | | RPR | No | / | | | | looks like a point repair |

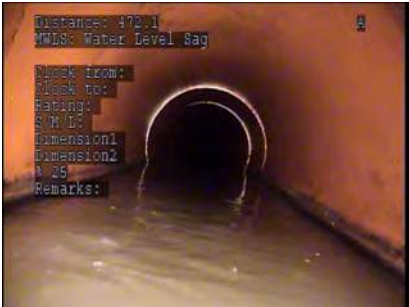
| Distance | Length | Code | Reversed | Clock Pos. | Severity | Rating | Category | Comment |
|---|---|---|---|---|---|---|---|---|
| 472.1 | | MWLS | No | / | | | Structural | |

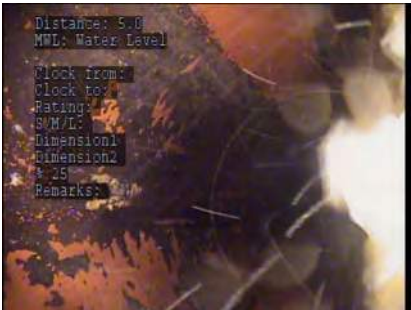
| Distance | Length | Code | Reversed | Clock Pos. | Severity | Rating | Category | Comment |
|---|---|---|---|---|---|---|---|---|
| 5.0 | | MWL | No | / | | | | |

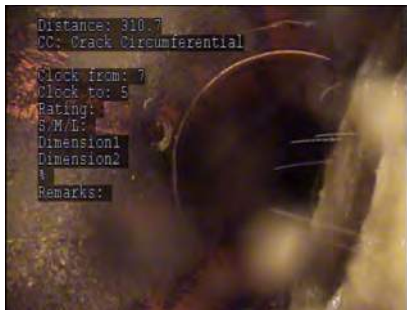
| Distance | Length | Code | Reversed | Clock Pos. | Severity | Rating | Category | Comment |
|---|---|---|---|---|---|---|---|---|
| 310.7 | CM | | No | 7 / 5 | | | Structural | |

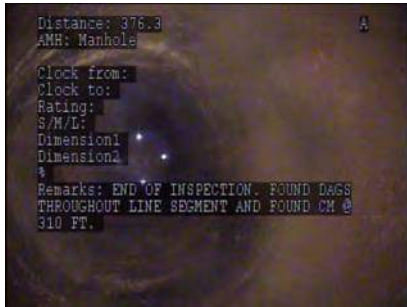
| Distance | Length | Code | Reversed | Clock Pos. | Severity | Rating | Category | Comment |
|---|---|---|---|---|---|---|---|---|
| 376.3 | | AMH | No | / | | | | END OF INSPECTION.<br>FOUND DAGS<br>THROUGHOUT LINE<br>SEGMENT AND FOUND<br>CM @ 310 FT. |

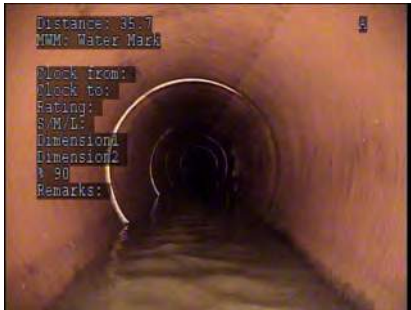
| Distance | Length | Code | Reversed | Clock Pos. | Severity | Rating | Category | Comment |
|---|---|---|---|---|---|---|---|---|
| 35.7 | | MWM | No | / | | | O&M | |

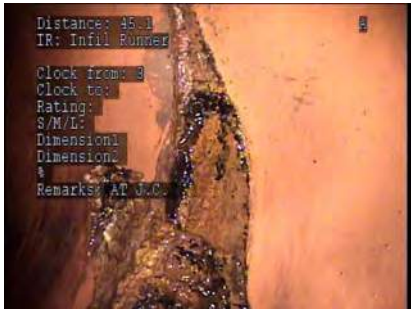
| 45.1 | | IR | No | 3 / | | | O&M | AT J.C. |

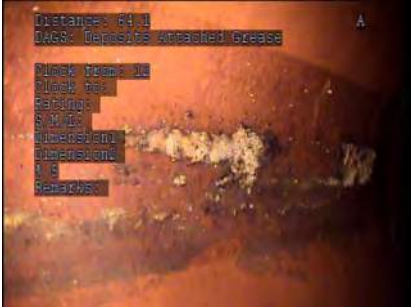
| Distance | Length | Code | Reversed | Clock Pos. | Severity | Rating | Category | Comment |
|---|---|---|---|---|---|---|---|---|
| 64.1 | | DAGS | No | 12 / | | | O&M | |

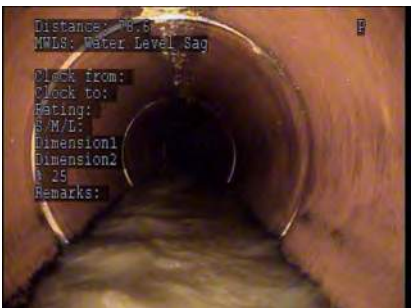
| Distance | Length | Code | Reversed | Clock Pos. | Severity | Rating | Category | Comment |
|---|---|---|---|---|---|---|---|---|
| 78.6 | | MWLS | No | / | | | Structural | |

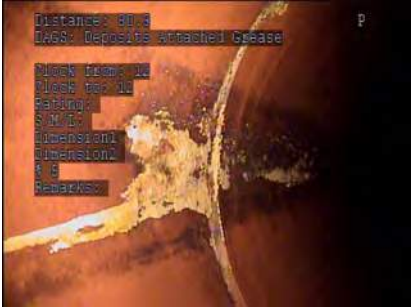
| Distance | Length | Code | Reversed | Clock Pos. | Severity | Rating | Category | Comment |
|---|---|---|---|---|---|---|---|---|
| 80.3 | | DAGS | No | 12 / 12 | | | O&M | |

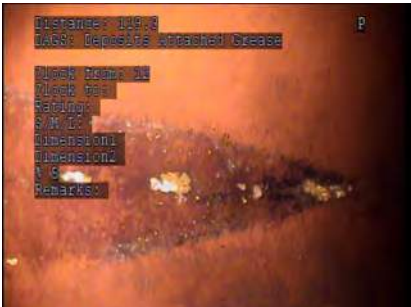
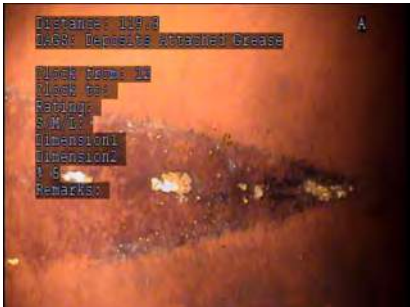
| Distance | Length | Code | Reversed | Clock Pos. | Severity | Rating | Category | Comment |
|---|---|---|---|---|---|---|---|---|
| 119.3 | | DAGS | No | 12 / | | | O&M | |

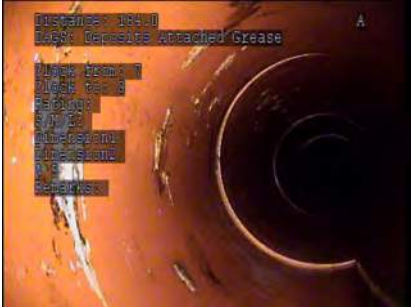
| Distance | Length | Code | Reversed | Clock Pos. | Severity | Rating | Category | Comment |
|---|---|---|---|---|---|---|---|---|
| 184.0 | | DAGS | No | 7 / 3 | | | O&M | |

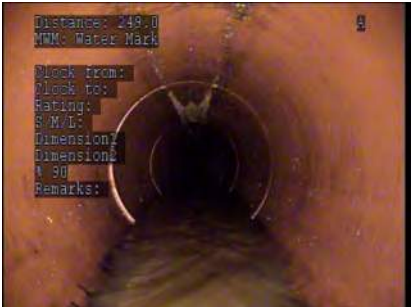
| Distance | Length | Code | Reversed | Clock Pos. | Severity | Rating | Category | Comment |
|---|---|---|---|---|---|---|---|---|
| 249.0 | | MWM | No | / | | | O&M | |

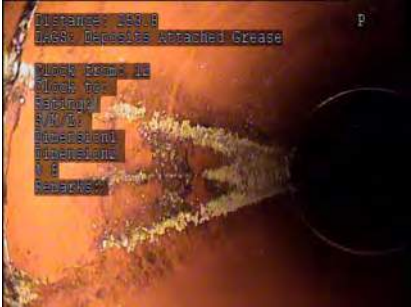
| Distance | Length | Code | Reversed | Clock Pos. | Severity | Rating | Category | Comment |
|---|---|---|---|---|---|---|---|---|
| 253.8 | | DAGS | No | 12 / | | | O&M | |

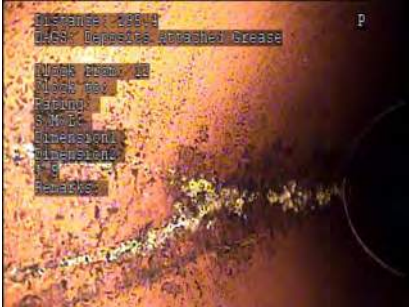
| Distance | Length | Code | Reversed | Clock Pos. | Severity | Rating | Category | Comment |
|---|---|---|---|---|---|---|---|---|
| 295.4 | | DAGS | No | 12 / | | | O&M | |

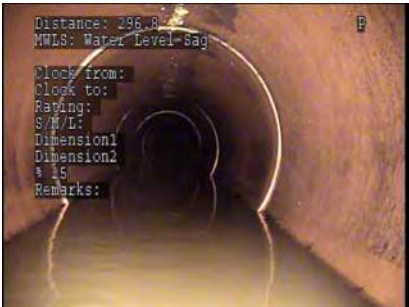
| Distance | Length | Code | Reversed | Clock Pos. | Severity | Rating | Category | Comment |
|---|---|---|---|---|---|---|---|---|
| 296.8 | | MWLS | No | / | | | Structural | |

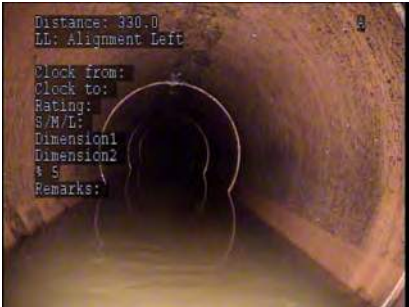
| Distance | Length | Code | Reversed | Clock Pos. | Severity | Rating | Category | Comment |
|---|---|---|---|---|---|---|---|---|
| 330.0 | | LL | No | / | | | O&M | |

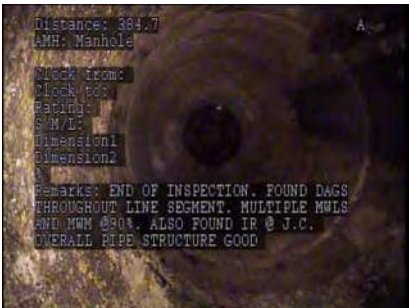
| Distance | Length | Code | Reversed | Clock Pos. | Severity | Rating | Category | Comment |
|---|---|---|---|---|---|---|---|---|
| 384.7 | | AMH | No | / | | | | END OF INSPECTION. FOUND DAGS THROUGHOUT LINE SEGMENT. MULTIPLE MWLS AND MWM @90%. ALSO FOUND IR @ J.C. OVERALL PIPE STRUCTURE GOOD |

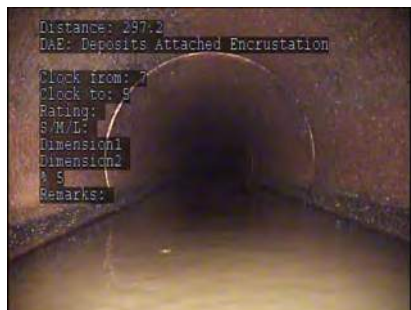
| Distance | Length | Code | Reversed | Clock Pos. | Severity | Rating | Category | Comment |
|---|---|---|---|---|---|---|---|---|
| 297.2 | | DAE | No | 7 / 5 | | | O&M | |

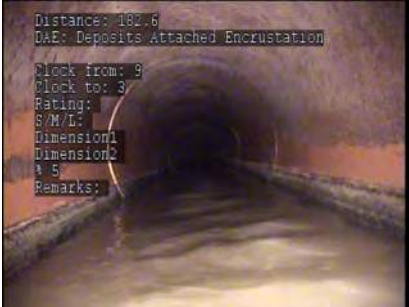
| Distance | Length | Code | Reversed | Clock Pos. | Severity | Rating | Category | Comment |
|---|---|---|---|---|---|---|---|---|
| 182.6 | | DAE | No | 9 / 3 | | | O&M | |

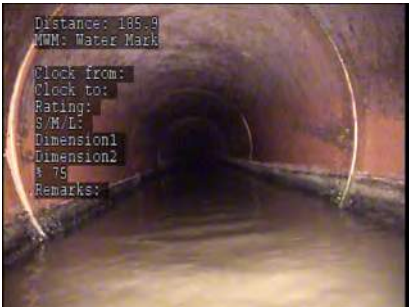
| Distance | Length | Code | Reversed | Clock Pos. | Severity | Rating | Category | Comment |
|---|---|---|---|---|---|---|---|---|
| 185.9 | | MWM | No | / | | | O&M | |

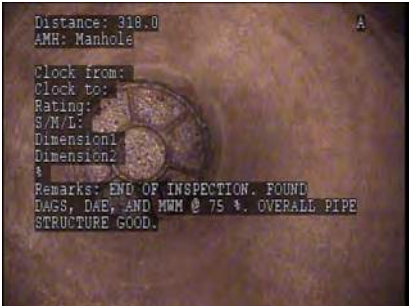
| Distance | Length | Code | Reversed | Clock Pos. | Severity | Rating | Category | Comment |
|---|---|---|---|---|---|---|---|---|
| 318.0 | | AMH | No | / | | | | END OF INSPECTION. FOUND DAGS, DAE, AND MWM @ 75 %. OVERALL PIPE STRUCTURE GOOD. |

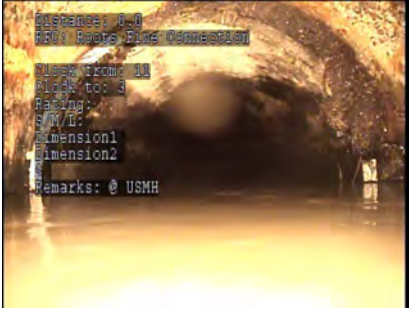
| Distance | Length | Code | Reversed | Clock Pos. | Severity | Rating | Category | Comment |
|---|---|---|---|---|---|---|---|---|
| 0.0 | | RFC | No | 11 / 3 | | | O&M | @ USMH |

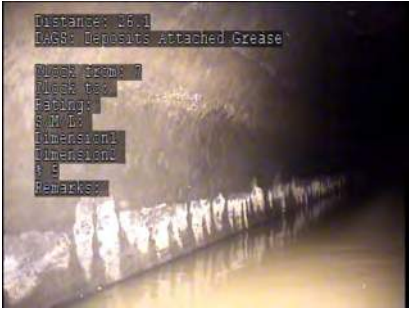
| Distance | Length | Code | Reversed | Clock Pos. | Severity | Rating | Category | Comment |
|---|---|---|---|---|---|---|---|---|
| 26.1 | | DAGS | No | 7 / | | | O&M | |

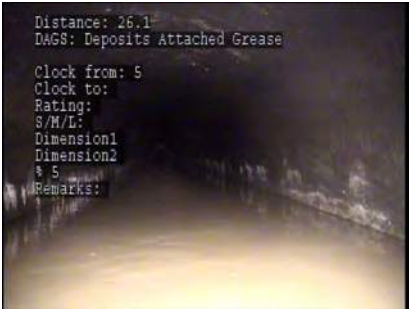
| Distance | Length | Code | Reversed | Clock Pos. | Severity | Rating | Category | Comment |
|---|---|---|---|---|---|---|---|---|
| 26.1 | | DAGS | No | 5 / | | | O&M | |

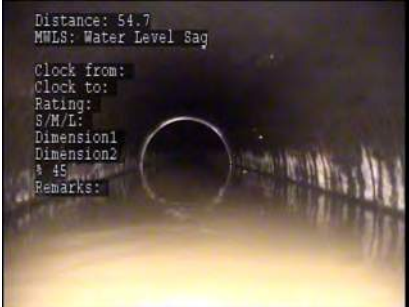
| Distance | Length | Code | Reversed | Clock Pos. | Severity | Rating | Category | Comment |
|---|---|---|---|---|---|---|---|---|
| 54.7 | | MWLS | No | / | | | Structural | |

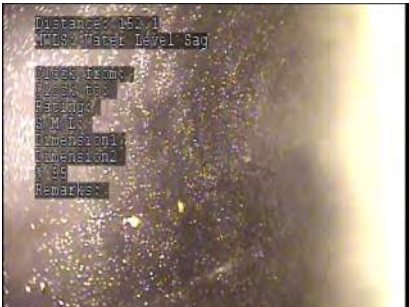
| Distance | Length | Code | Reversed | Clock Pos. | Severity | Rating | Category | Comment |
|---|---|---|---|---|---|---|---|---|
| 152.1 | | MWLS | No | / | | | Structural | |

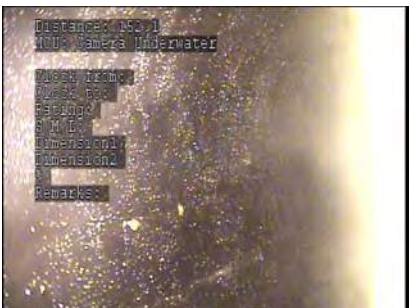
| Distance | Length | Code | Reversed | Clock Pos. | Severity | Rating | Category | Comment |
|---|---|---|---|---|---|---|---|---|
| 152.1 | | MCU | No | / | | | O&M | |

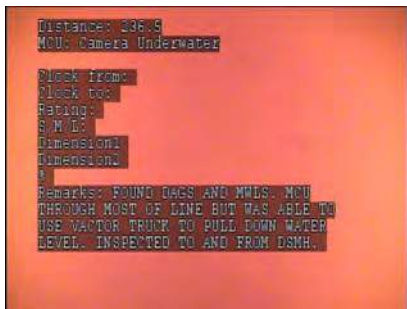
| 236.5 | | MCU | No | / | | | O&M | FOUND DAGS AND MWLS. MCU THROUGH MOST OF LINE BUT WAS ABLE TO USE VACTOR TRUCK TO PULL DOWN WATER LEVEL. INSPECTED TO AND FROM DSMH. |

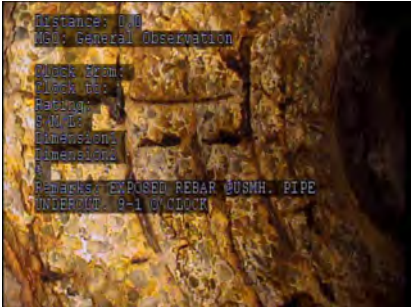
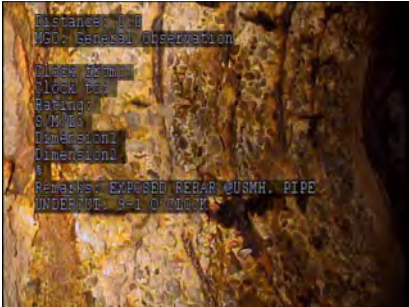
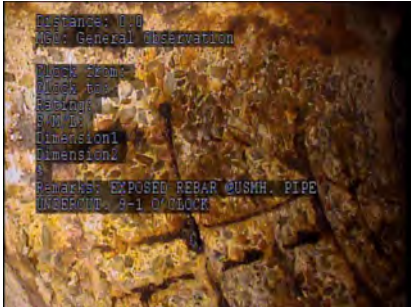
| Distance | Length | Code | Reversed | Clock Pos. | Severity | Rating | Category | Comment |
|---|---|---|---|---|---|---|---|---|
| 0.0 | | MGO | No | / | | | | EXPOSED REBAR @USMH. PIPE UNDERCUT. 9-1 O'CLOCK |

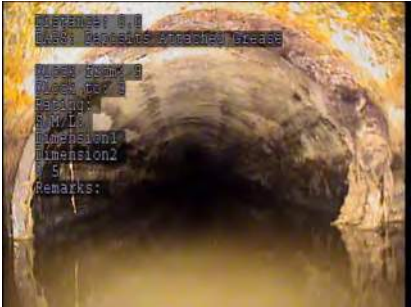
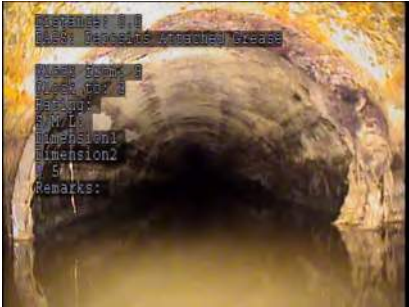
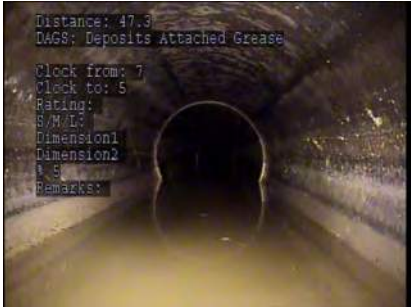
| Distance | Length | Code | Reversed | Clock Pos. | Severity | Rating | Category | Comment |
|---|---|---|---|---|---|---|---|---|
| 0.0 | | DAGS | No | 7 / 5 | | | O&M | |

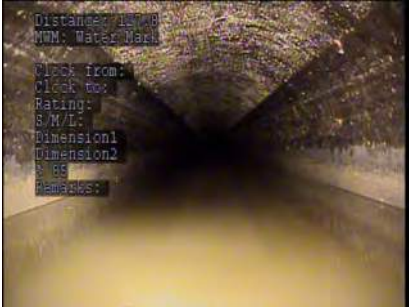
| Distance | Length | Code | Reversed | Clock Pos. | Severity | Rating | Category | Comment |
|---|---|---|---|---|---|---|---|---|
| 127.9 | | MWM | No | / | | | O&M | |

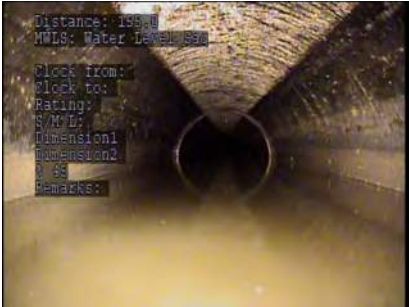
| Distance | Length | Code | Reversed | Clock Pos. | Severity | Rating | Category | Comment |
|---|---|---|---|---|---|---|---|---|
| 155.0 | | MWLS | No | / | | | Structural | |

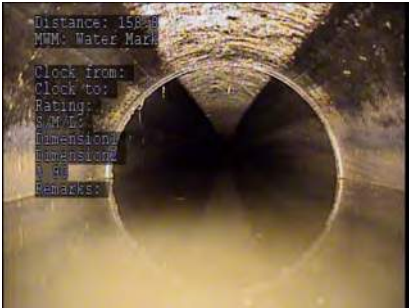
| Distance | Length | Code | Reversed | Clock Pos. | Severity | Rating | Category | Comment |
|---|---|---|---|---|---|---|---|---|
| 158.8 | | MWM | No | / | | | O&M | |

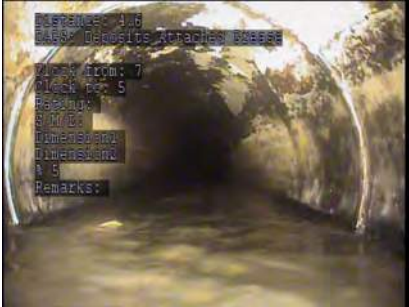
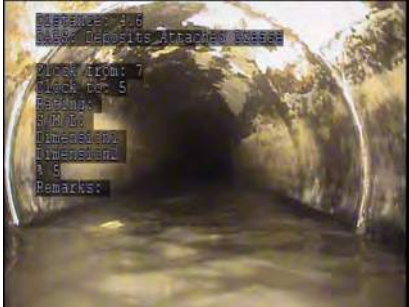
| Distance | Length | Code | Reversed | Clock Pos. | Severity | Rating | Category | Comment |
|---|---|---|---|---|---|---|---|---|
| 5.0 | | DAGS | No | 7 / 5 | | | O&M | |

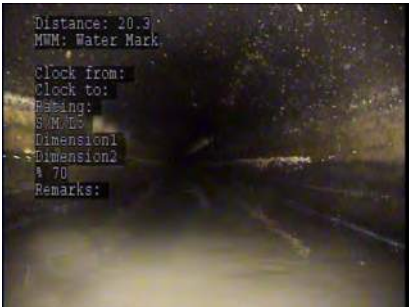
| Distance | Length | Code | Reversed | Clock Pos. | Severity | Rating | Category | Comment |
|---|---|---|---|---|---|---|---|---|
| 20.3 | | MWM | No | / | | | O&M | |

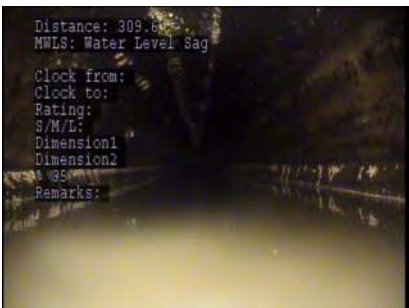
| Distance | Length | Code | Reversed | Clock Pos. | Severity | Rating | Category | Comment |
|---|---|---|---|---|---|---|---|---|
| 309.6 | | MWLS | No | / | | | Structural | |

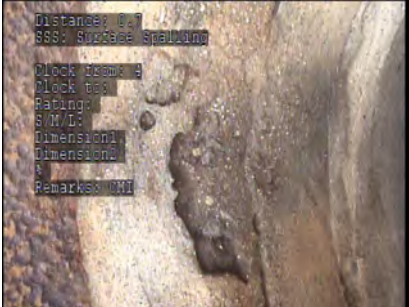
| Distance | Length | Code | Reversed | Clock Pos. | Severity | Rating | Category | Comment |
|---|---|---|---|---|---|---|---|---|
| 0.7 | | SSS | No | 4 / | | | Structural | CMI |

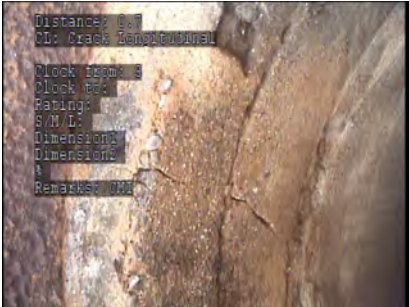
| Distance | Length | Code | Reversed | Clock Pos. | Severity | Rating | Category | Comment |
|---|---|---|---|---|---|---|---|---|
| 0.7 | | CL | No | 3 / | | | Structural | CMI |

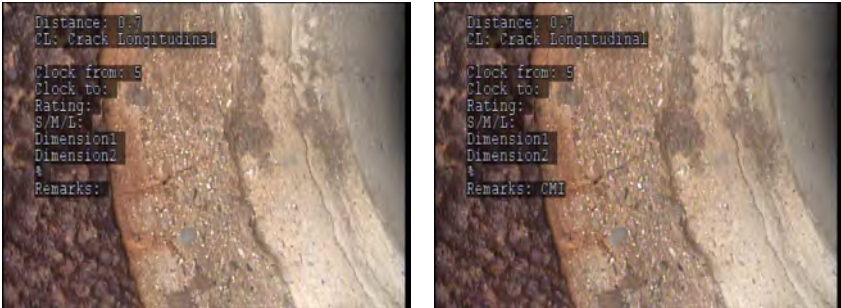
| Distance | Length | Code | Reversed | Clock Pos. | Severity | Rating | Category | Comment |
|---|---|---|---|---|---|---|---|---|
| 0.7 | | CL | No | 5 / | | | Structural | CMI |

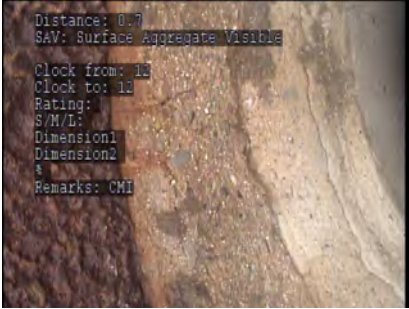
| Distance | Length | Code | Reversed | Clock Pos. | Severity | Rating | Category | Comment |
|---|---|---|---|---|---|---|---|---|
| 0.7 | | SAV | No | 12 / 12 | | | Structural | CMI |

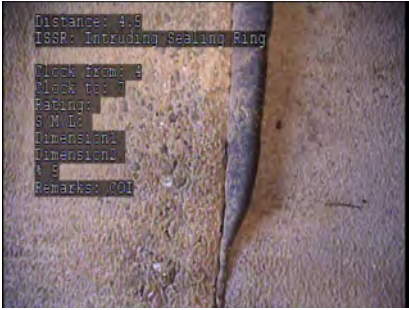
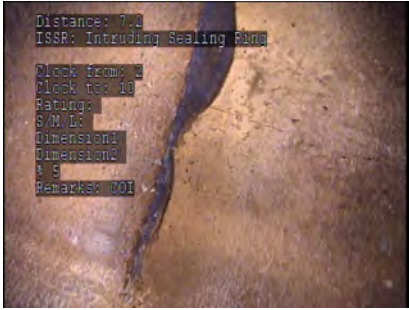
| Distance | Length | Code | Reversed | Clock Pos. | Severity | Rating | Category | Comment |
|---|---|---|---|---|---|---|---|---|
| 5.0 | | ISSR | No | 2 / 10 | | | O&M | COI |

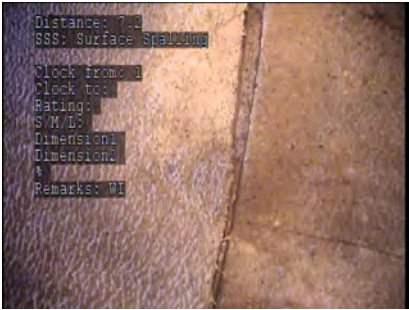
| Distance | Length | Code | Reversed | Clock Pos. | Severity | Rating | Category | Comment |
|---|---|---|---|---|---|---|---|---|
| 7.2 | | SSS | No | 1 / | | | Structural | WI |

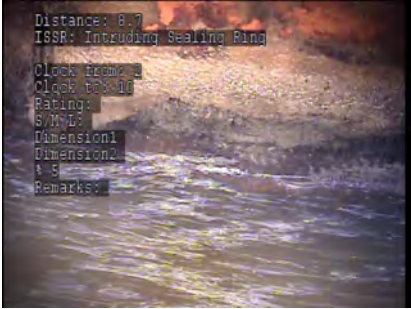
| Distance | Length | Code | Reversed | Clock Pos. | Severity | Rating | Category | Comment |
|---|---|---|---|---|---|---|---|---|
| 8.7 | | ISSR | No | 2 / 10 | | | O&M | |

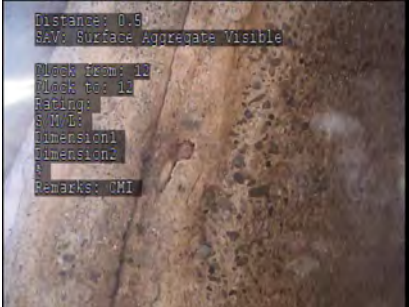
| Distance | Length | Code | Reversed | Clock Pos. | Severity | Rating | Category | Comment |
|---|---|---|---|---|---|---|---|---|
| 0.5 | | SAV | No | 12 / 12 | | | Structural | CMI |

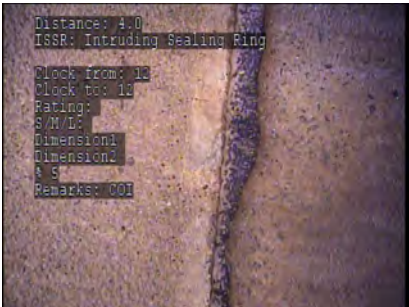
| Distance | Length | Code | Reversed | Clock Pos. | Severity | Rating | Category | Comment |
|---|---|---|---|---|---|---|---|---|
| 4.0 | | ISSR | No | 12 / 12 | | | O&M | COI |

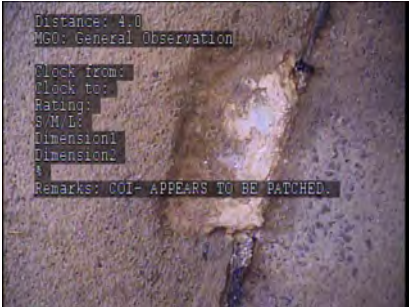
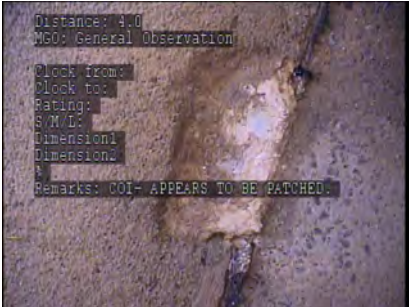
| Distance | Length | Code | Reversed | Clock Pos. | Severity | Rating | Category | Comment |
|---|---|---|---|---|---|---|---|---|
| 4.0 | | MGO | No | / | | | | COI- APPEARS TO BE PATCHED. |

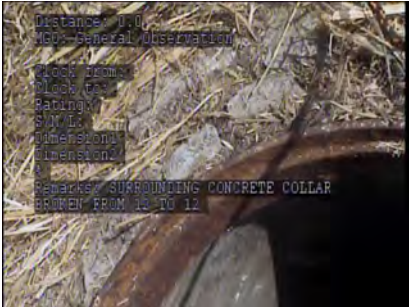
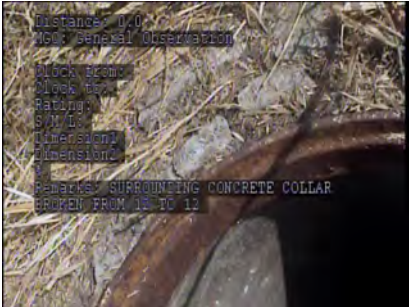
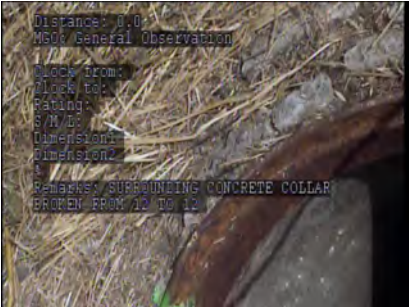
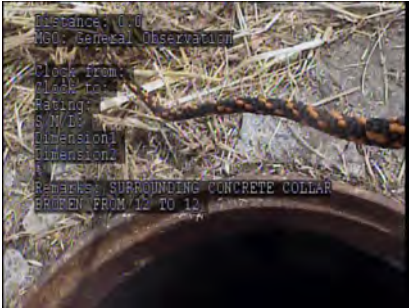
| Distance | Length | Code | Reversed | Clock Pos. | Severity | Rating | Category | Comment |
|---|---|---|---|---|---|---|---|---|
| 0.0 | | MGO | No | / | | | | SURROUNDING<br>CONCRETE COLLAR<br>BROKEN FROM 12 TO<br>12 |

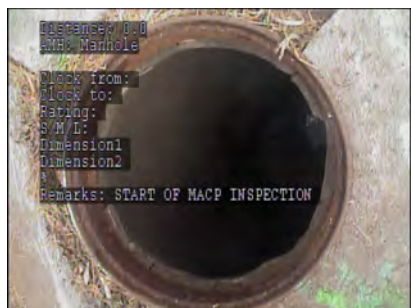
| 0.0 | | AMH | No | / | | | | START OF MACP INSPECTION |

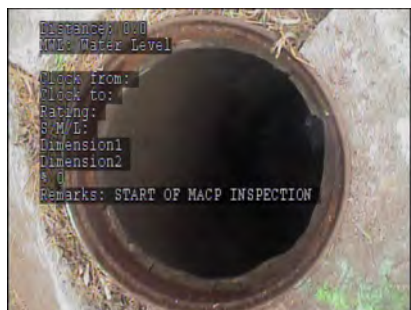
| 0.0 | | MWL | No | / | | | | START OF MACP INSPECTION |

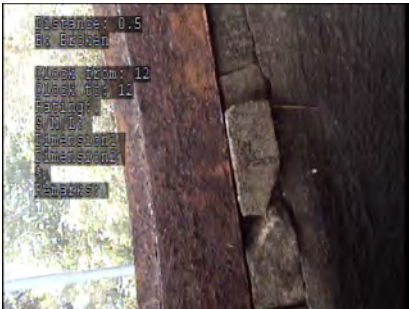
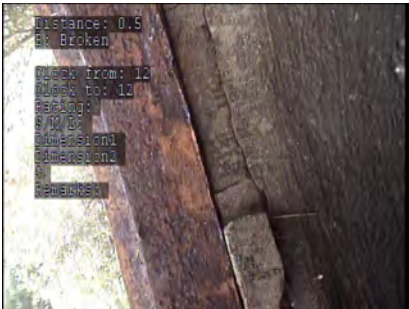
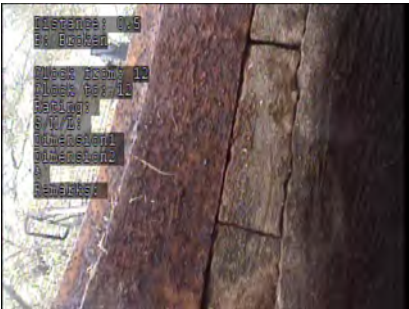
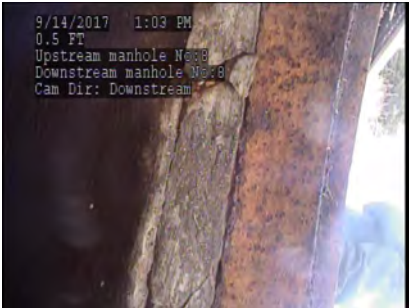
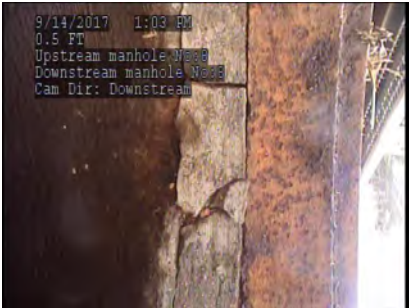
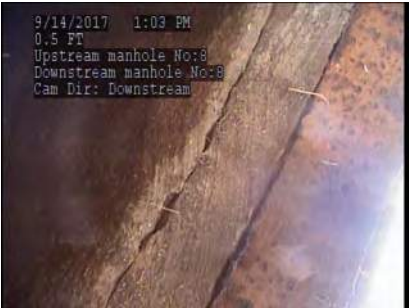
| 0.5 | | B | No | 12 / 12 | | | Structural | |

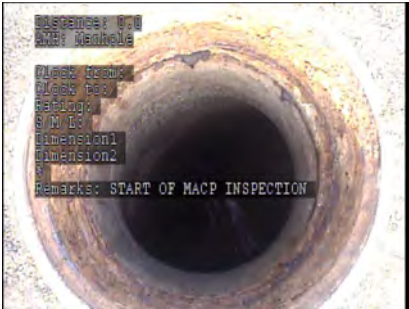
| Distance | Length | Code | Reversed | Clock Pos. | Severity | Rating | Category | Comment |
|---|---|---|---|---|---|---|---|---|
| 0.0 | | AMH | No | / | | | | START OF MACP INSPECTION |

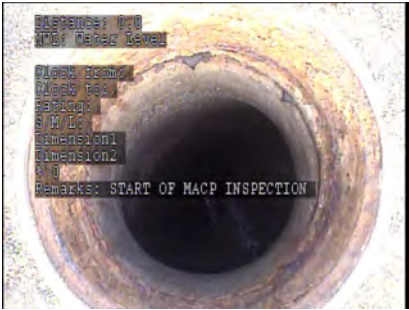
| Distance | Length | Code | Reversed | Clock Pos. | Severity | Rating | Category | Comment |
|---|---|---|---|---|---|---|---|---|
| 0.0 | | MWL | No | / | | | | START OF MACP INSPECTION |

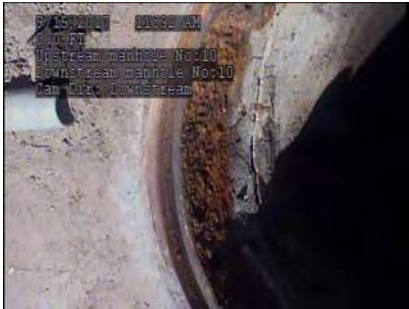
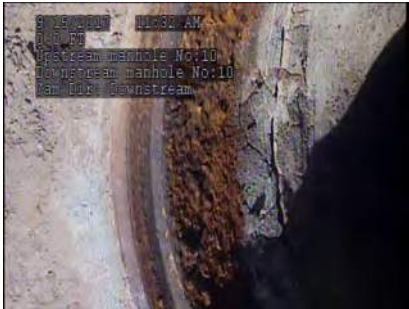
| Distance | Length | Code | Reversed | Clock Pos. | Severity | Rating | Category | Comment |
|---|---|---|---|---|---|---|---|---|
| 0.0 | | SCP | No | 12 / 12 | | | Structural | FRAME - CMI - HEAVILY CORRODED AND BUBBLING |

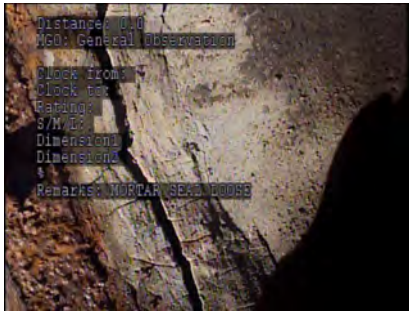
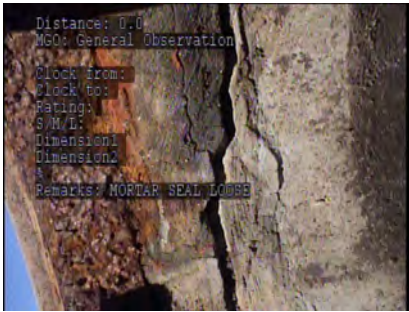
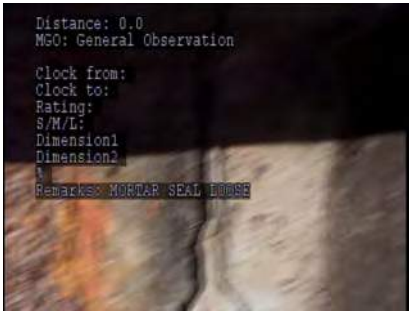
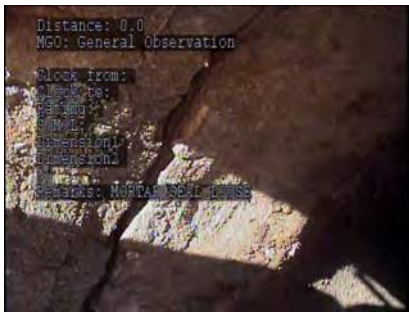
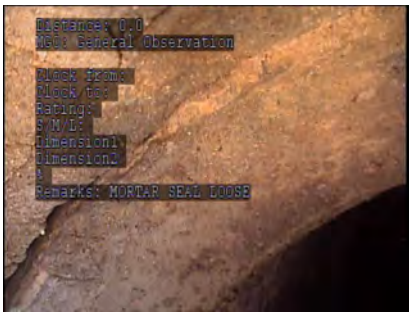
| 0.0 | | MGO | No | / | | | | MORTAR SEAL LOOSE |

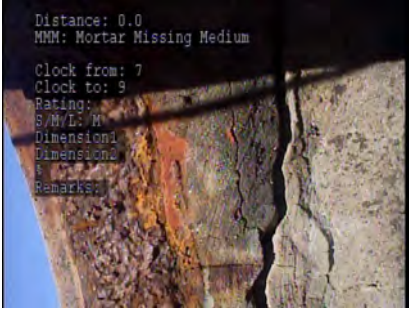
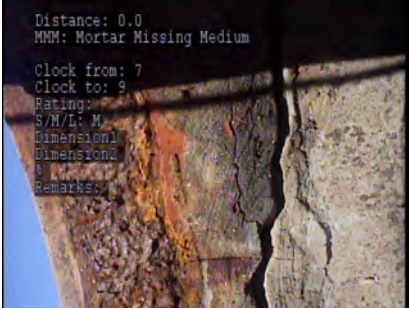
| Distance | Length | Code | Reversed | Clock Pos. | Severity | Rating | Category | Comment |
|---|---|---|---|---|---|---|---|---|
| 0.5 | | MMM | No | 7 / 9 | | | Structural | |

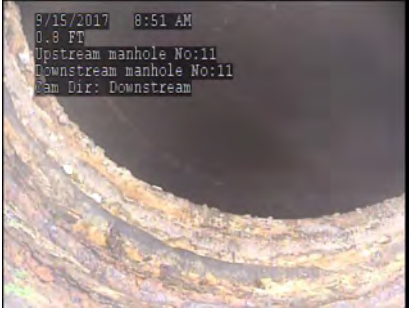
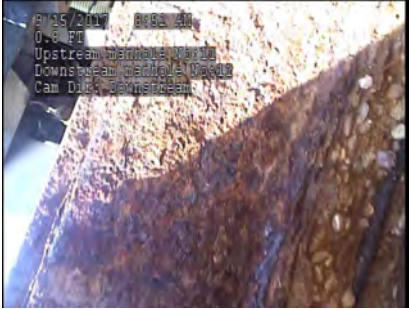
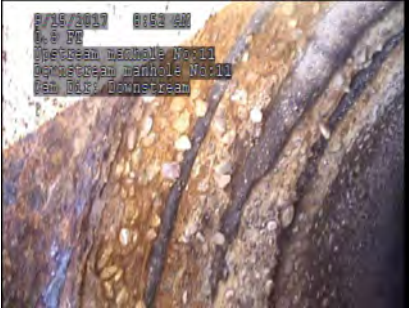
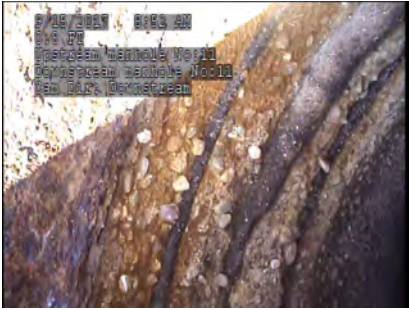
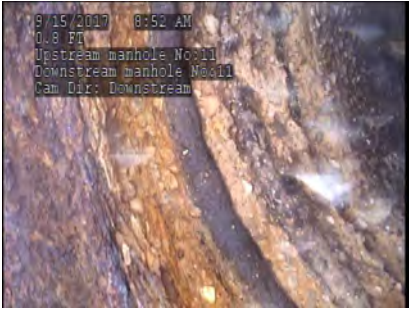
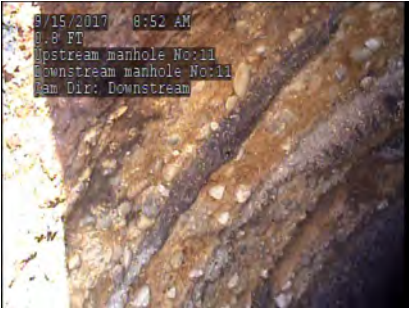
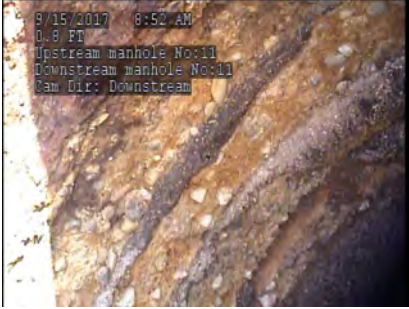
| Distance | Length | Code | Reversed | Clock Pos. | Severity | Rating | Category | Comment |
|---|---|---|---|---|---|---|---|---|
| 0.8 | SAP | No | | 12 / 12 | | | Structural | |

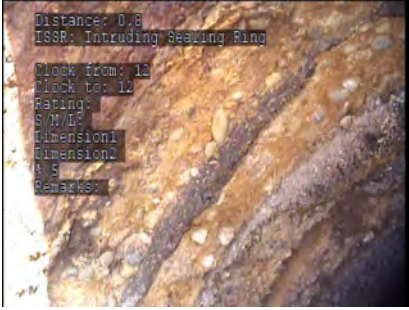
| Distance | Length | Code | Reversed | Clock Pos. | Severity | Rating | Category | Comment |
|---|---|---|---|---|---|---|---|---|
| 0.8 | ISSR | No | | 12 / 12 | | | O&M | |

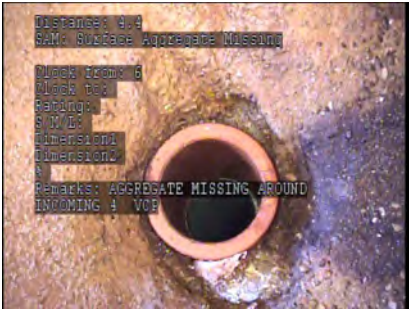
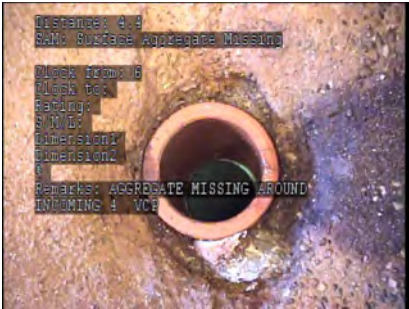
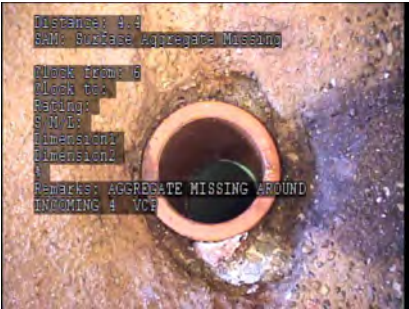
| Distance | Length | Code | Reversed | Clock Pos. | Severity | Rating | Category | Comment |
|---|---|---|---|---|---|---|---|---|
| 4.4 | | SAM | No | 6 / | | | Structural | AGGREGATE MISSING AROUND INCOMING 4" VCP |

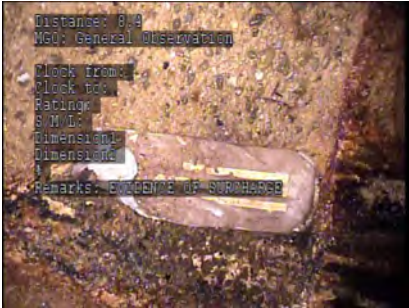
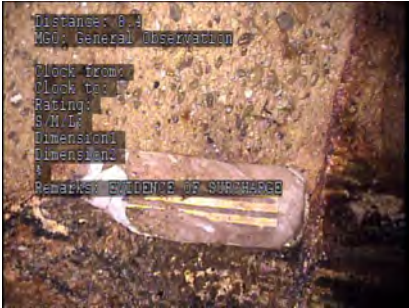
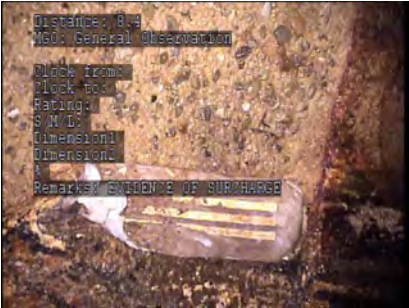
| 8.4 | | MGO | No | / | | | | EVIDENCE OF SURCHARGE |

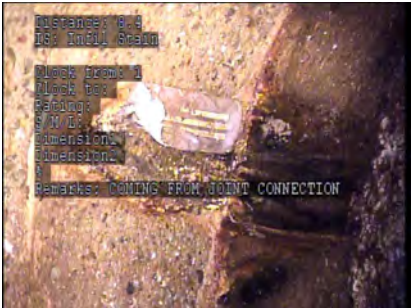
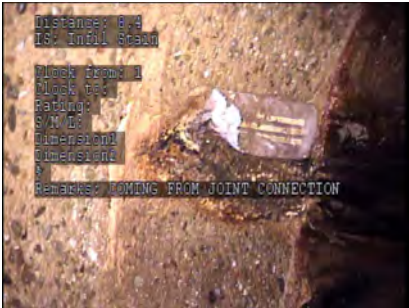
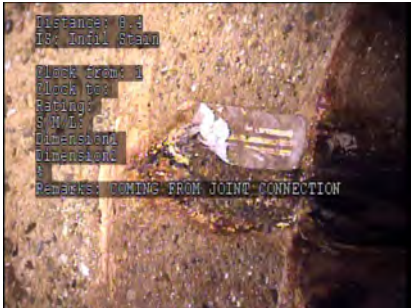
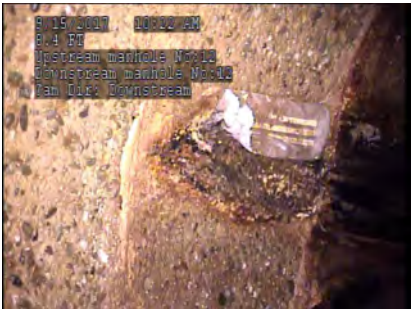
| Distance | Length | Code | Reversed | Clock Pos. | Severity | Rating | Category | Comment |
|---|---|---|---|---|---|---|---|---|
| 8.4 | IS | | No | 1 / | | | | COMING FROM JOINT CONNECTION |

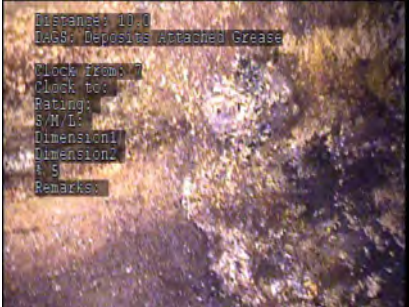
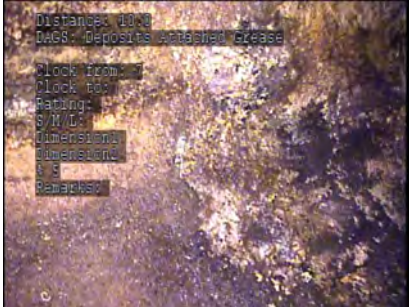
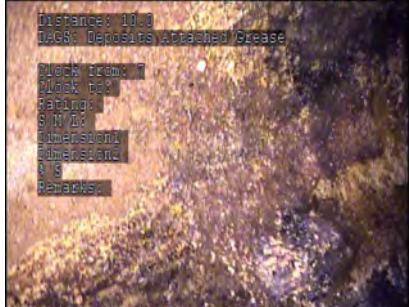
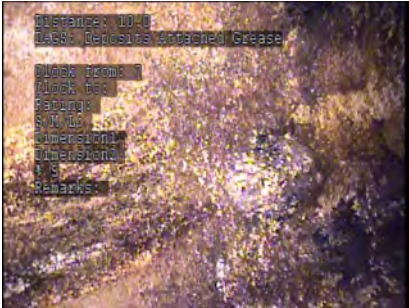
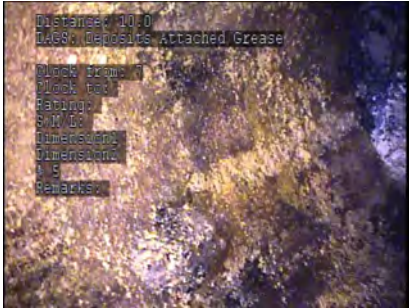
| Distance | Length | Code | Reversed | Clock Pos. | Severity | Rating | Category | Comment |
|---|---|---|---|---|---|---|---|---|
| 10.0 | | DAGS | No | 7 / | | | O&M | |

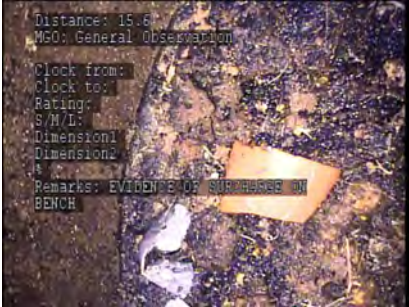
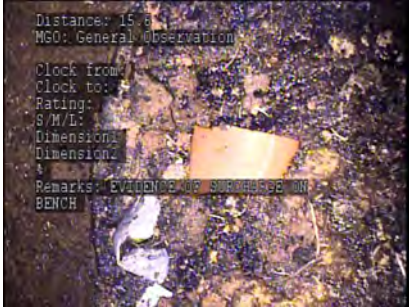
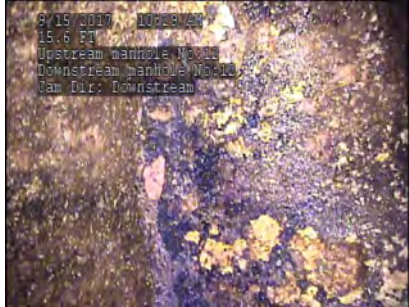
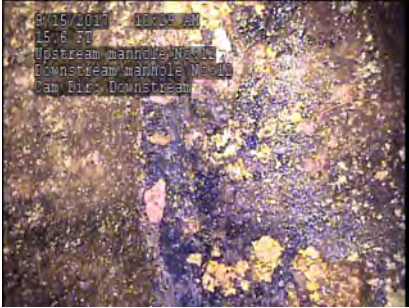
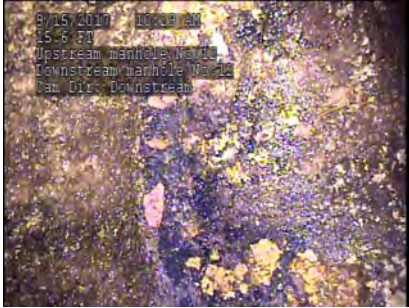
| Distance | Length | Code | Reversed | Clock Pos. | Severity | Rating | Category | Comment |
|---|---|---|---|---|---|---|---|---|
| 15.6 | | MGO | No | / | | | | EVIDENCE OF SURCHARGE ON BENCH |

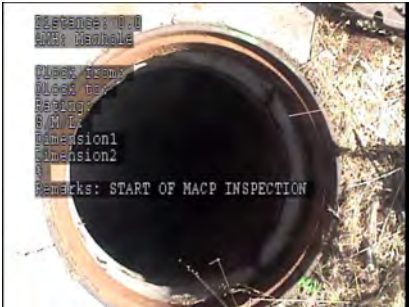
| Distance | Length | Code | Reversed | Clock Pos. | Severity | Rating | Category | Comment |
|---|---|---|---|---|---|---|---|---|
| 0.0 | | AMH | No | / | | | | START OF MACP INSPECTION |

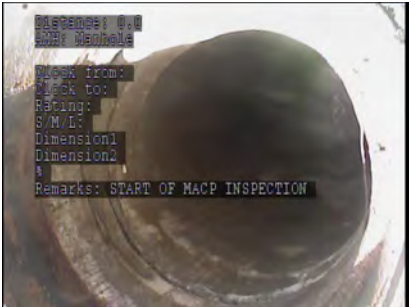
| Distance | Length | Code | Reversed | Clock Pos. | Severity | Rating | Category | Comment |
|---|---|---|---|---|---|---|---|---|
| 0.0 | | AMH | No | / | | | | START OF MACP INSPECTION |

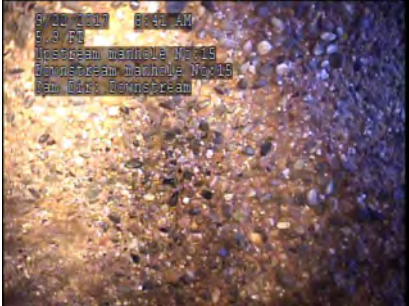
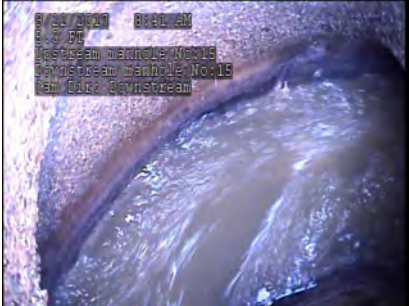
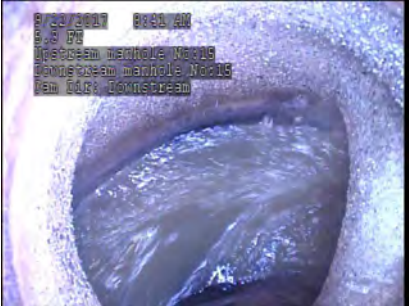
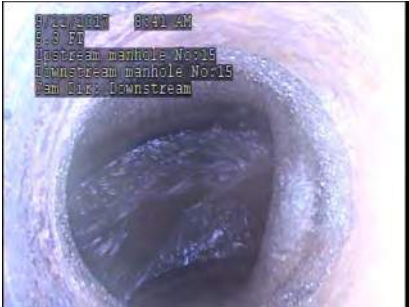
| Distance | Length | Code | Reversed | Clock Pos. | Severity | Rating | Category | Comment |
|---|---|---|---|---|---|---|---|---|
| 5.3 | | SAP | No | 12 / 12 | | | Structural | CMI - CHANNEL |

| Ref | Description | Remark |
|---|---|---|
| 6 | SSMH - 15 | Recommend PCC collar and bring MH lid 6" up slope away MH lid to prevent I/I & install marker |

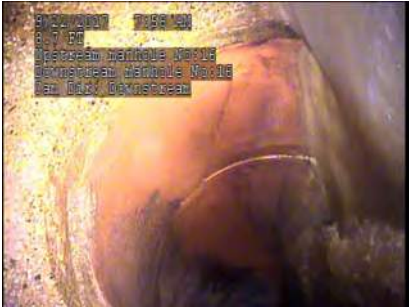
| Distance | Length | Code | Reversed | Clock Pos. | Severity | Rating | Category | Comment |
|---|---|---|---|---|---|---|---|---|
| 8.7 | | DAGS | No | 12 / 12 | | | O&M | CMI - CHANNEL |

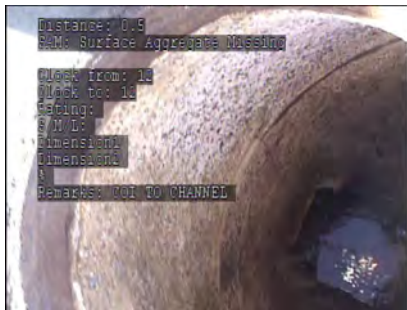
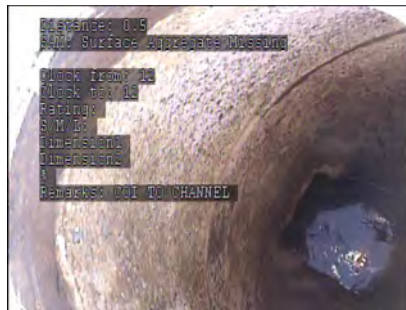
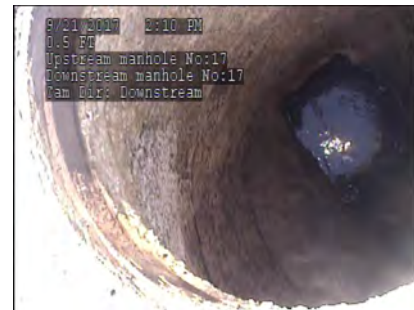
| Distance | Length | Code | Reversed | Clock Pos. | Severity | Rating | Category | Comment |
|---|---|---|---|---|---|---|---|---|
| 0.5 | | SAM | No | 12 / 12 | | | Structural | COI TO CHANNEL |

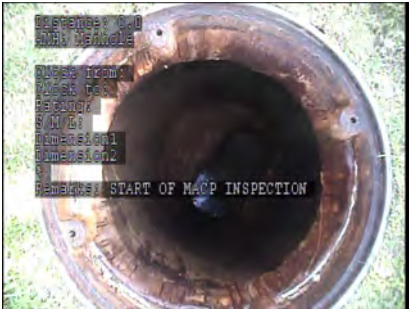
| Distance | Length | Code | Reversed | Clock Pos. | Severity | Rating | Category | Comment |
|---|---|---|---|---|---|---|---|---|
| 0.0 | | AMH | No | / | | | | START OF MACP INSPECTION |

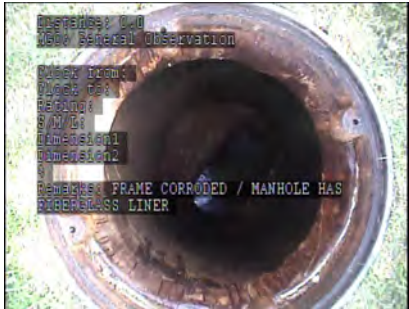
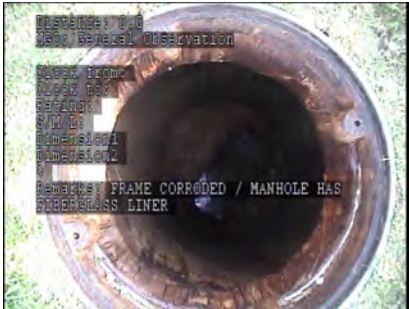
| Distance | Length | Code | Reversed | Clock Pos. | Severity | Rating | Category | Comment |
|---|---|---|---|---|---|---|---|---|
| 0.0 | MGO | | No | / | | | | FRAME CORRODED /<br>MANHOLE HAS<br>FIBERGLASS LINER |
