This report presents the results of our Closed-Circuit Television (CCTV) inspections performed to address the conditions of sanitary sewer mains and manholes in various locations throughout the City of Salinas. The CCTV inspections were conducted on large diameter sewer mains ranging from 12" to 30" diameter pipes and were completed using Pipeline Assessment Certification Program (PACP) standards.

The City of Salinas retained Mark Thomas to inspect and analyze the condition of approximately 5,300 linear feet of sanitary sewer mains and 23 manhole structures.

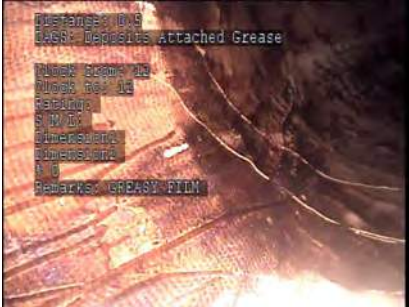
| Distance | Length | Code | Reversed | Clock Pos. | Severity | Rating | Category | Comment |
|---|---|---|---|---|---|---|---|---|
| 0.5 | | DAGS | No | 12 / 12 | | | O&M | GREASY FILM |

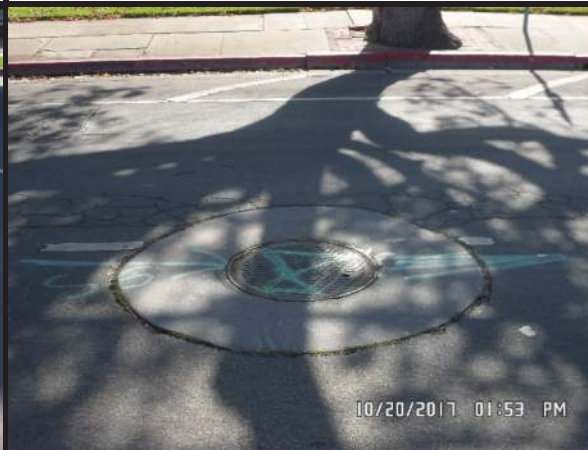
Photo SSMH – 20

| Ref | Description | Remark |
|---|---|---|
| 5 | SSMH – 20 | No work need at pavement surface |

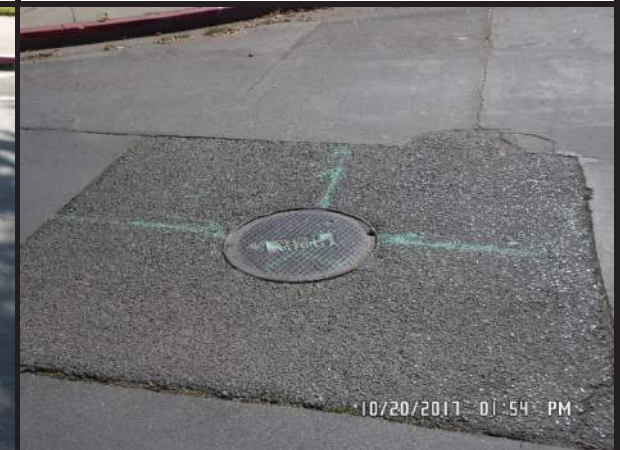
Photo SSMH – 21

| Ref | Description | Remark |
|---|---|---|
| 6 | SSMH – 21 | No work need at pavement surface |
