## Re: Project Management and Construction Management for Renovation of the Salinas Fire Stations 1-6 Facilities

# PROJECT MANAGEMENT AND CONSTRUCTION MANAGEMENT FOR RENOVATION OF THE SALINAS FIRE STATIONS 1-6 FACILITIES PRELIMINARY JOB WALK ASSESSSMENT OCTOBER 13, 2022

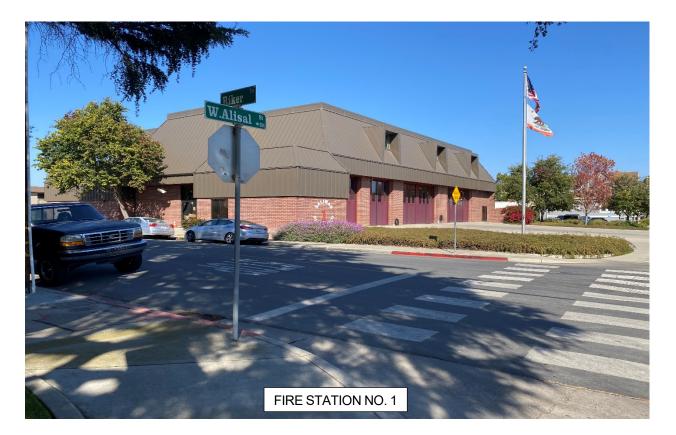
For this Fire Station No. 1, the following were noted during the job walk:

- 2. An assessment of the plumbing system in the bathroom areas that have drainage problems related to frequent blockage is required. (Could be a design issue.)

- 3. There are electrical issues that may be related to lack of capacity.
- 4. A complete remodel of the kitchen is required. There are electrical power issues and non-working appliances.

- 5. New flooring is required throughout the day room (where floor is being replaced, except for the sleeping areas, VCT should be used). Carpets are not an acceptable floor finish.

- 6. A full height retractable divider is to be installed in the day room.
- 7. A new cooling system should be installed. (There is no air-conditioning in the building, only heating from gas furnaces.)

- 8. Complete interior painting of the building is required.
- 9. An upgrade to the meeting room layout is required.

- 10. Since the renovation work may require new lighting fixtures, and HVAC diffusers and grilles, the installation of new ceiling tiles throughout the affected areas should be included since there was damage to the many of the tiles from roof leaks.
- 11. Provide new concrete paving in the parking lot.
- 12. Replacement of the rear (west) apparatus bay doors to match the front doors is required.
- 13. Complete replacement of the vent extractor system for the trucks since the existing system vendor is out of business and parts are no longer available.
- 14. An evaluation by the design consultant of the options to reduce the response time and path of travel for employees to get to the trucks.
- 15. Privacy screens to be added to the dormitory.
- 16. Add a card reader system for the building entry.

During the job walk it was observed that:

- 1. A new roof had been installed
- 2. A new metal fascia had been installed
- 3. Fencing, gate, and generator replacement work has been scheduled by the City. An option discussed was to place this work on hold to be completed with the other work listed above for a complete project.
- 4. The building is non-sprinklered. Since this is an essential facility, should sprinklers be added?

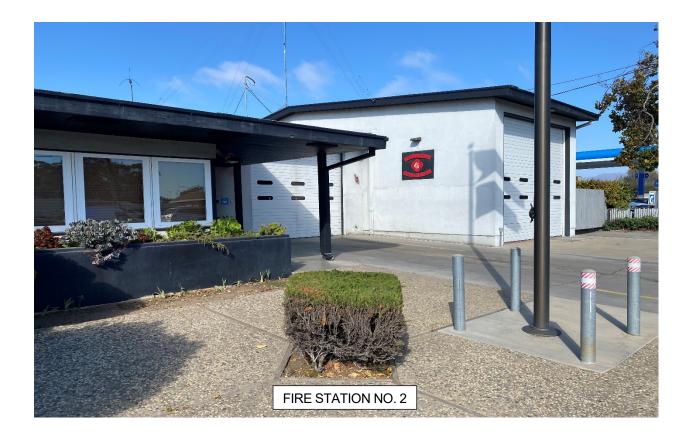
For this Fire Station No. 2, the following were noted during the job walk:

- 1. This building is sprinklered.
- 2. A complete remodel of the kitchen is required (priority no. 2).
- 3. The complete painting of interior and exterior is required.

- 4. Demolition and replacement of the existing onsite storage shed with a new storage shed to be included.
- 5. Signage "Keep Clear" upgrade to front of station for truck emergency egress is required.

- 6. A solution to the workout room open to the apparatus bay and exposed to the exhaust emissions is required.
- 7. A new cooling system should be installed. (There is no air-conditioning in the building, only heating.)

- 8. New paving in the parking lot is required.
- 9. Complete replacement of the vent extractor system for the trucks is required since the existing system vendor is out of business and parts are no longer available.

- 10. SFD noted that this is a backup only apparatus bay, and when the truck is fully backed up the clearance between the rear of the truck and the adjacent wall/door does not allow for a free and easy pedestrian pathway. Is there a solution?

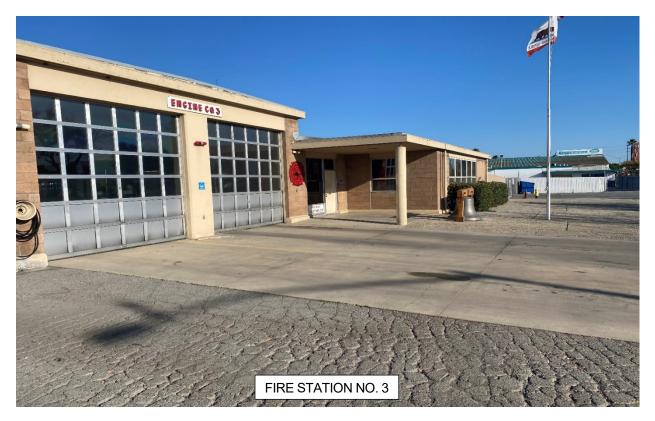
For this Fire Station No. 3, the following were noted during the job walk:

- 1. A complete remodel of the kitchen is required.
- 2. A new cooling system (maybe a central system) is required since there are non-working window air-conditioning systems at this facility.

- 3. Complete replacement of the vent extractor system for the trucks is required since the existing system vendor is out of business and parts are no longer available.

- 4. The dormitory is directly connected to the apparatus bay and exposed to the exhaust emissions. A solution is required.
- 5. A solution to the workout room open to the apparatus bay and exposed to the exhaust emissions is required.

- 6. There are numerous leaks throughout the building so a new roof may be required.
- 7. There are significant plumbing issues that may require a building drain and sewer replacement.

- 8. Complete painting of interior and exterior should be included.
- 9. Demolition of the training tower with a 1-story underground that will backfill should be included.

- 10. Bathroom remodel to be discussed. Facility does not have a co-ed bathroom and a shower with two small heads. Access to the shower is limited and not code compliant.

- 11. Provide dividers in the dormitory area.
- 12. The area for the staff jackets and other clothing is not ventilated.
- 13. Floor covering replacement is required.

- 14. The building is non-sprinklered.

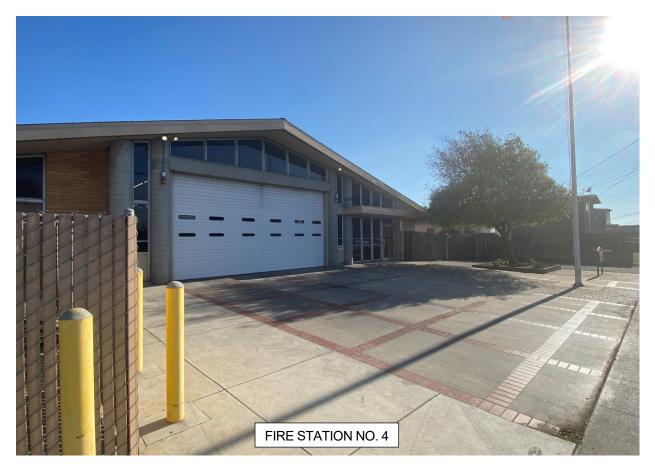
For Fire Station No. 4, the following were noted during the job walk:

- 1. Complete repair/replacement of vehicle ramp at front of building is required.
- 2. New paving in the parking lot is required.
- 3. Exterior painting is required.
- 4. A complete remodel of the kitchen is required (priority no. 2 work).
- 5. Windows and bay doors in this building are single pane and require upgrade to more energy efficient double pane windows.
- 6. There are non-working window air-conditioning systems at this facility, so a new central system is proposed.
- 7. Complete replacement of the vent extractor system for the trucks is required since the existing system vendor is out of business and parts are no longer available

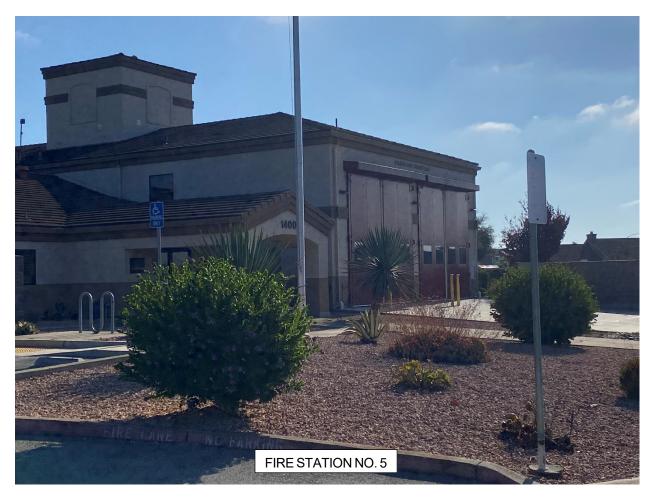
For Fire Station No. 5, the following were noted during the job walk:

- 1. There is no air-conditioning at this facility, so a new central air-conditioning system is requested.
- 2. There was localized water damage at some windows and wall areas that require investigation.
- 3. Complete replacement of the vent extractor system for the trucks is required since the existing system vendor is out of business and parts are no longer available.
- 4. A solution to the workout room open to the apparatus bay and exposed to the exhaust emissions.

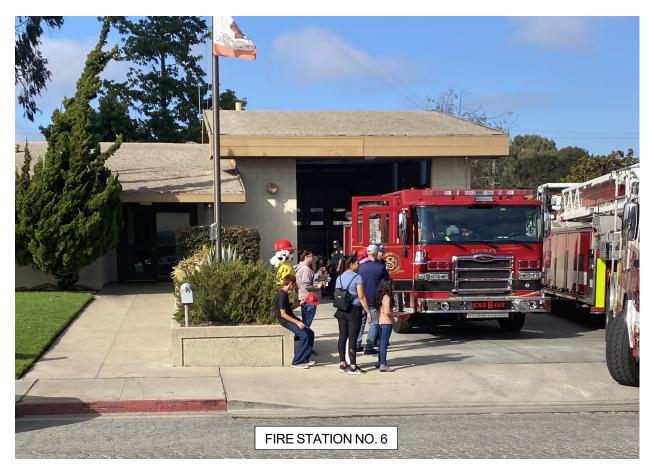
From field visit on 10/12/22, the following were noted during the job walk:

- 1. There is no air-conditioning at this facility, so a new central system is proposed
- 2. A solution to the workout room open to the apparatus bay and exposed to the exhaust emissions.
- 3. Complete interior and exterior painting should be included.
- 4. Complete replacement of the vent extractor system for the trucks since the existing system vendor is out of business and parts are no longer available
- 5. Replacement of the apparatus room doors is required.
