State of California — The Resources Agency  
DEPARTMENT OF PARKS AND RECREATION  
**PRIMARY RECORD**

\*Resource Name or #: (assigned by recorder) 147 Central Ave.

c. Address: 147 Central Ave.

Salinas Historic Resources Survey

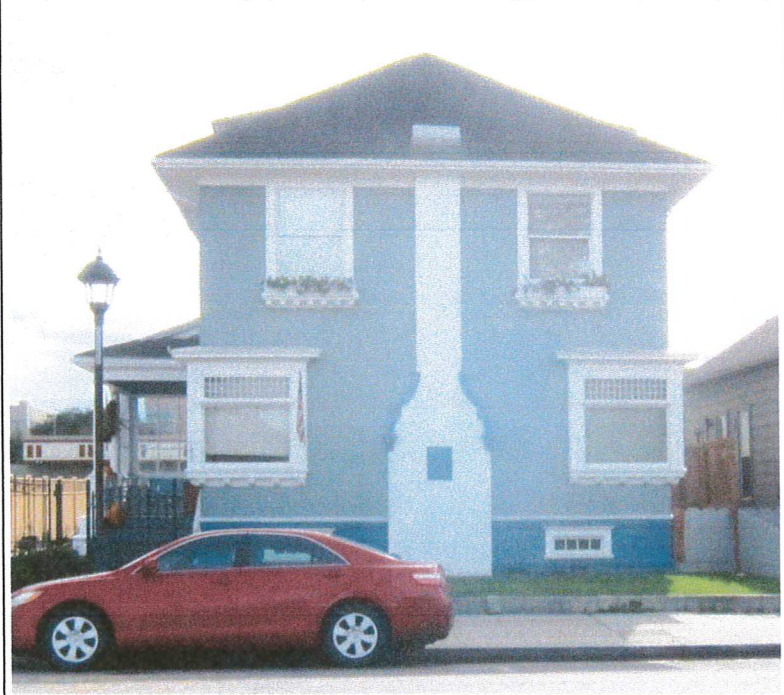
P5b. Description of Photo: (View, date, accession #) North Elevation, 2016

A two-story redwood-framed residence, rectangular in plan. The exterior wall cladding is a narrow horizontal clapboard. The hipped roof is covered with composition shingle and has paired hipped dormers in the roof plane of the left side elevation. On this elevation, a raised, partially glazed entry porch is supported on turned wood columns whose bases are enclosed by a solid porch rail with applied geometric detailing. Fenestration is basically 1/1 double-hung sash with leaded glass in most upper lights. Two such windows on the first floor of the north elevation flank a shaped brick chimney and have tiny balconies with shaped baulsters. Extended and square fixed-corner windows with tiny multipaned units above further articulate this elevation.

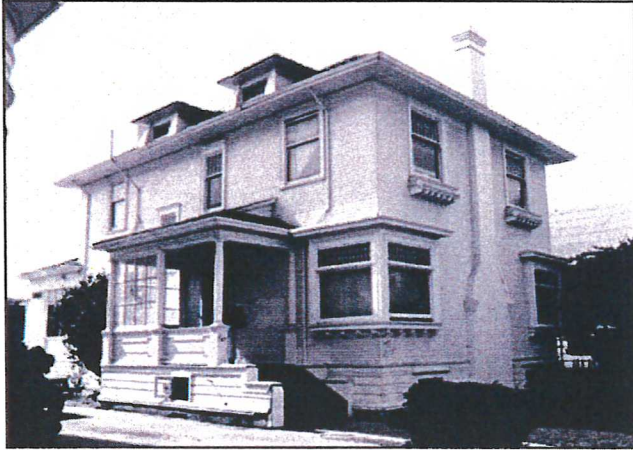
**Figure 1.** Circa 1988 image of the north and east elevations.

The chimney on the north elevation has been shortened at the roofline. Despite this alteration, the building maintains sufficient character-defining features to establish its historic integrity.
