FACILITY CONDITION ASSESSMENT

100 Howard Street
100 Howard Street
Salinas, California 93901

AEI Project No. 448476

City of Salinas
200 Lincoln Avenue
Salinas, California 93901

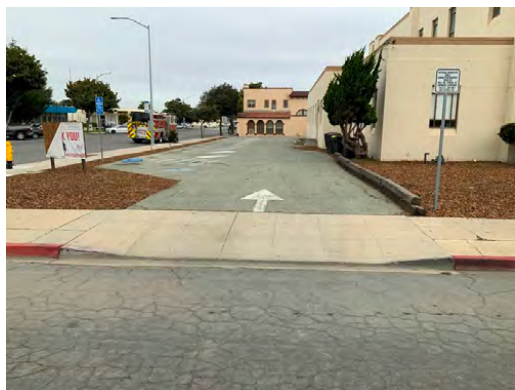
Southwest parking lot entrance

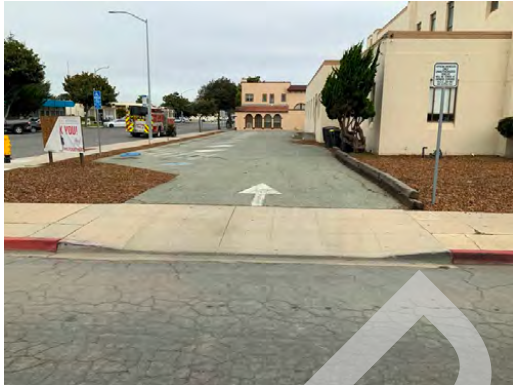
Southwest parking lot entrance

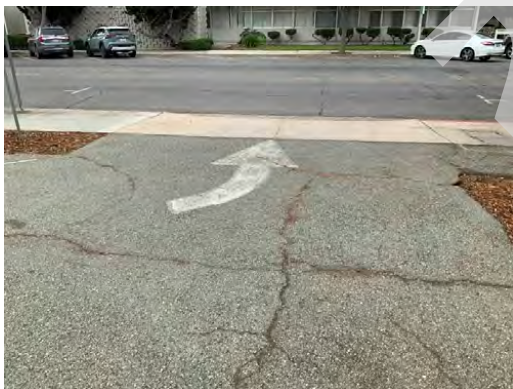
West parking lot egress

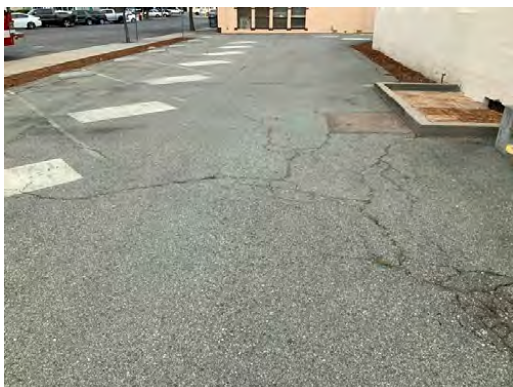
The west parking lot asphalt pavement is reaching the end of its effective useful life. Although the asphalt has limited structural cracking or alligating, the asphalt is a prime candidate for overlay resurfacing to extend its effective useful life. Asphalt maintenance is typically addressed by applying a 2" overlay surface to the asphalt as it approaches its effective useful life and before structural cracking occurs. An overlay application is not a repair solution but rather is a proactive maintenance recommendation to avoid system failure.

Wets parking lot finish

If an overlay is applied, it should be applied before significant stress cracking occurs. Ideally, the wear (top) course of asphalt should be milled 2" or the perimeter of the pavement should be milled to avoid changing surface drainage patterns and to allow the new asphalt surface to integrate into the surrounding surfaces such as curbs and sidewalks. Areas of alligating should be cut out and replaced prior to installing the overlay. Mill and overlay of the west parking lot is recommended. An opinion of cost for this work is included in the Tables.

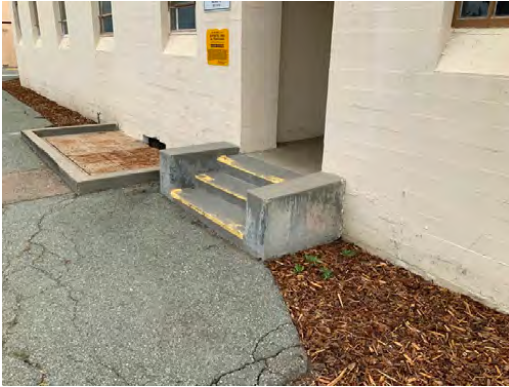
West exterior steps

Handrails were not observed to the exterior stairs on the west elevation of the building. AEI recommends the installation of handrails. An opinion of cost for this work is included in the Tables.

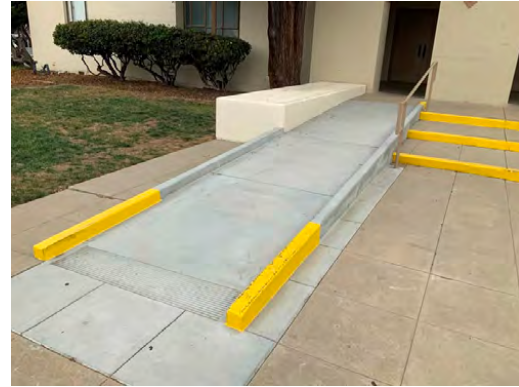
South elevation pedestrian ramp

The two (2) ramps at the main entrance to the building on the south elevation only had handrails on one side of the ramp. In addition, the handrails did not extend pass the length of the ramp at the lowest point. AEI recommends the installation of handrails on both sides of the ramps and extending the handrails to the full length of the ramp. An opinion of cost for this work is included in the Tables.

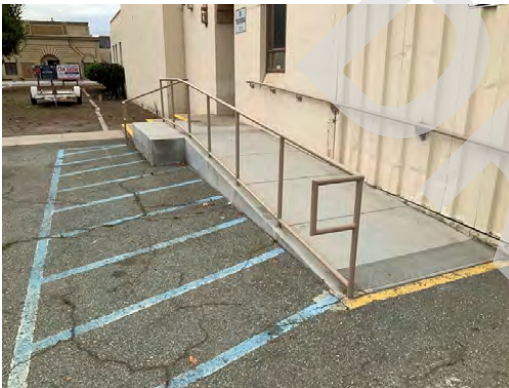
East access ramp

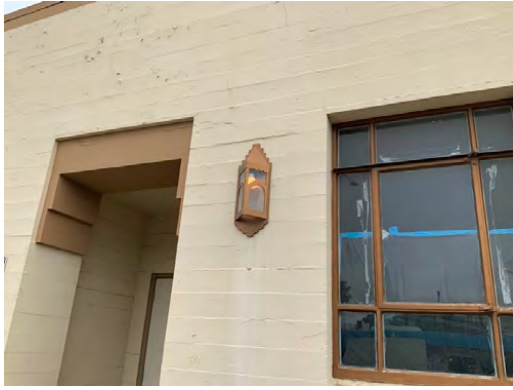
Exterior wall lighting

The exterior building mounted lighting fixtures appear to be more than 20 years old and have had the bulbs updated to LED. Based on the age and condition of the fixtures, fixture replacement should be anticipated during the assessment period to provide necessary levels of night lighting for security. An opinion of cost for this work is included in the Tables.

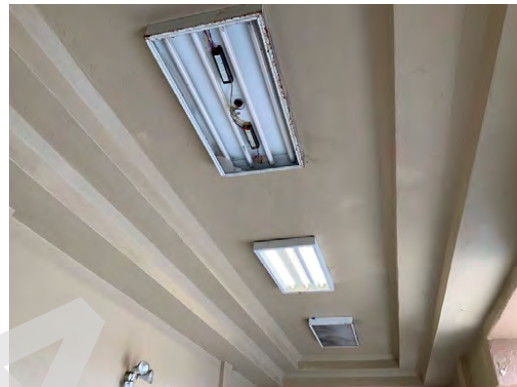
Exterior ceiling lighting

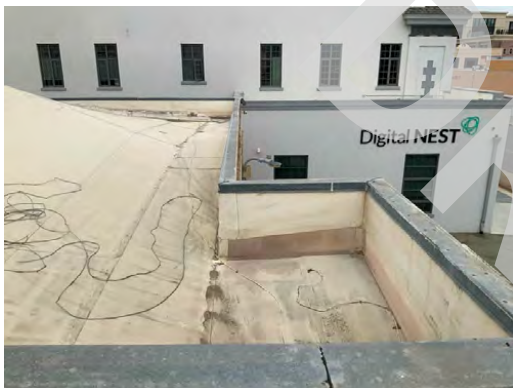
Parapet wall cap

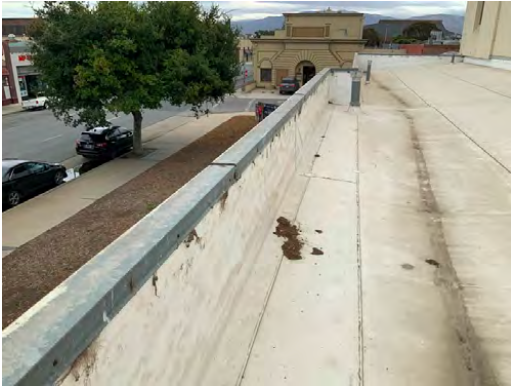
Parapet wall

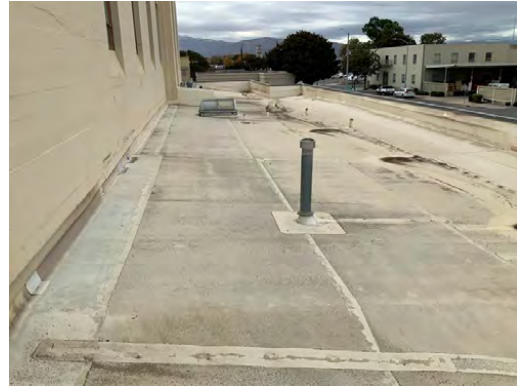
West roof overview

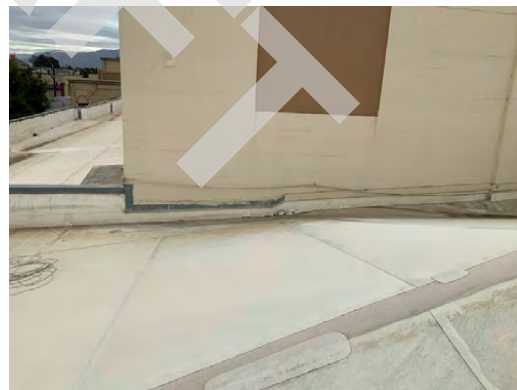
Unattached sections of the north roof

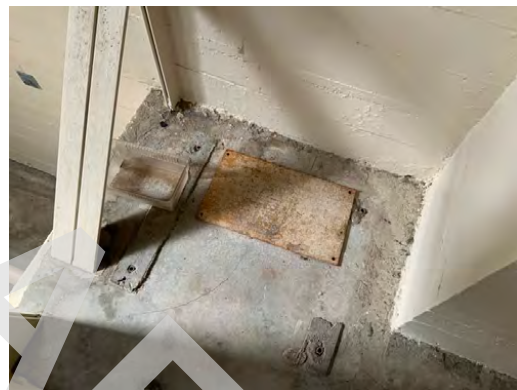
Voids in the flooring on the ends of the balcony area were observed to be covered with unsecured plywood. The voids were possibly created when a piece of equipment was removed. AEI recommends permanently covering the voids so the cover cannot be easily removed. An opinion of cost for this work is included in the Tables.

Concrete hole covered with plywood

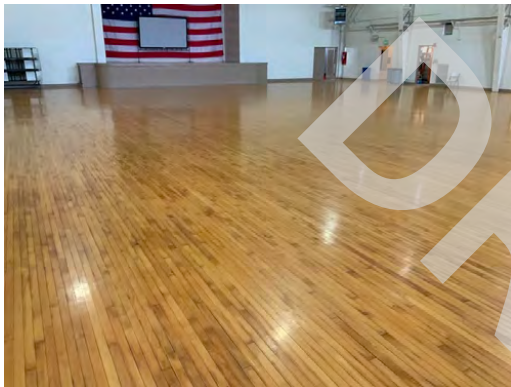
Open space flooring

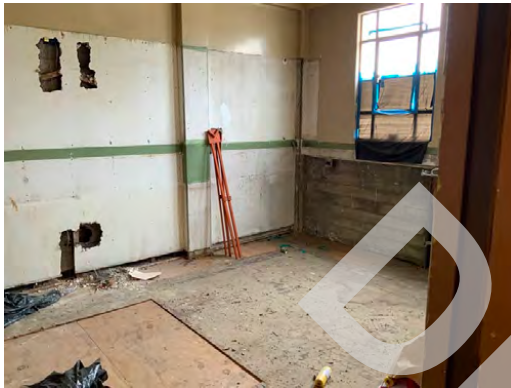
According to the site contact, a commercial kitchen with limited equipment was previously demolished. It is currently unknown if a new commercial kitchen has been budgeted for. An opinion of cost to refurbish floor and wall finishes and include light commercial kitchen equipment in the mid-term is included in the Tables.

Former commercial kitchen

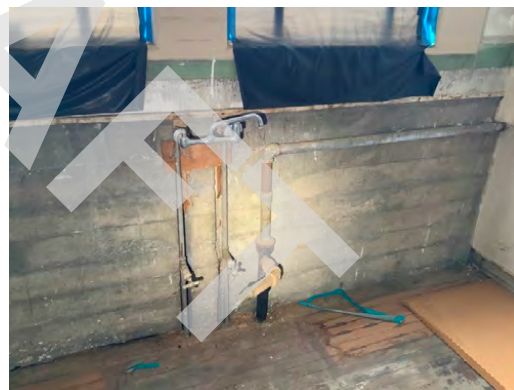
Galvanized piping was observed in the former kitchen. It is unknown how much galvanized piping is currently left in the building. AEI recommends a budgetary allowance to replace the remaining galvanized piping with copper or PEX. An allowance for this work is included in the Tables.

Possible galvanized piping

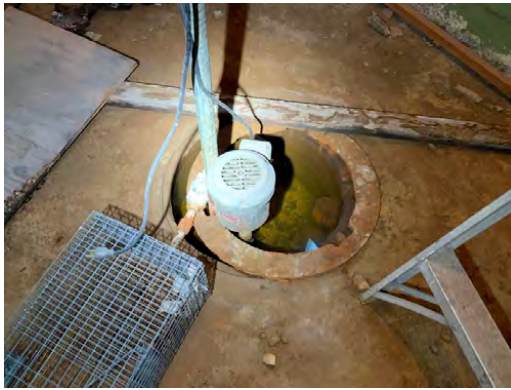
A sump pump was observed in the basement level on the west side of the building. Based on the age and condition, replacement of the sump pump should be anticipated during the assessment period. An opinion of cost is included in the Tables.

Basement sump pump

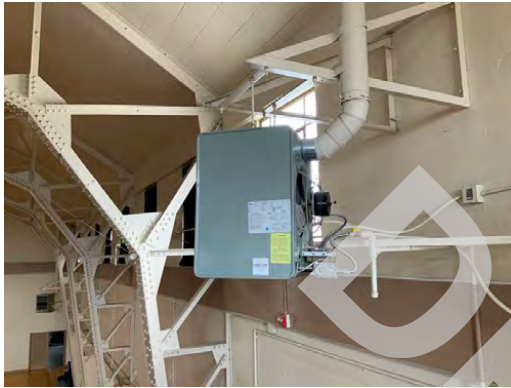
Current heating in the building is provided by ceiling hung gas-fired space heaters located in all sections and rooms of the building. Each space heater has a dedicated thermostat and are in good condition. Based on the age, condition and expected useful life, replacement should be anticipated during the assessment period. An opinion of cost for this work is included in the Tables.

Ceiling hung space heater

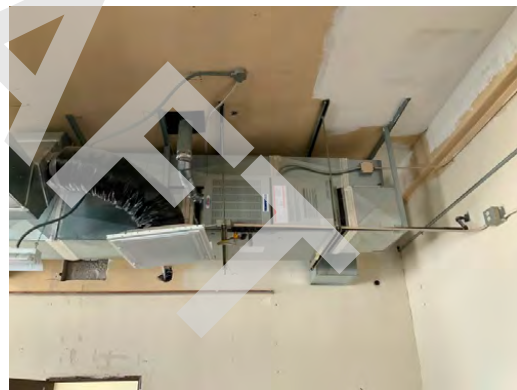
Heating in the west storage room is provided by a ceiling hung gas-fired furnace. According to the site contact, it is unknown if the unit is in operating condition. The digital thermostat was observed to have no power and the inlet gas valve was in the "on" position. AEI recommends an HVAC technician to put the unit back into service. An opinion of cost is included in the Tables.

Ceiling hung gas-fired furnace

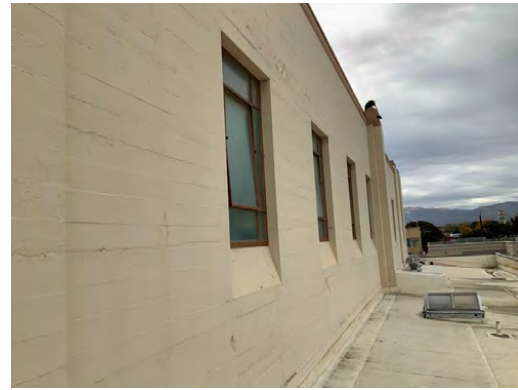
Natural cooling and ventilation for the building is provided by operable windows on the upper section of the east and west elevations. Windows are opened and closed by a manual crank located on the east and west interior walls. The crank system is in good and operating condition. Based on the age, condition, and expected useful life, routine maintenance is expected to be adequate to maintain the operable windows in good condition during the projection period covered by this report.

Operable upper windows

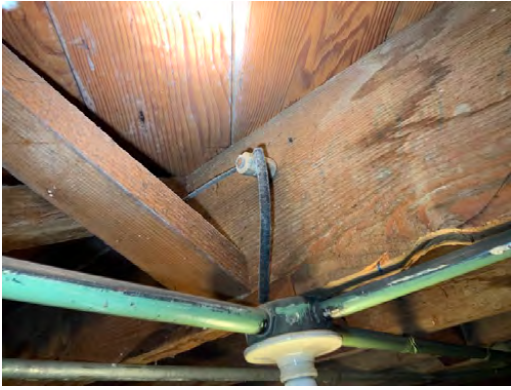
Knob and tube wiring

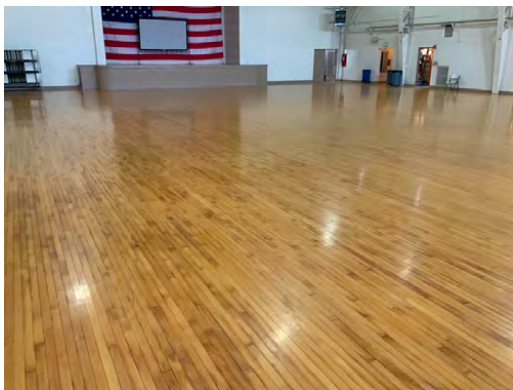
Damage to the open space wood plank flooring was observed at the northwest corner. The damage appears to be the outcome of a roof leak where the internal drain piping breaks through the roofing finishes. AEI recommends repairing the damaged wood plank section. An opinion of cost is included in the Tables.

Gymnasium flooring

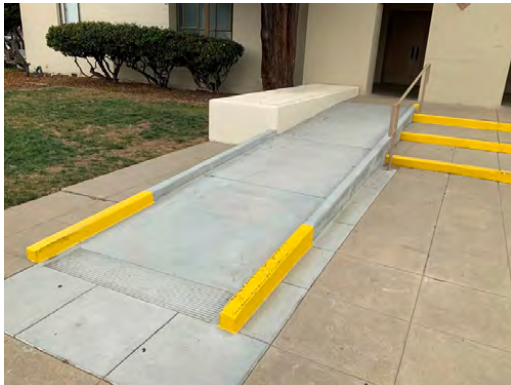
South elevation pedestrian ramp

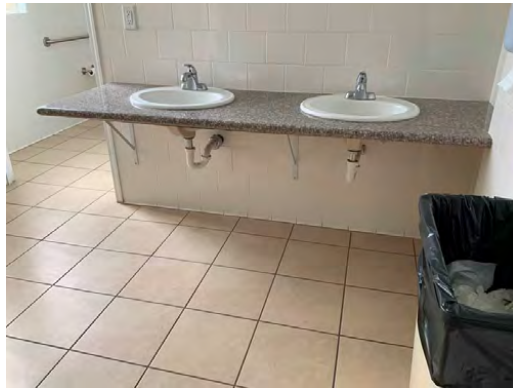
Protection of waste piping at common restroom sinks recommended. An opinion of cost for this work is included in the Tables.

Women's restroom exposed sink piping

Cost Recommendation	EUL	EFF AGE	RUL	Year	Cost
Public restroom, Wrap drain pipes below lavatory with insulation; protect against contact with hot, sharp, or abrasive surfaces	0	0	0	Immediate	\$70
Total					\$70

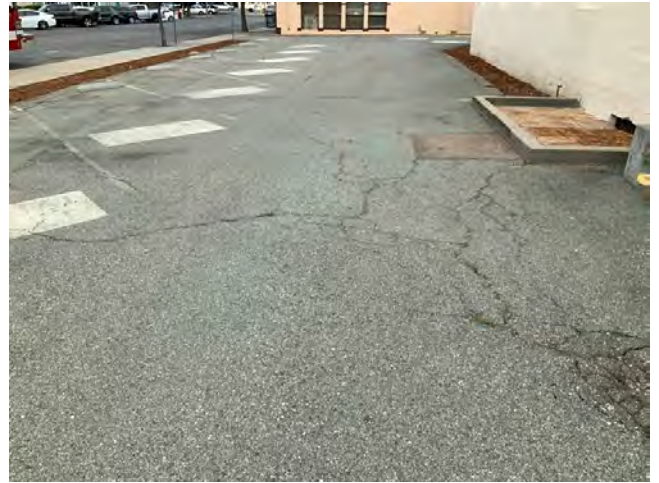
6. Wets parking lot finish

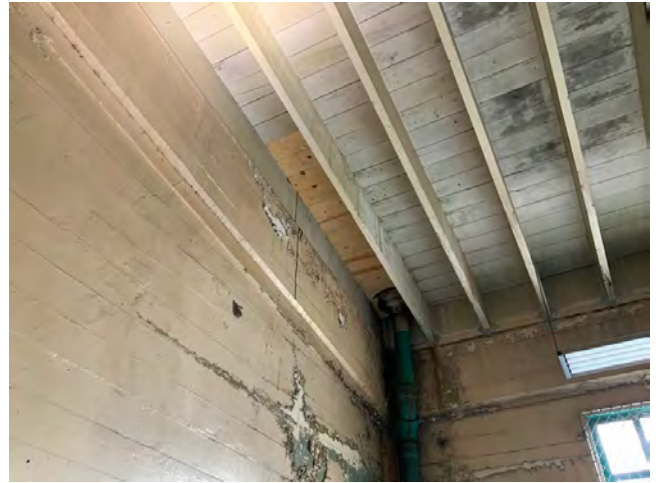
30. Repaired roof decking

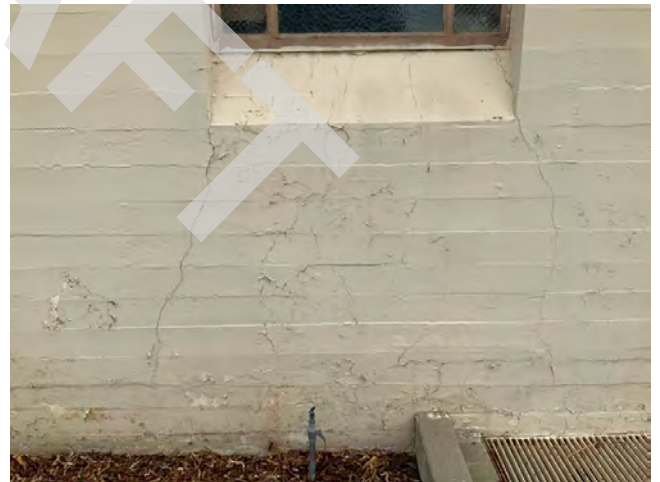
36. Exterior paint condition

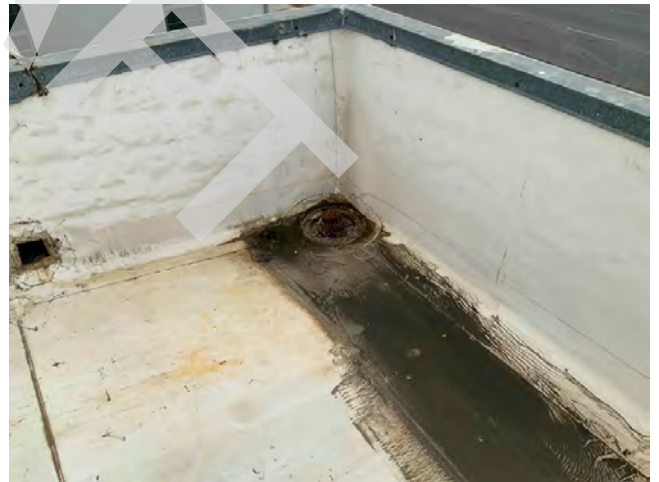
40. Roof drain

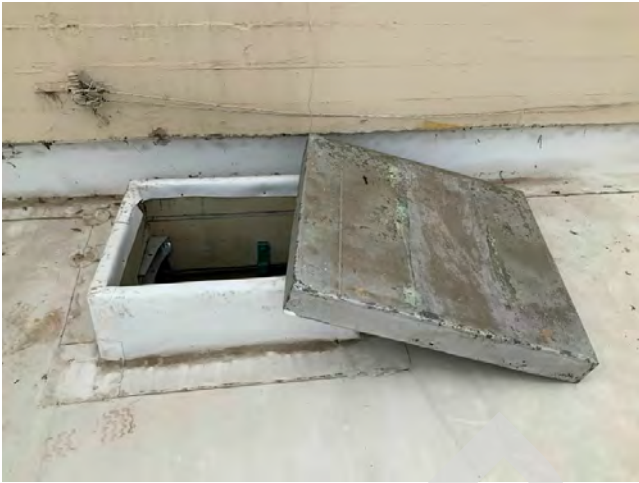
41. East lower roof lid

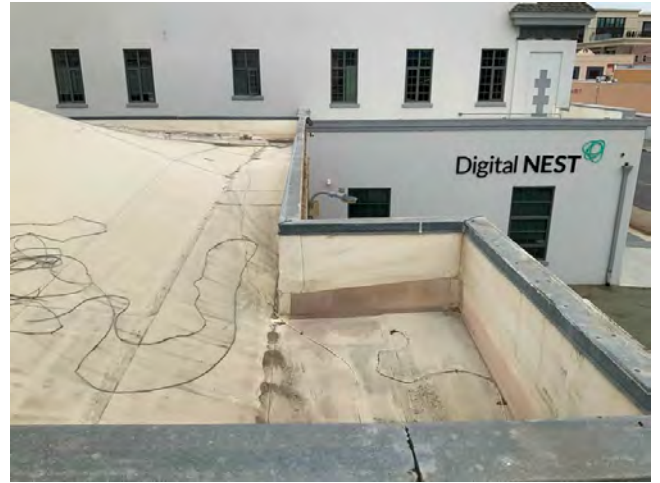
42. Parapet wall cap

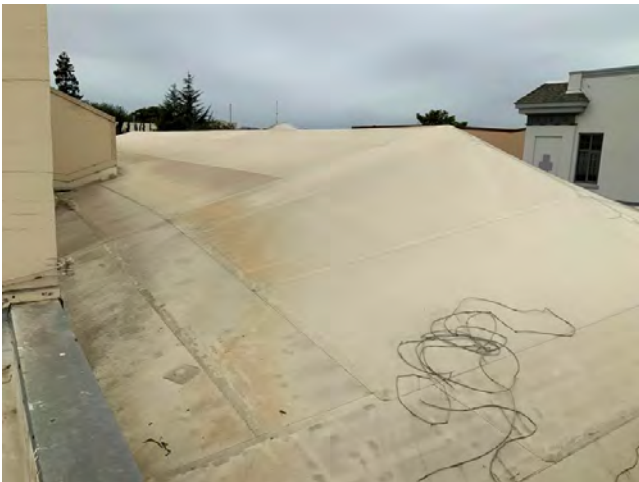
43. North lower roof

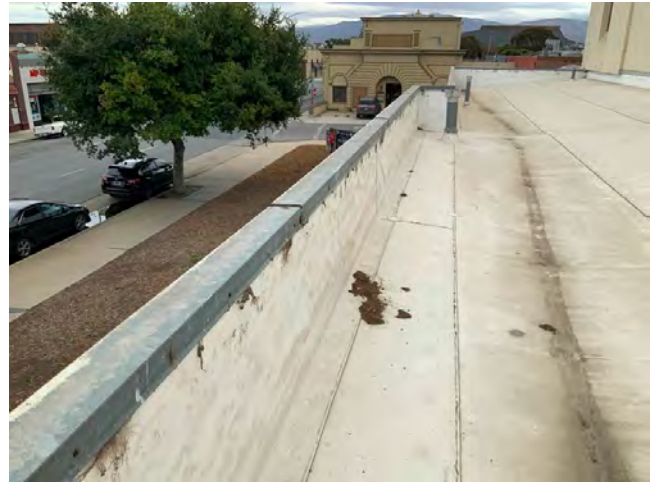
46. Parapet wall

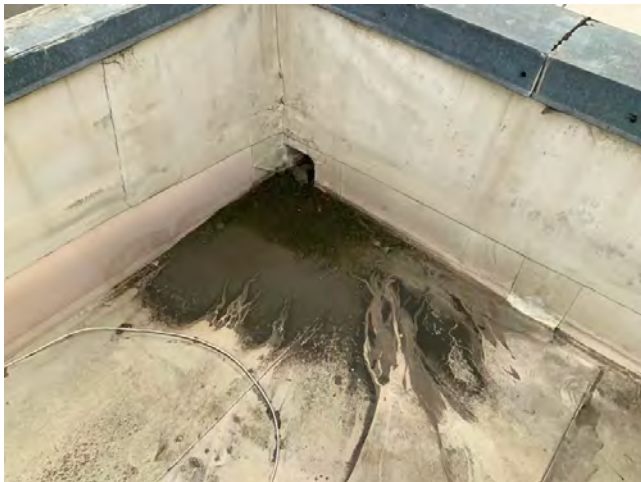
47. Roof scupper

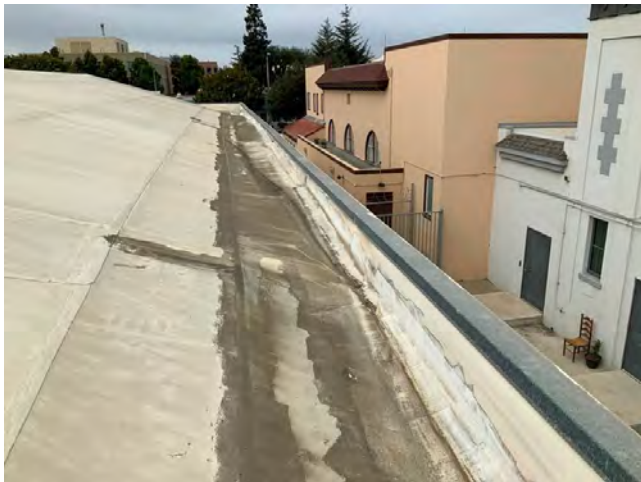
52. Roof repair damage

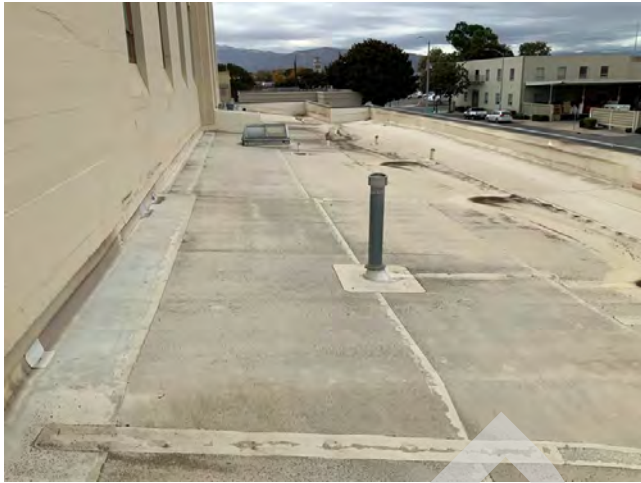
54. Roof patchwork and low spots

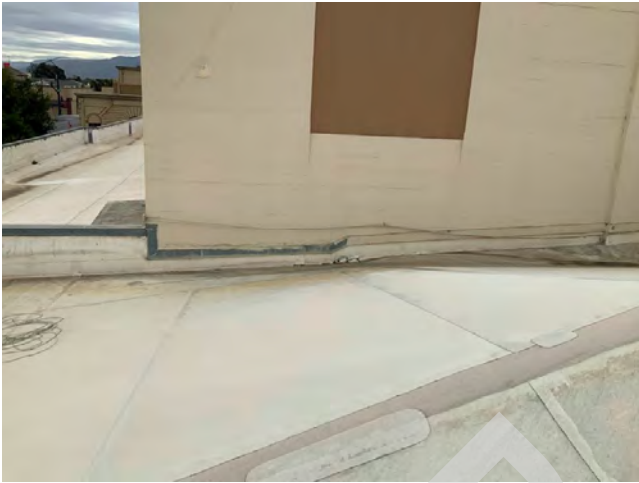
57. Unattached sections of the north roof

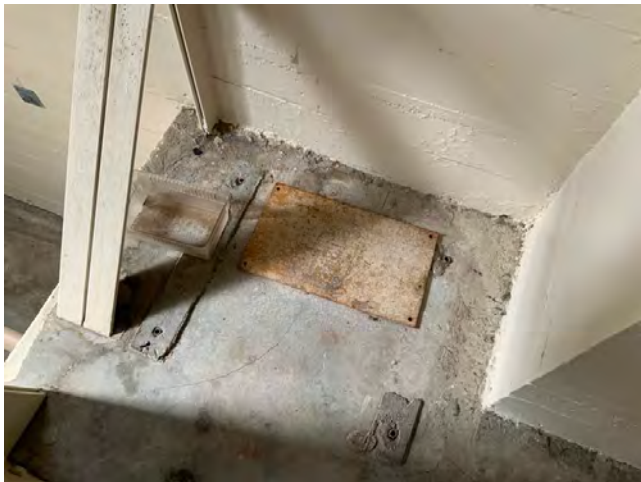
67. Concrete hole covered with plywood

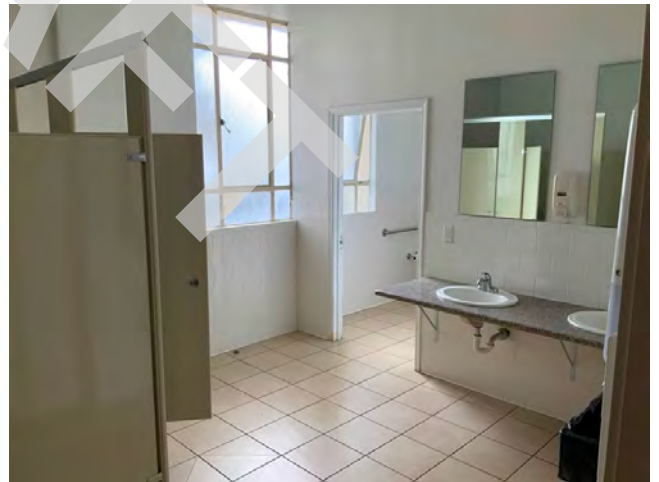
84. Women's restroom overview

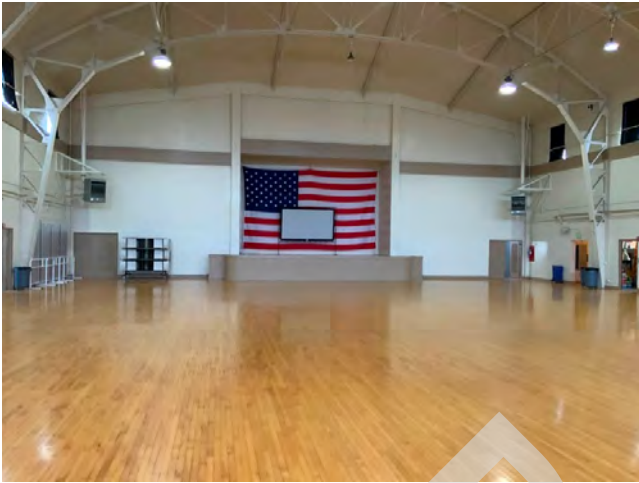
85. Gymnasium overview

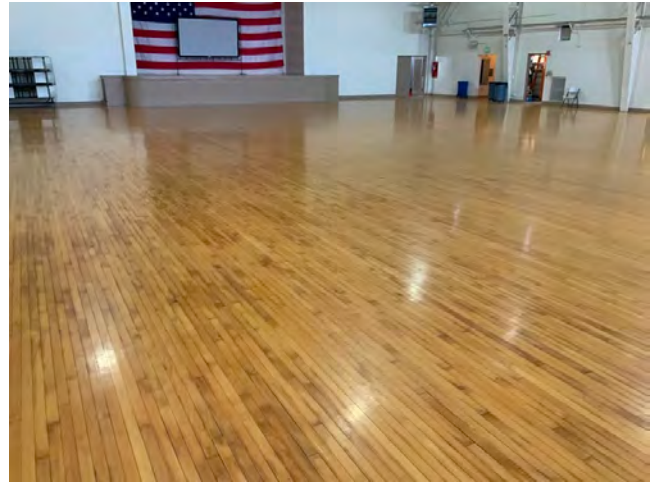
86. Gymnasium flooring

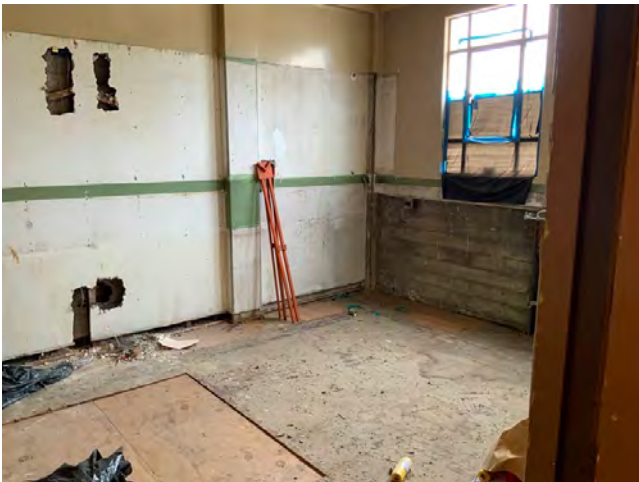
87. Former commercial kitchen

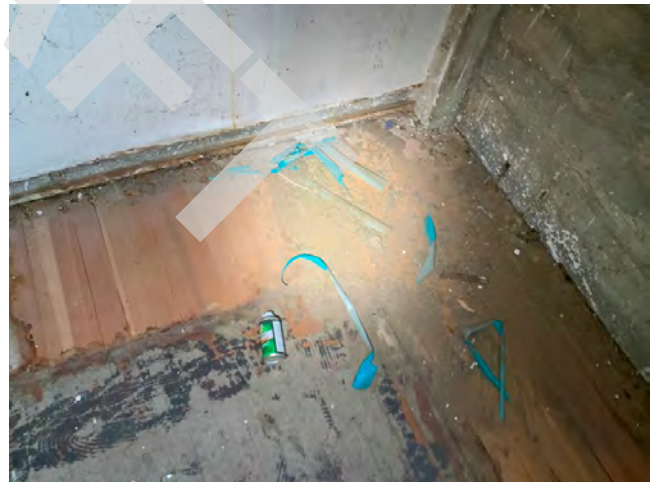
88. Flooring finish

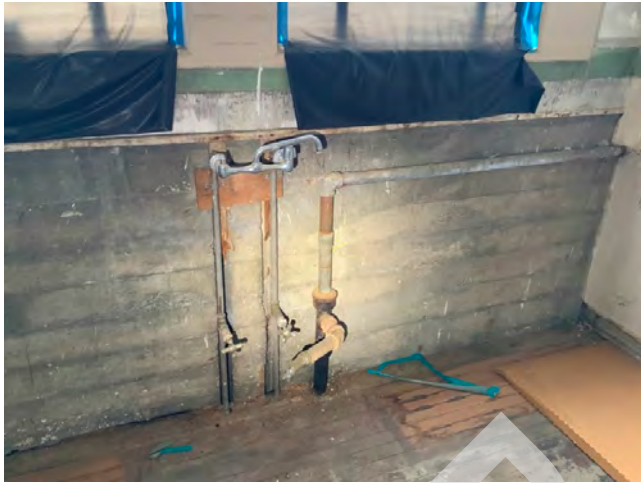
89. Plumbing piping

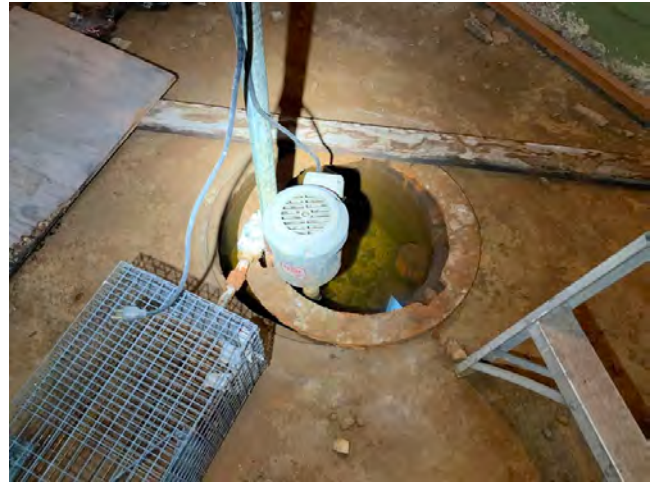
90. Basement sump pump

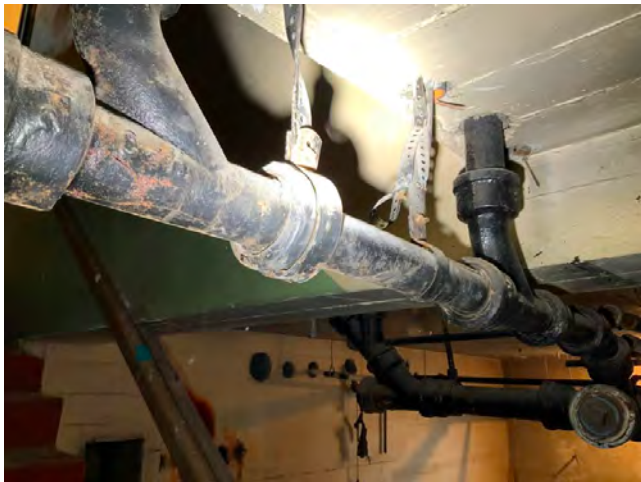
91. Waste piping

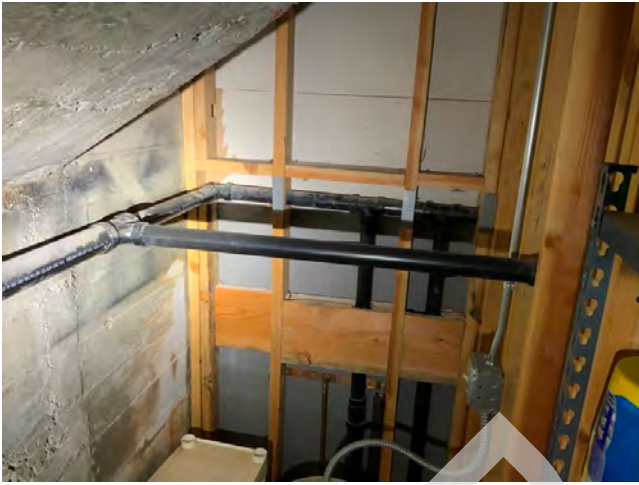
93. Restroom ABS plumbing

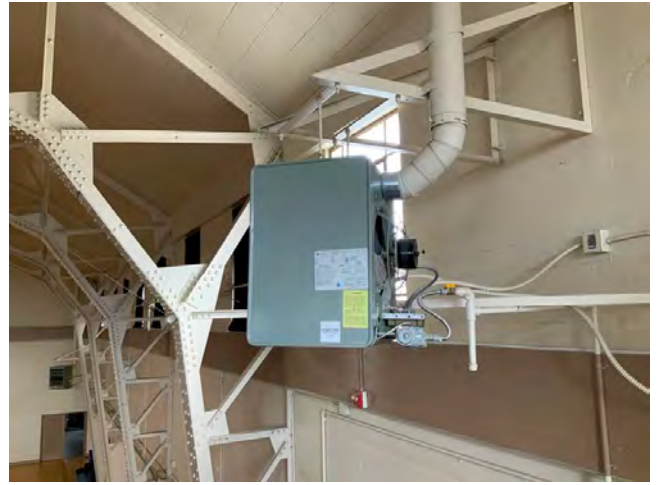
94. Ceiling hung space heater

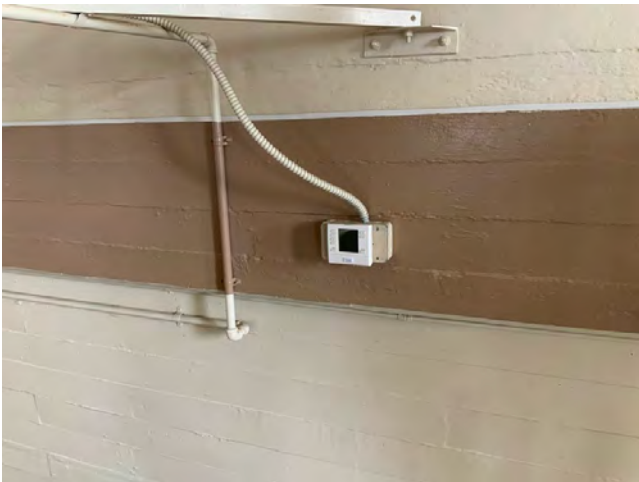
95. Space heater thermostat

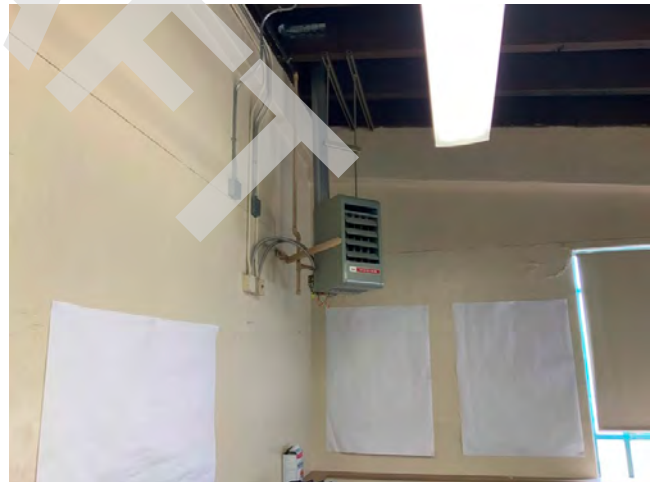
96. Conference room space heater

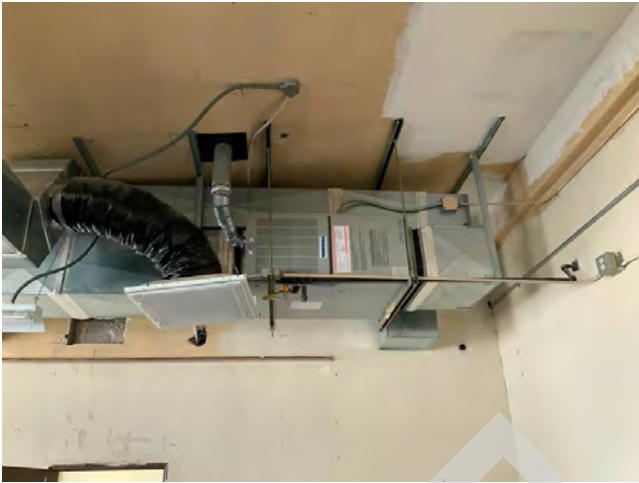
97. Ceiling hung gas-fired furnace

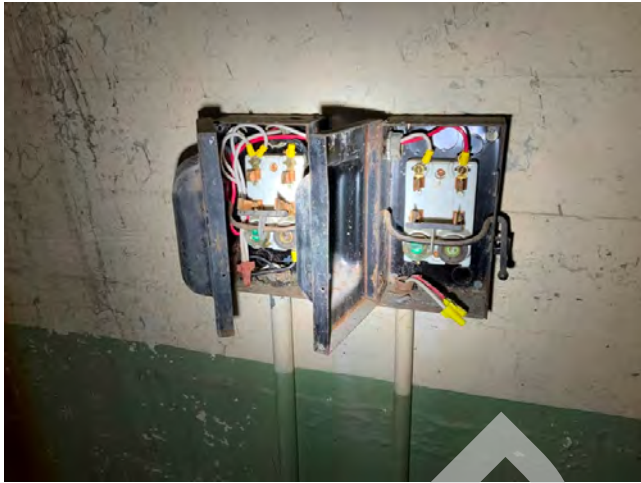
101. Basement screw in fuses

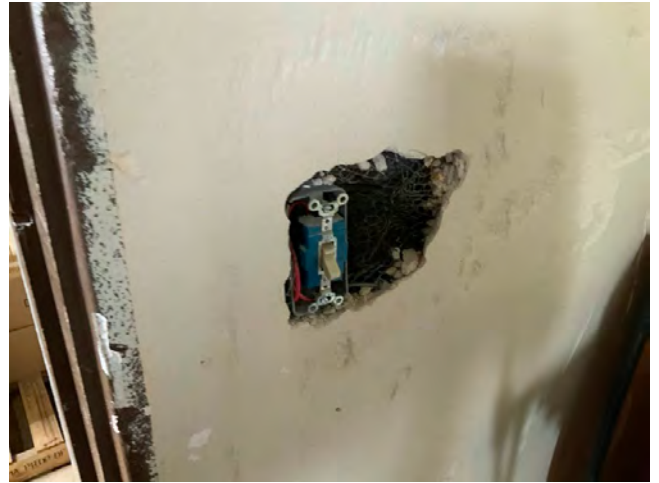
102. Exposed electrical wiring

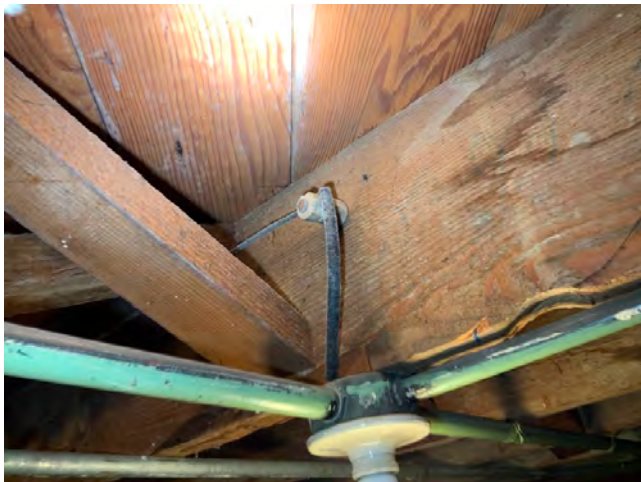
103. Knob and tube wiring

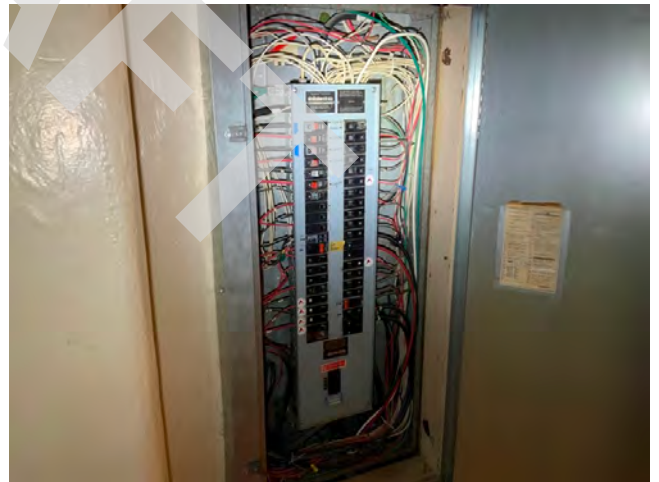
104. Main electrical panel

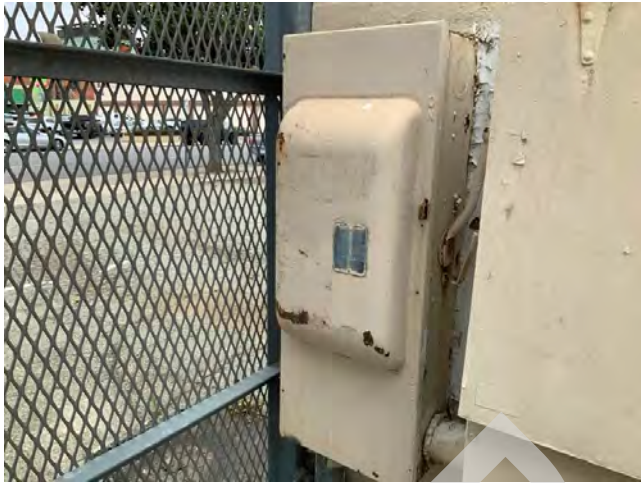
105. Main service disconnect

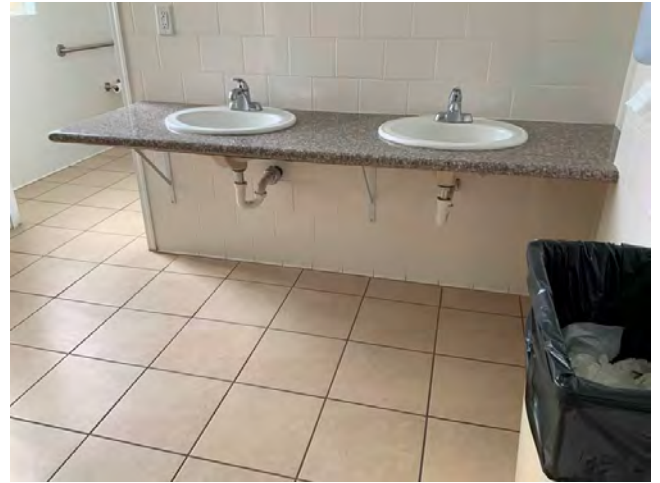
118. Women's restroom exposed sink piping

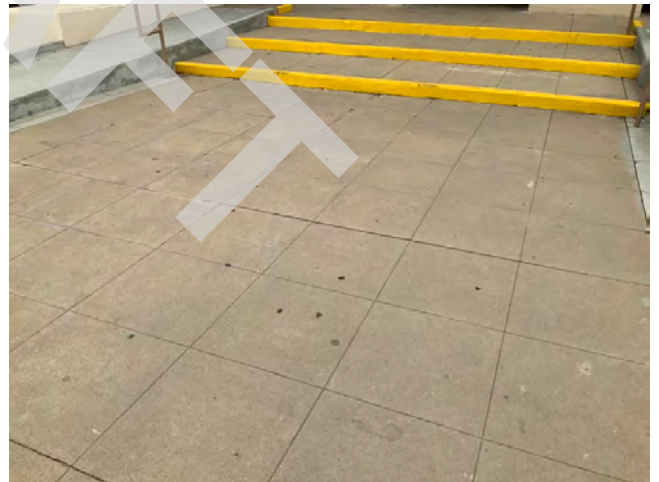
127. South site sidewalk cracking

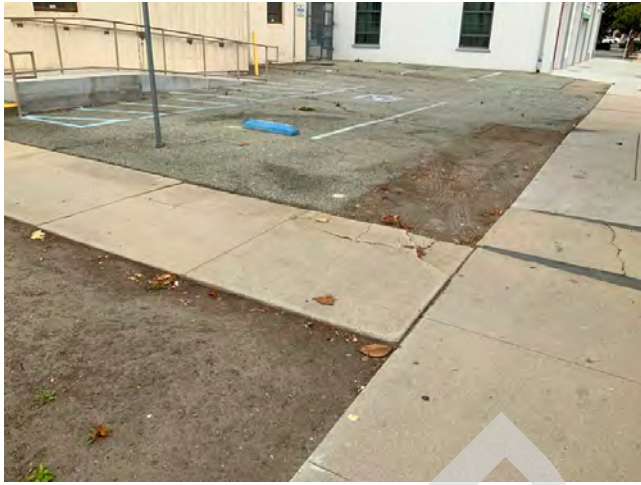
132. Public sidewalk displacement

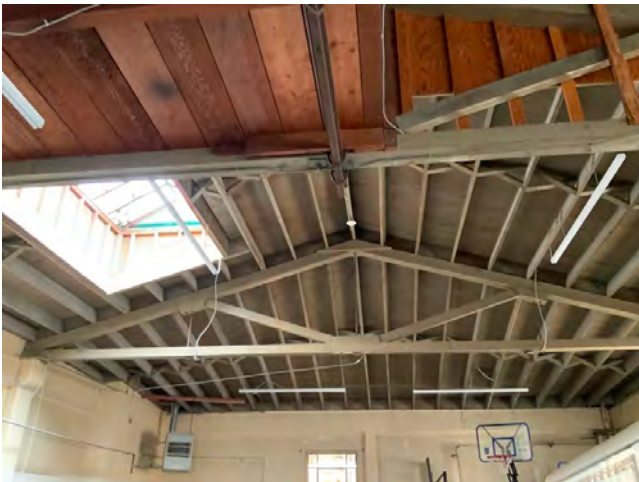
162. Knob and tube wiring

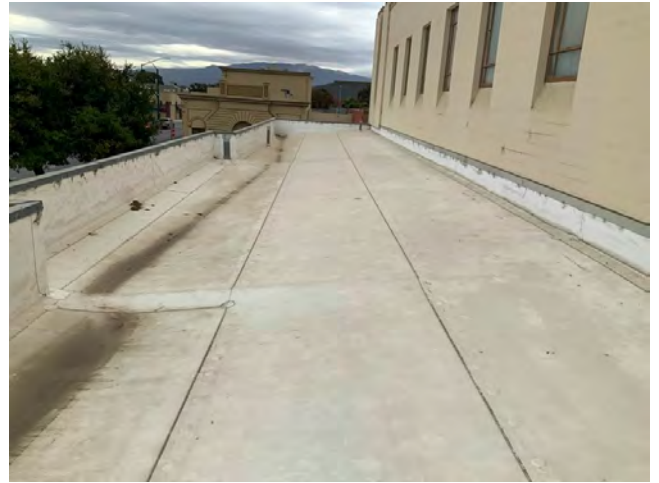
170. East lower roof

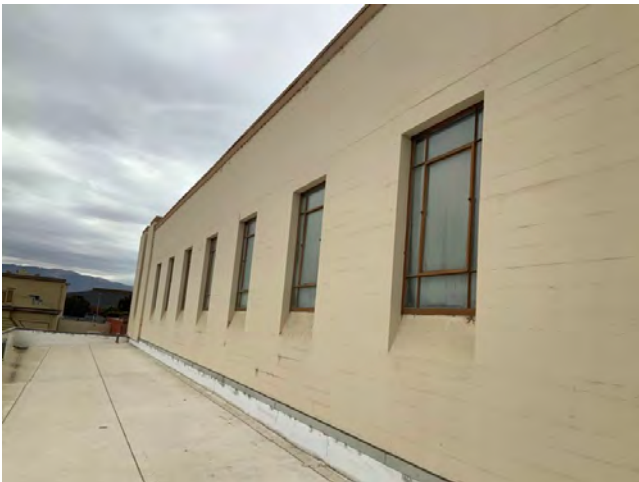
171. Upper exterior wall finishes

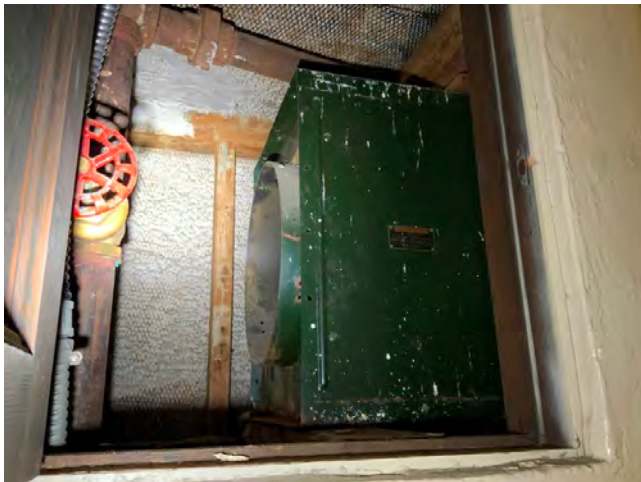
183. Decommissioned hydronic fan coil unit

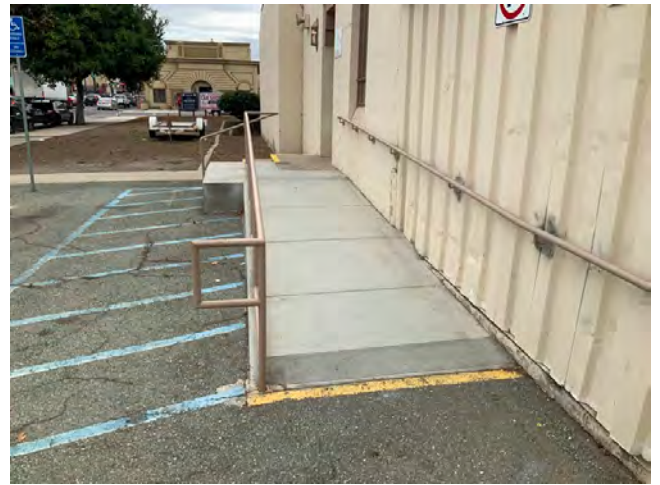
195. Deteriorating exterior

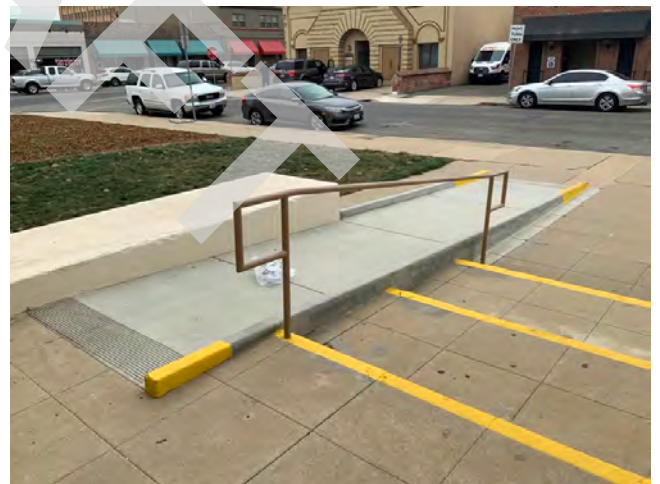
196. South ramp handrails
